DOT US Department of Transportation  
PHMSA Pipeline and Hazardous Materials Safety Administration  
OPS Office of Pipeline Safety – Accident Investigation Division

**Principal Investigator** Wesley Mathews  
**Acting Accident Investigation Director** Chris Ruhl  
**Date of Report** May 26, 2022  
**Subject** Failure Investigation Report - Denbury Gulf Coast  
Pipelines, LLC – Pipeline Rupture/ Natural Force Damage

**Failure Investigation Report – Denbury Gulf Coast Pipelines LLC**  
**Pipeline Rupture/Natural Force Damage**  
February 22, 2020

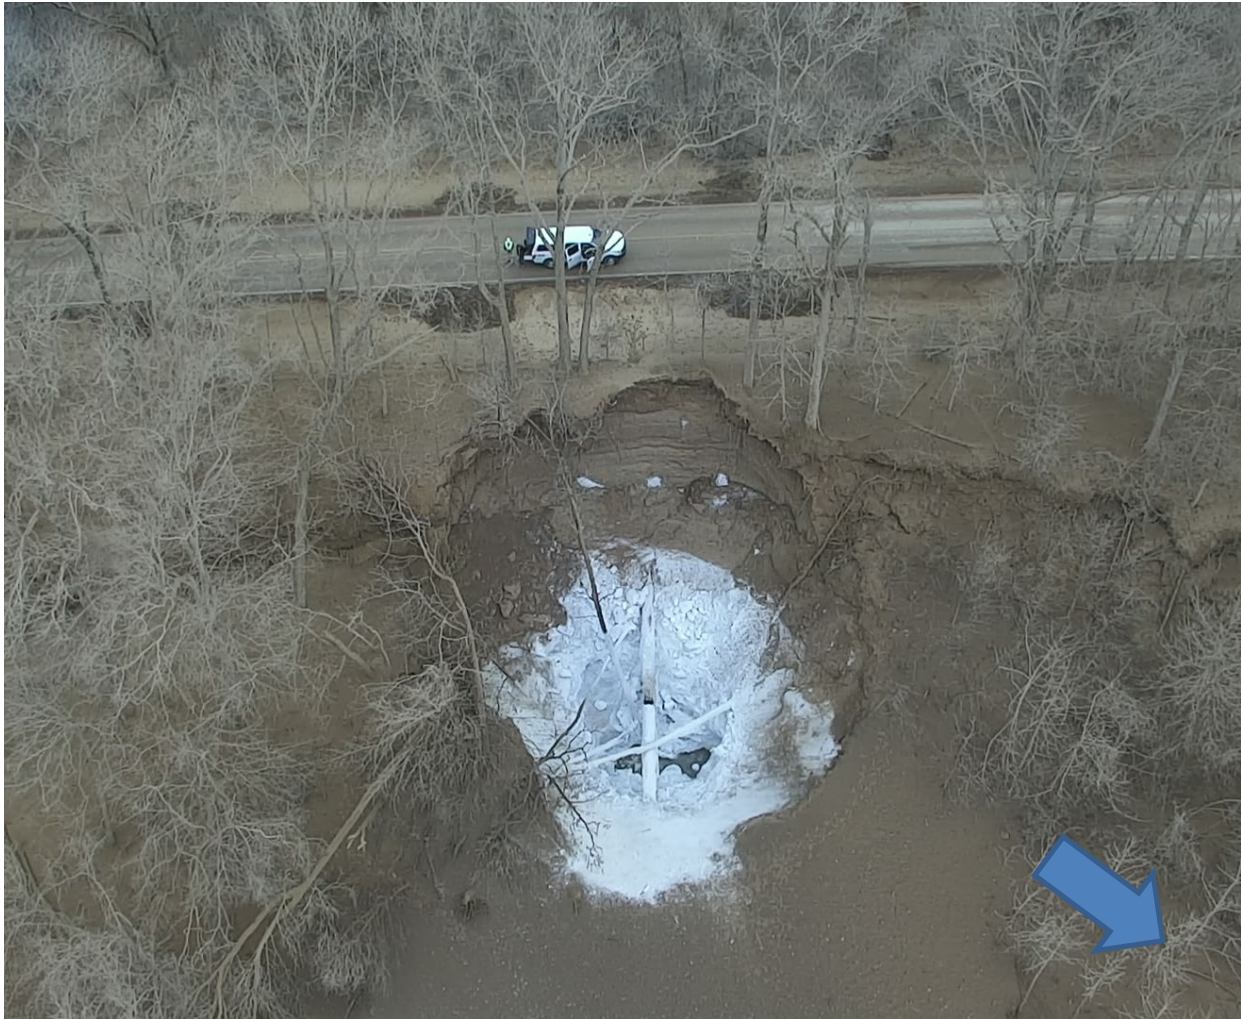
On February 23, 2020, at 10:09 a.m., a PHMSA AID investigator from Oklahoma City arrived at the intersection of HWY 433 and Highway 3 to meet with Denbury representatives and emergency response organizations. The group then proceeded to the site of the rupture (Figure 2). By that time, the IC had demobilized, and roadblocks had been removed. Denbury crews were in the process of setting up caution fencing and slowing traffic on HWY 433 for public and worker safety. The rupture crater was on the northeast side of HWY 433 (Figure 2).

*Figure 2: Vehicle is Parked on HWY 433 - The White is Ice Generated by the Release of CO<sub>2</sub> - The Blue Arrow Points North (Aerial Drone Photograph Courtesy of the Mississippi Emergency Management Agency)*

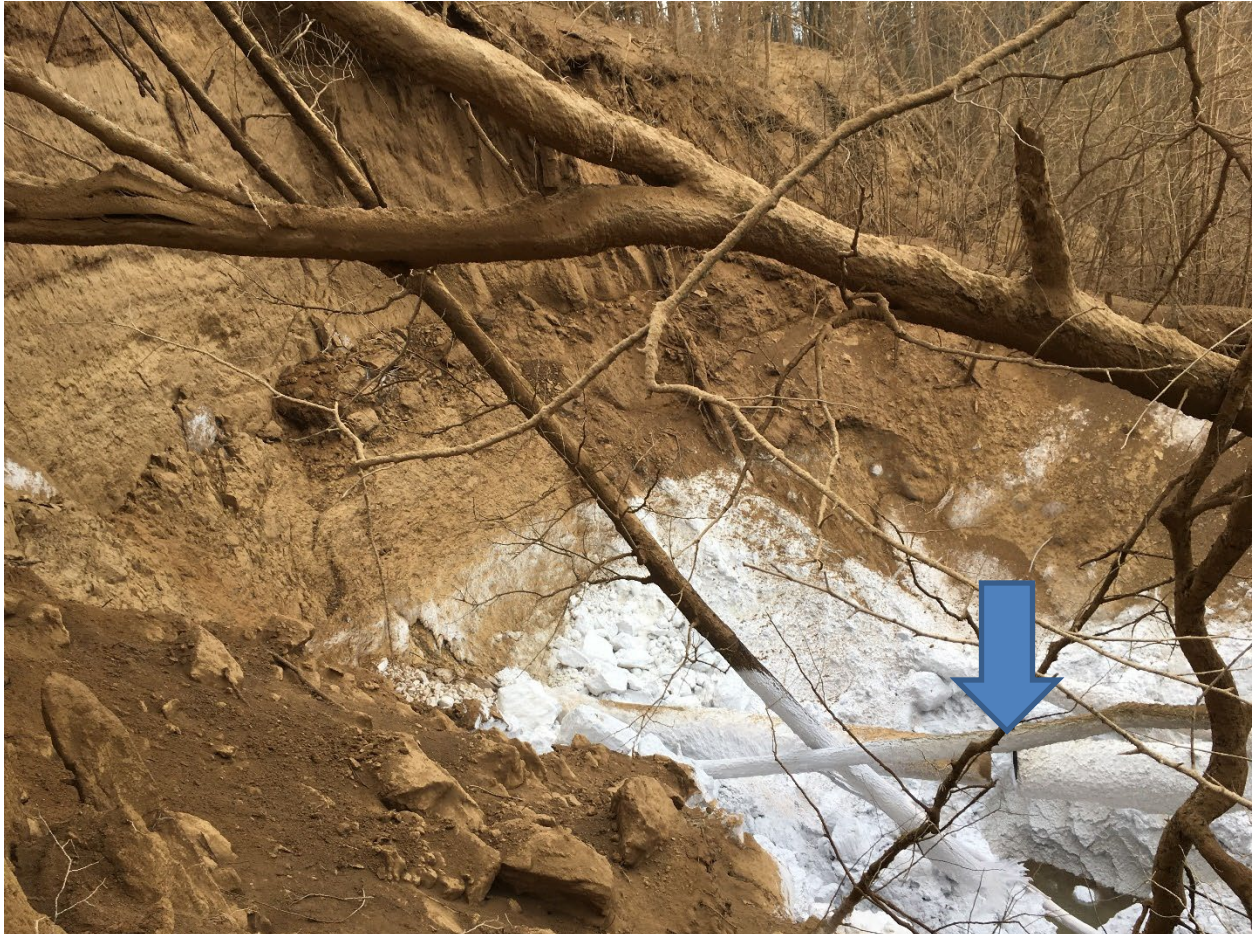
*Figure 3: Crater Created by the Rupture Containing Fallen Debris (dry ice, and the failed pipe sections)  
(Blue Arrow is Pointing at the Pipeline Separation)*

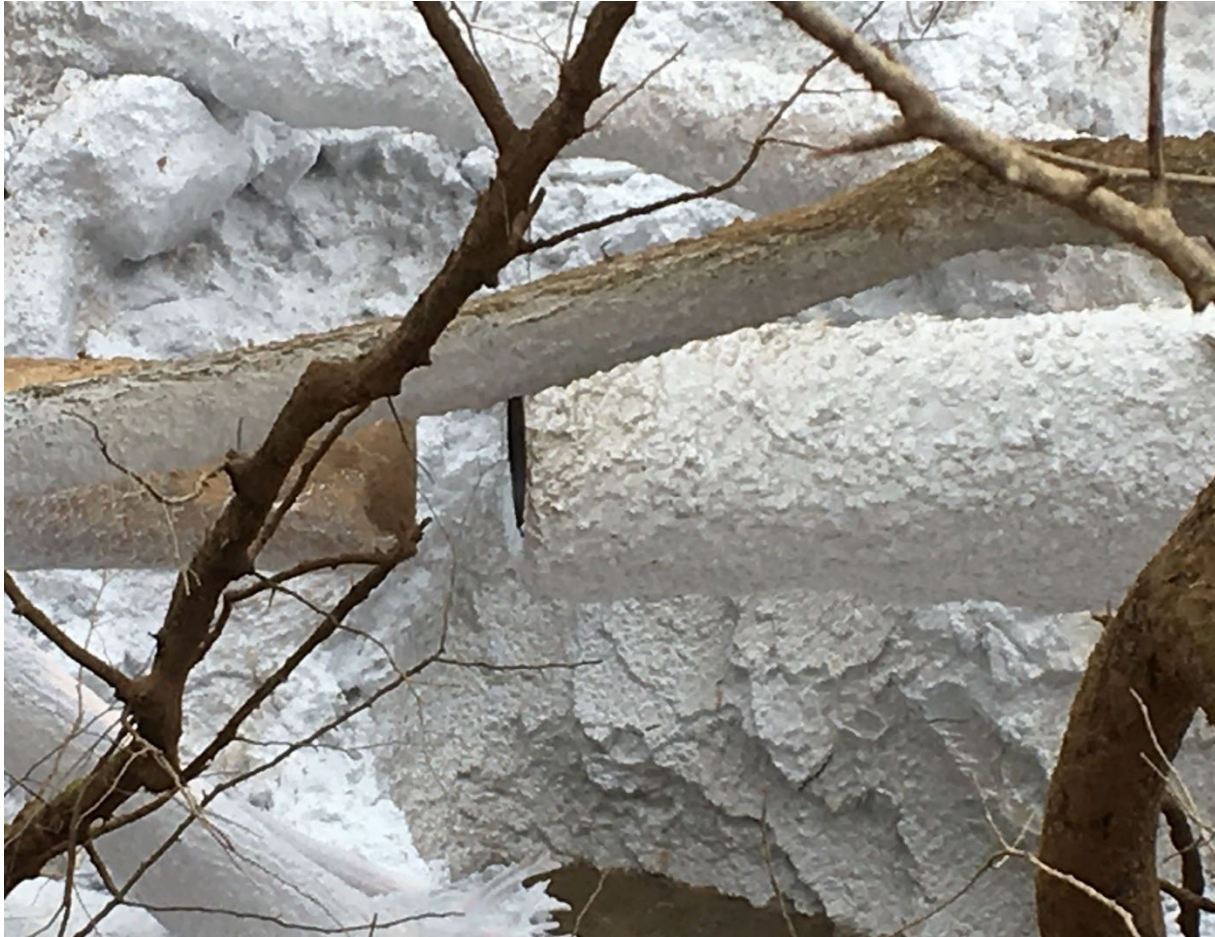
The pipeline failed on a steep embankment adjacent to HWY 433, which had recently subsided. Heavy rains are believed to have led to a landslide, which created axial strain on the pipeline and resulted in a full circumferential girth weld failure. After the accident, Denbury, under PHMSA's oversight, cut out the failed sections of pipe and sent them to Det Norske Veritas' (DNV) Columbus, Ohio laboratory for metallurgical analysis. DNV confirmed the initial onsite observations of a girth weld failure.

*Figure 4: The failed pipe sections shown separated by a few inches.*

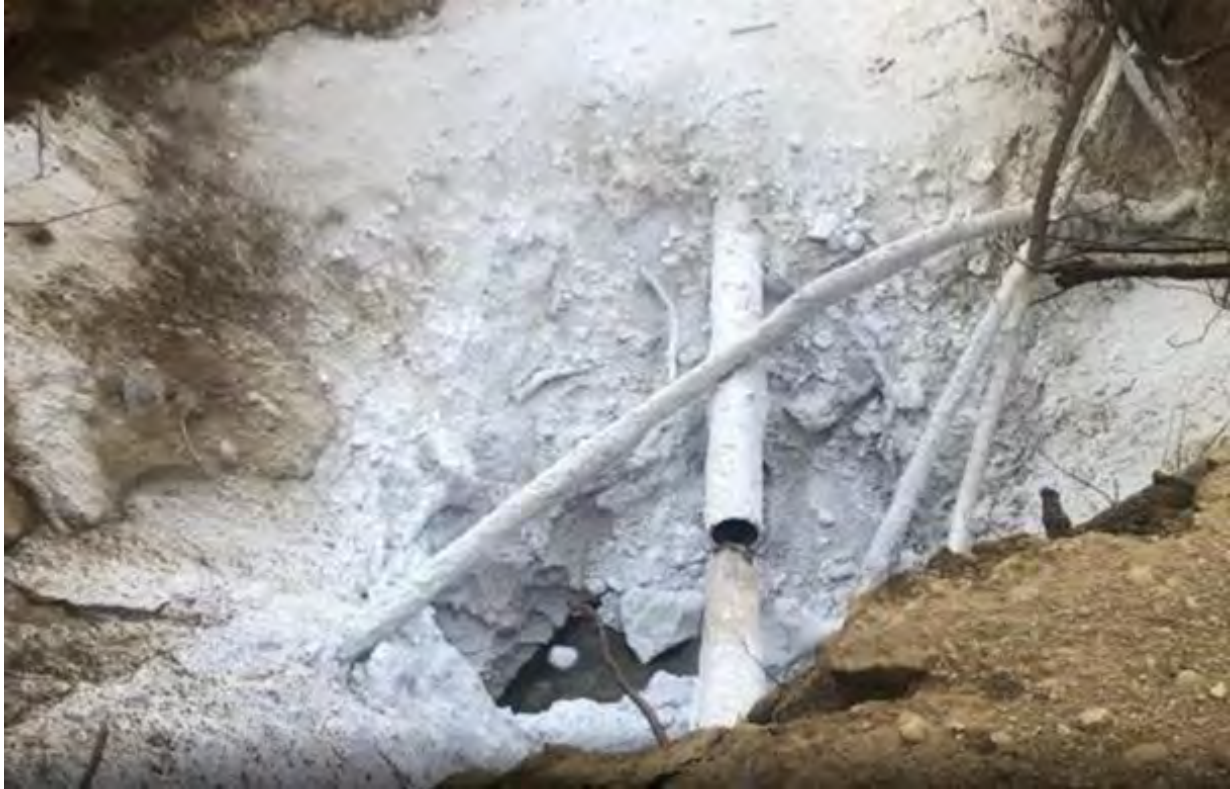
**Figure 4. Post-Incident Photo of Failure Location (Downstream to Upstream)**

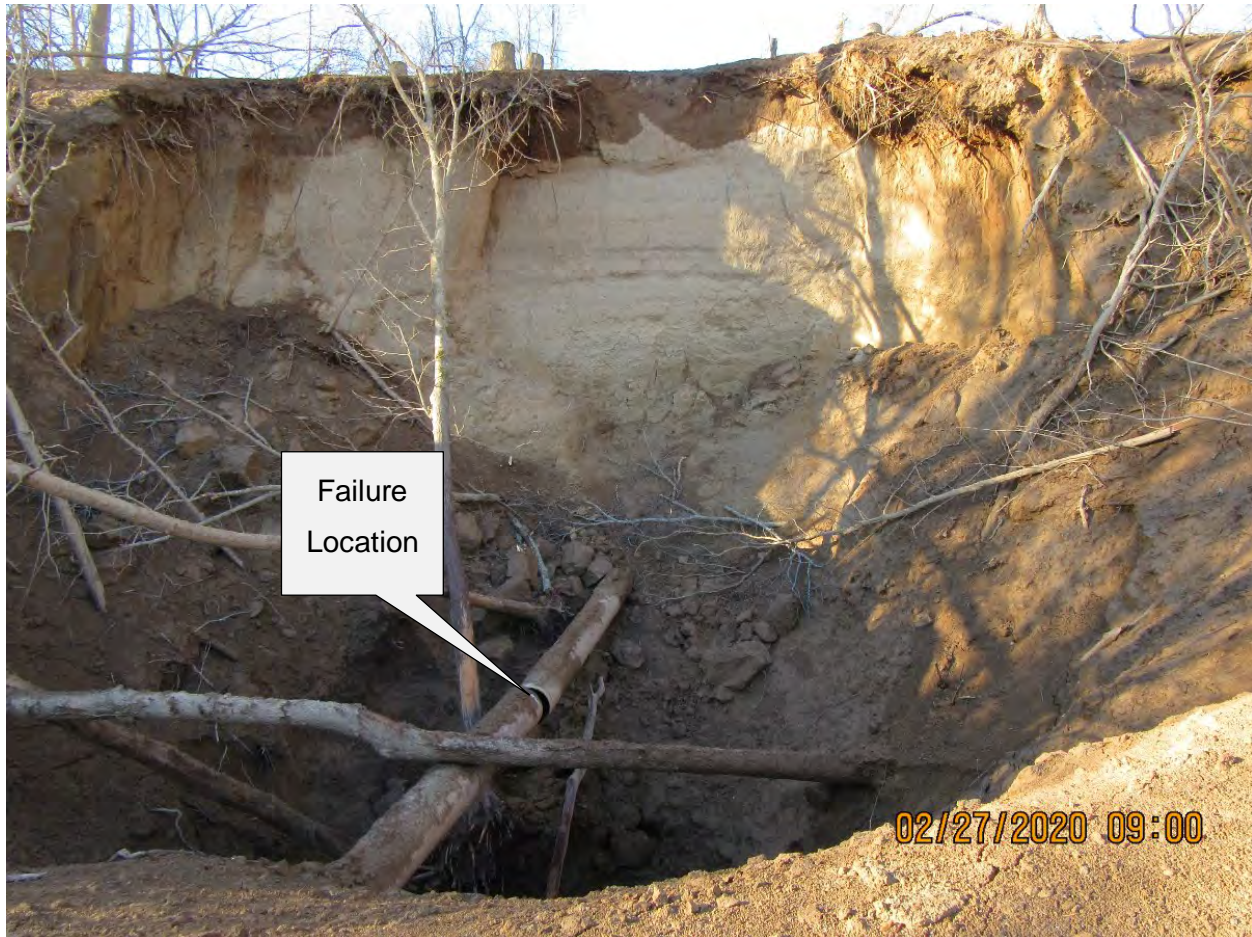
**Figure 6. Failure Location (Upstream to Downstream)**

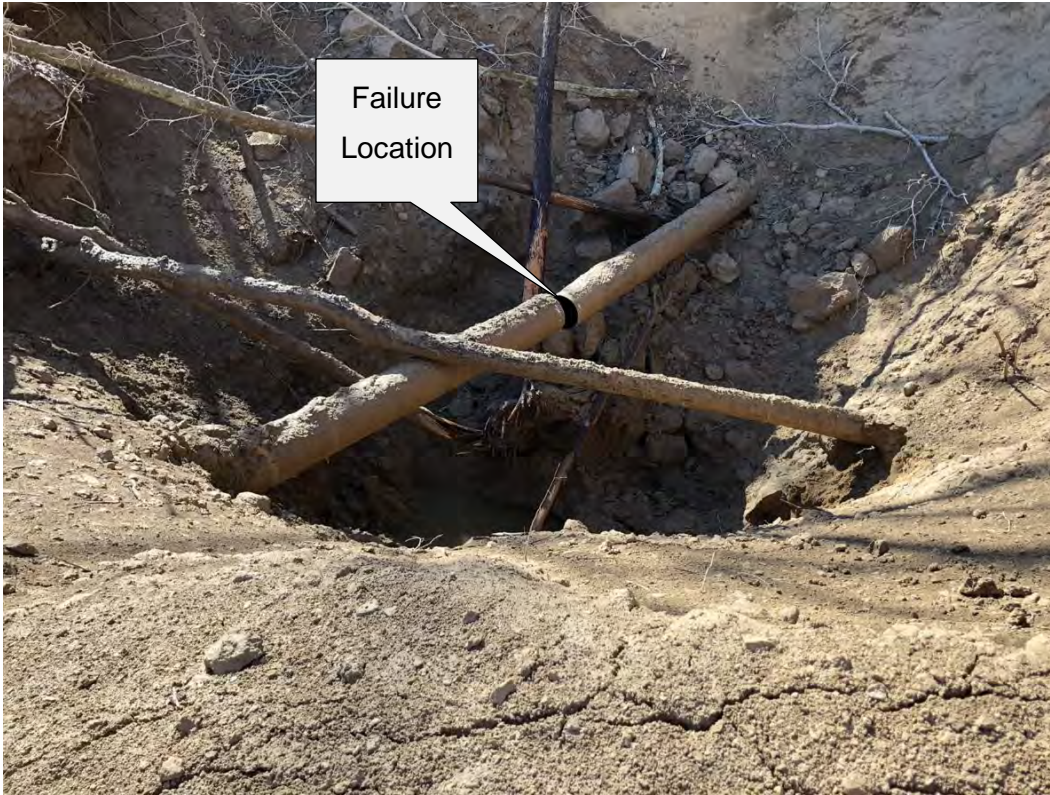
**Figure 7. Failure Location (Upstream to Downstream)**

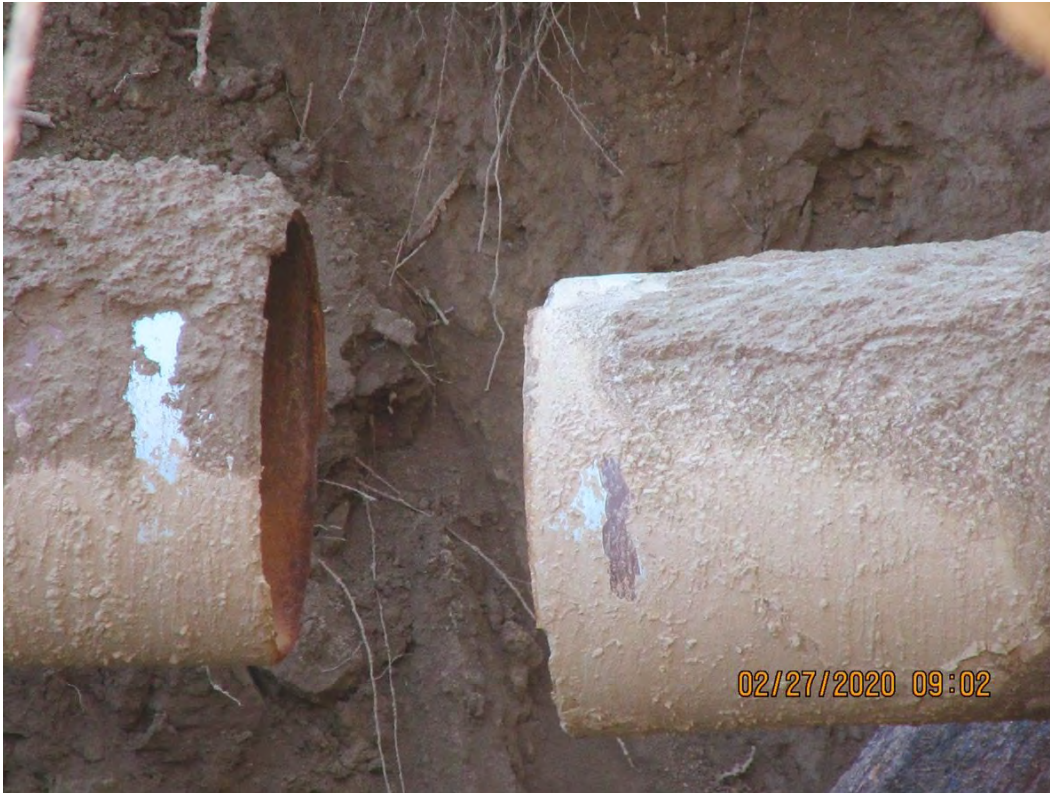
In-situ visual inspection of the exterior surface of the pipe identified a separation of the piping at a girth weld of approximately 8 inches, with slight misalignment between the upstream and downstream joints. Figure 8 provides a close-up of the as-found pipe and coating condition at the separation.

**Figure 8. Delhi 24-inch Transmission Line Failure - As-Found Condition at Girth Weld**

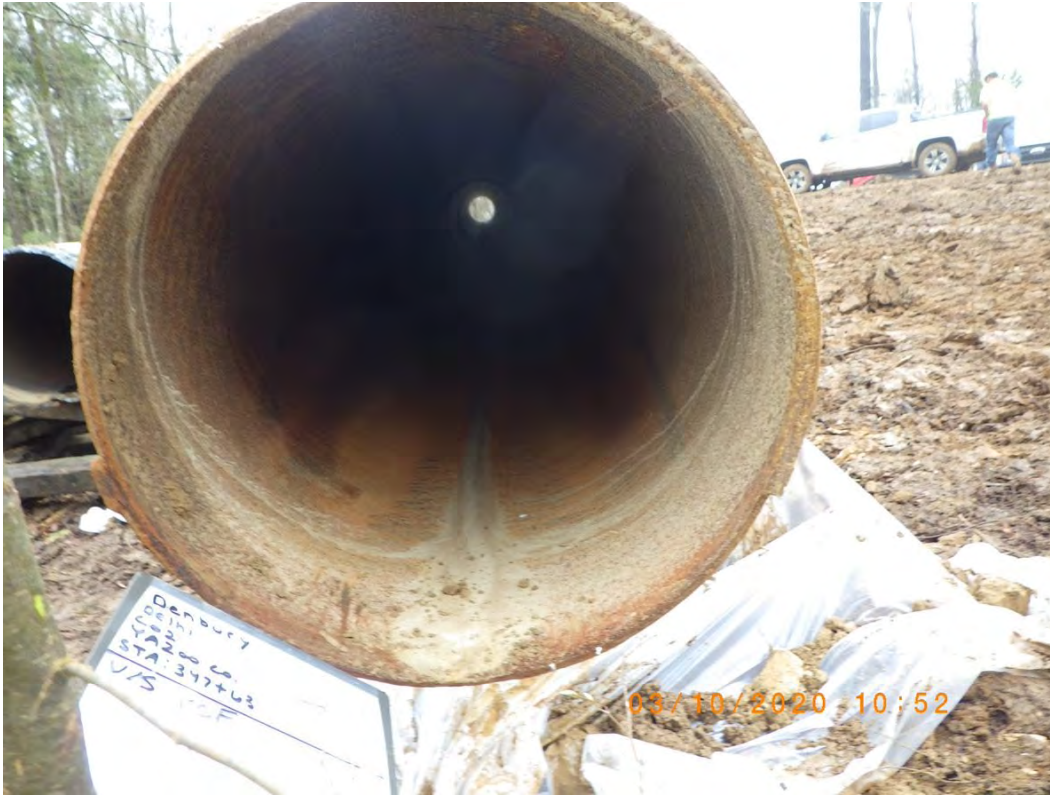
Initial visual inspection of the internal surface of the piping showed no accumulated solids or liquids in the pipe sample and no indications of pitting or corrosion. A view of the internal condition of the pipe section containing samples B & C after removal is provided in Figure 11.

**Figure 11. Internal Condition of Pipe Sample During Removal**

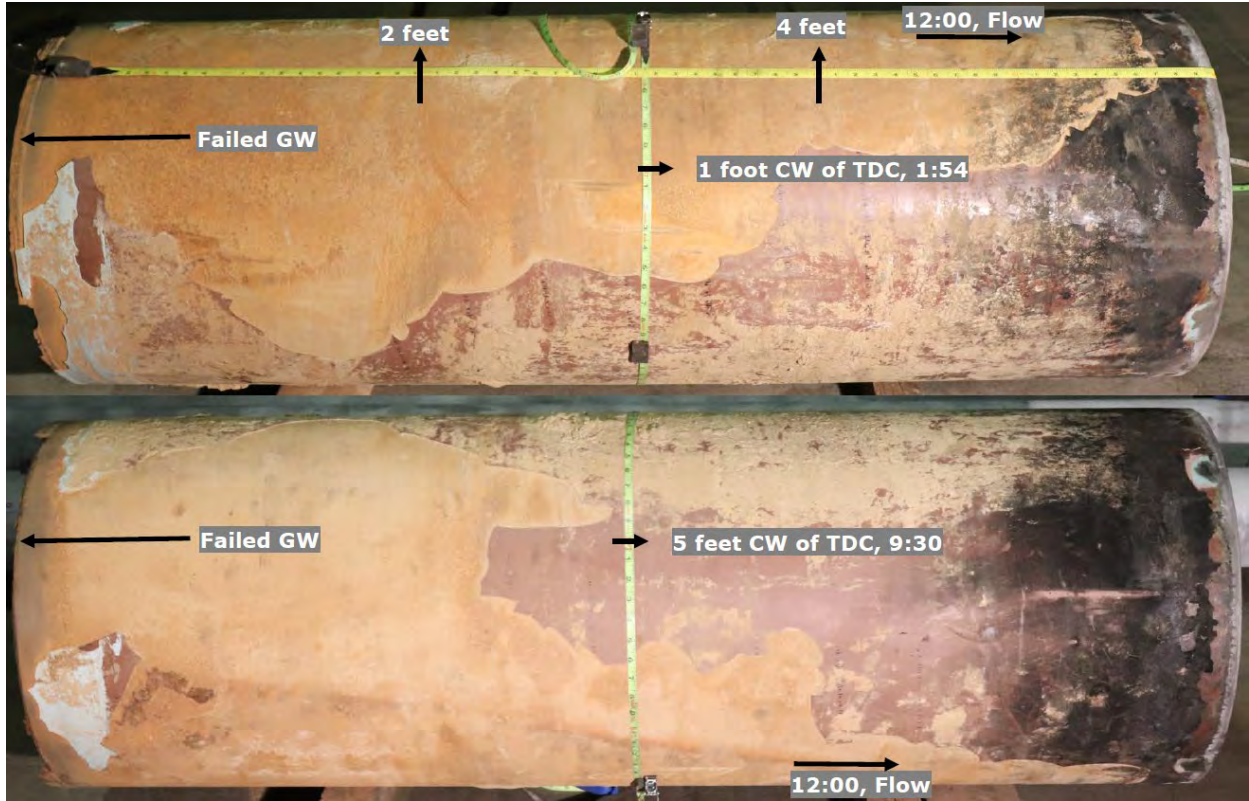
Figure 12. Pipe Sample A (PS A)

The pipe adjacent to the fracture surfaces and failed girth weld were visually inspected. The fractured surface was flat and generally at a 180-degree angle with no thinning and/or reduction of the affected area. The fracture path traversed or crossed over the weld at various locations.

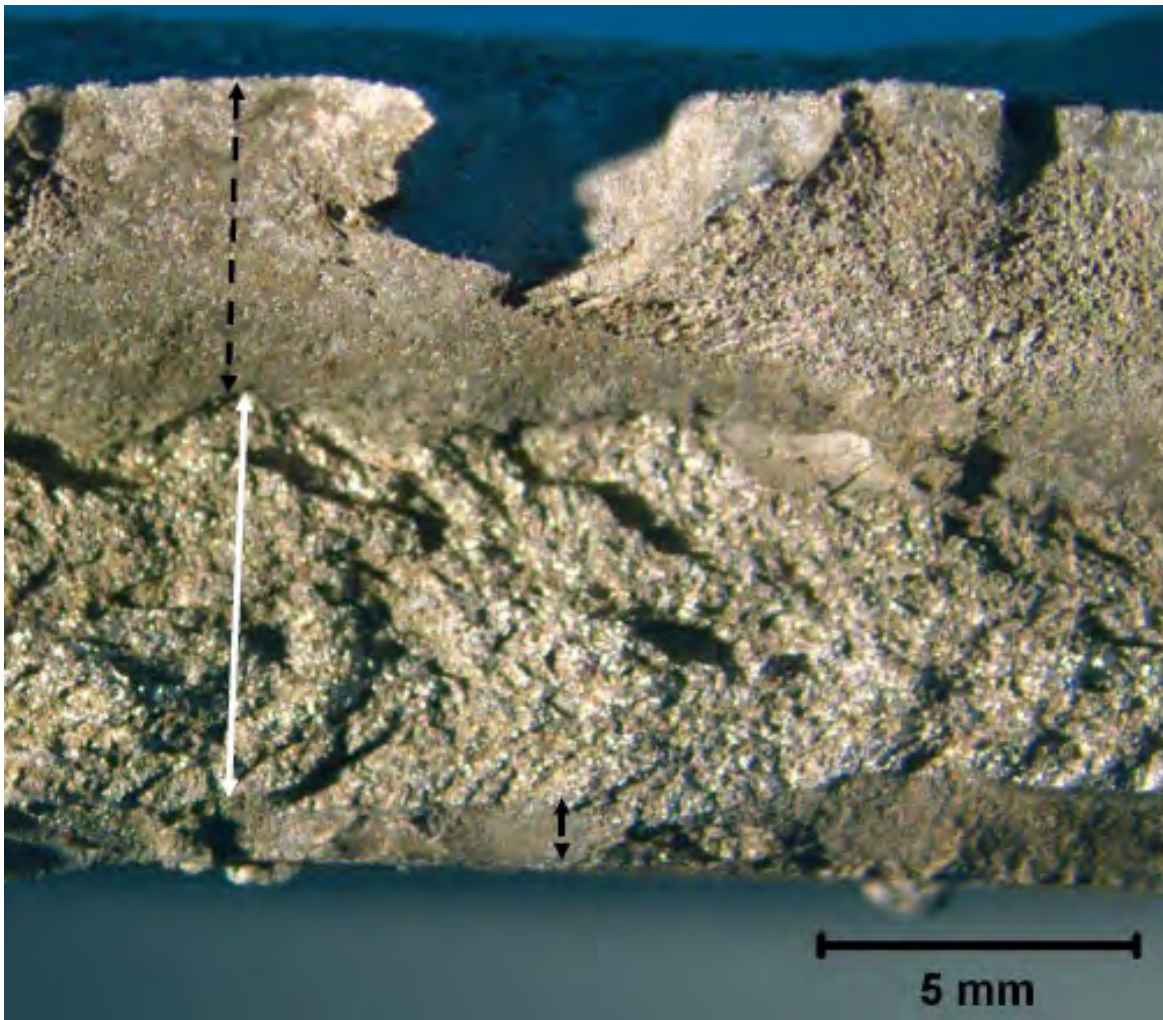
Figure 17. Image of Sample S2 - Smooth (Black Arrow) and Rough (White Arrow) Regions

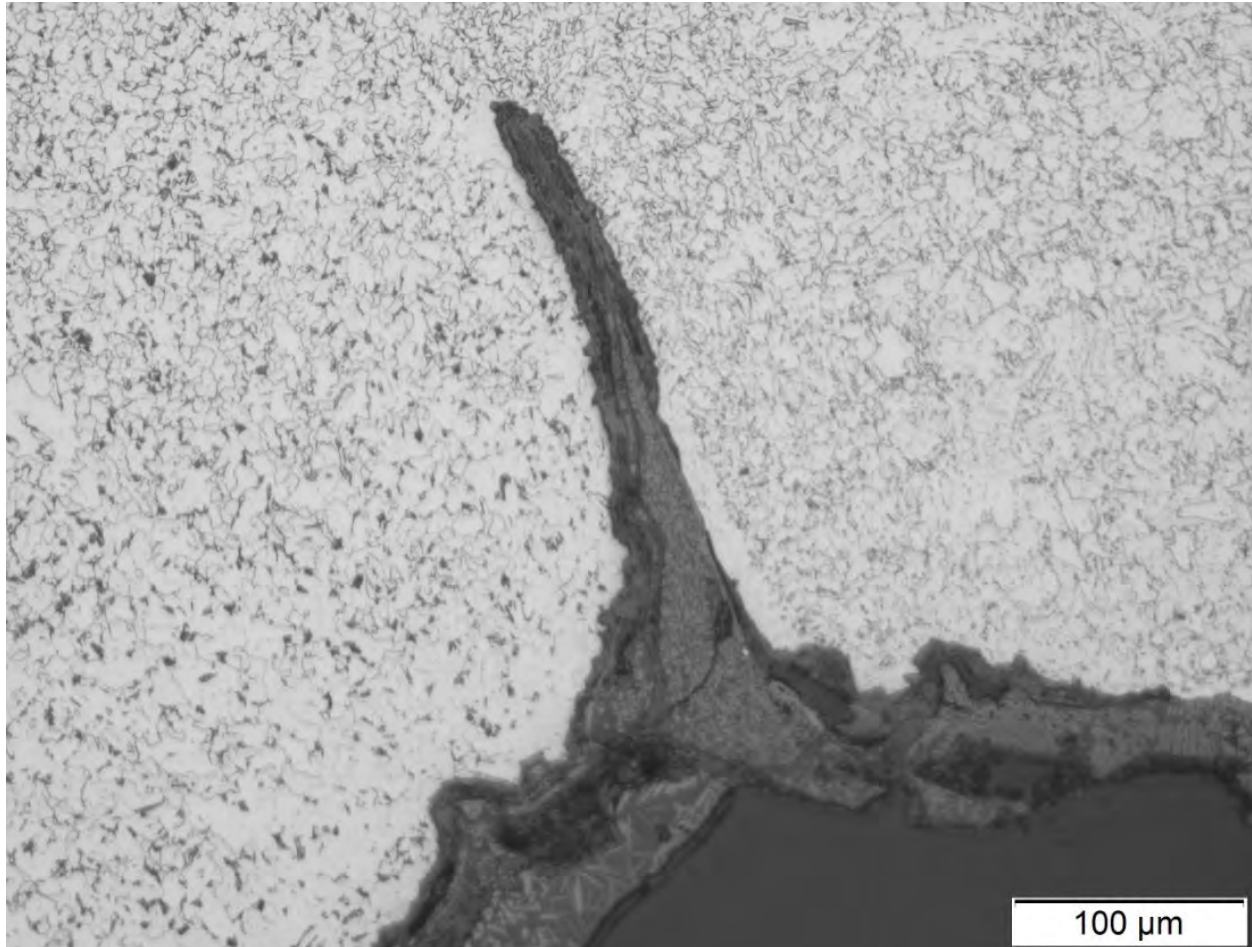
**Figure 35. Close Up View of Sample MU1 Flaw**

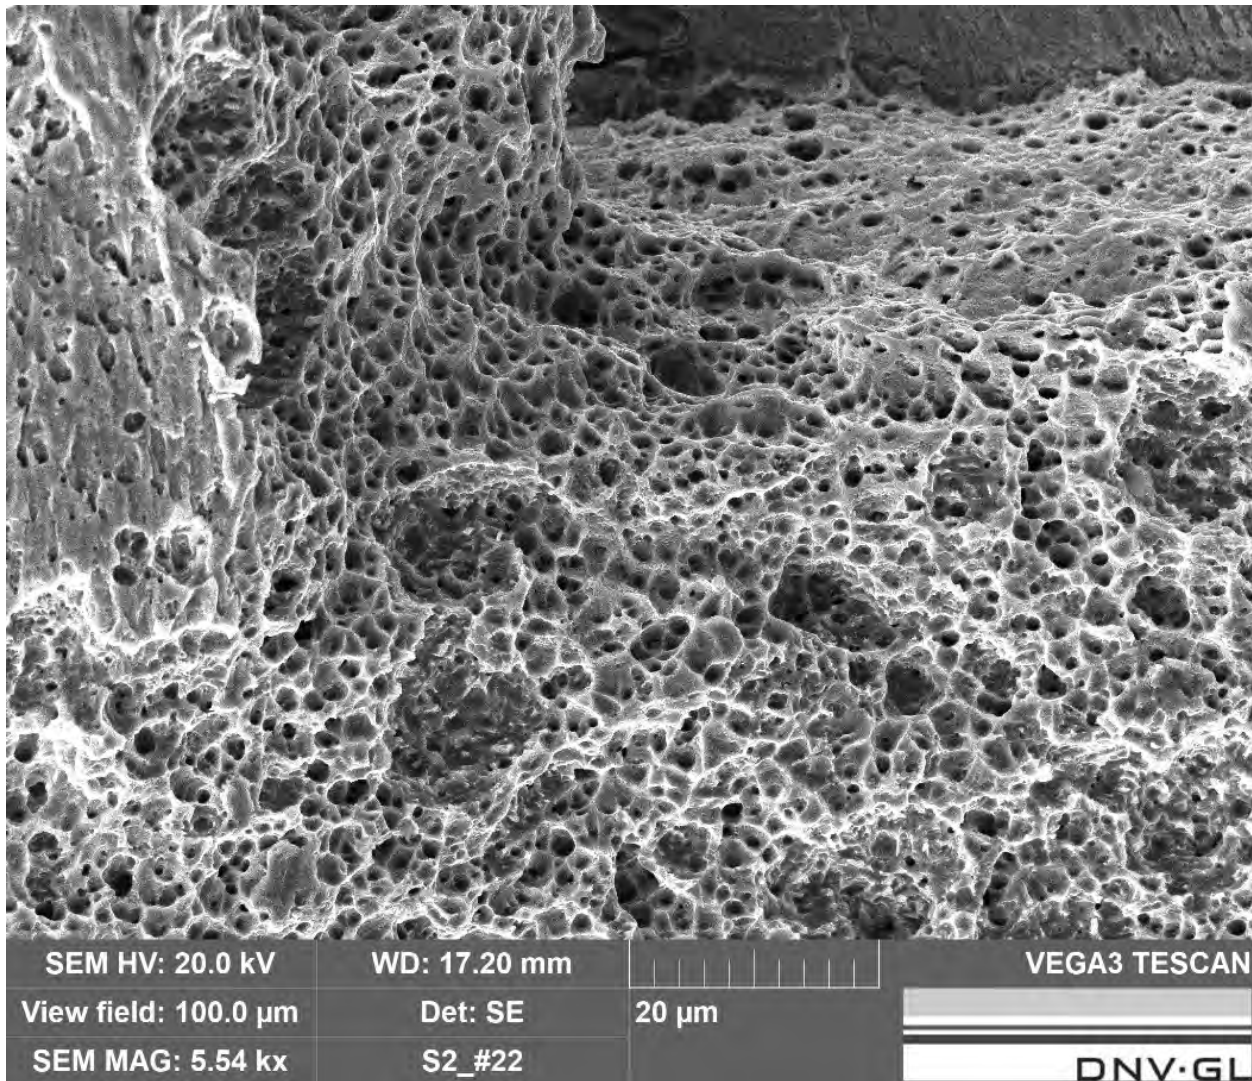
Figure 36. Sample S2 – Dimples Associated with Ductile Fracture

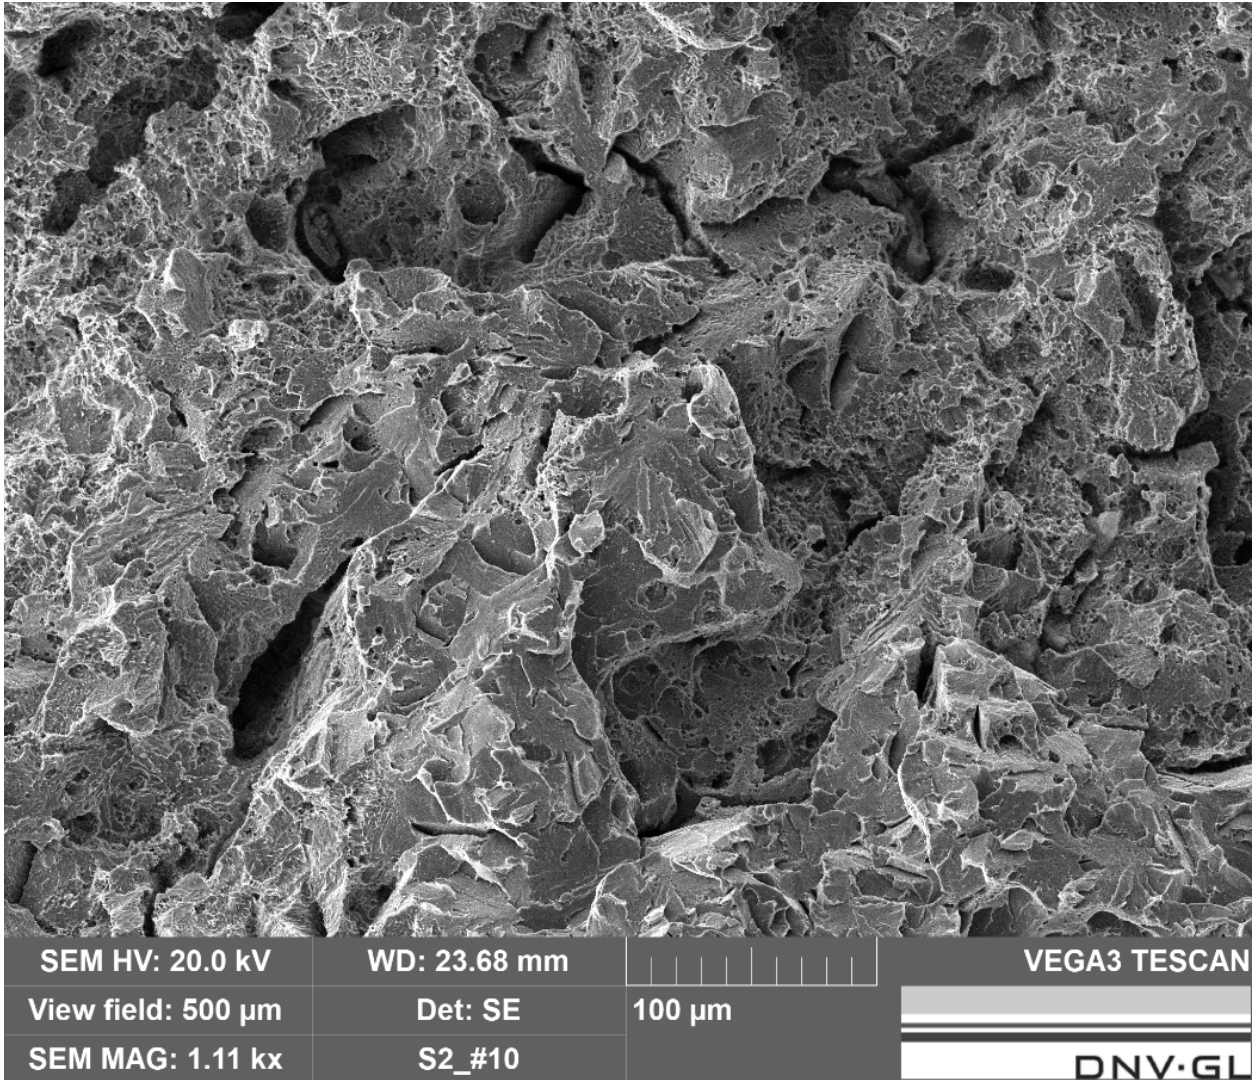
**Figure 37. Sample S2 – Facets Associated with Brittle Fracture**

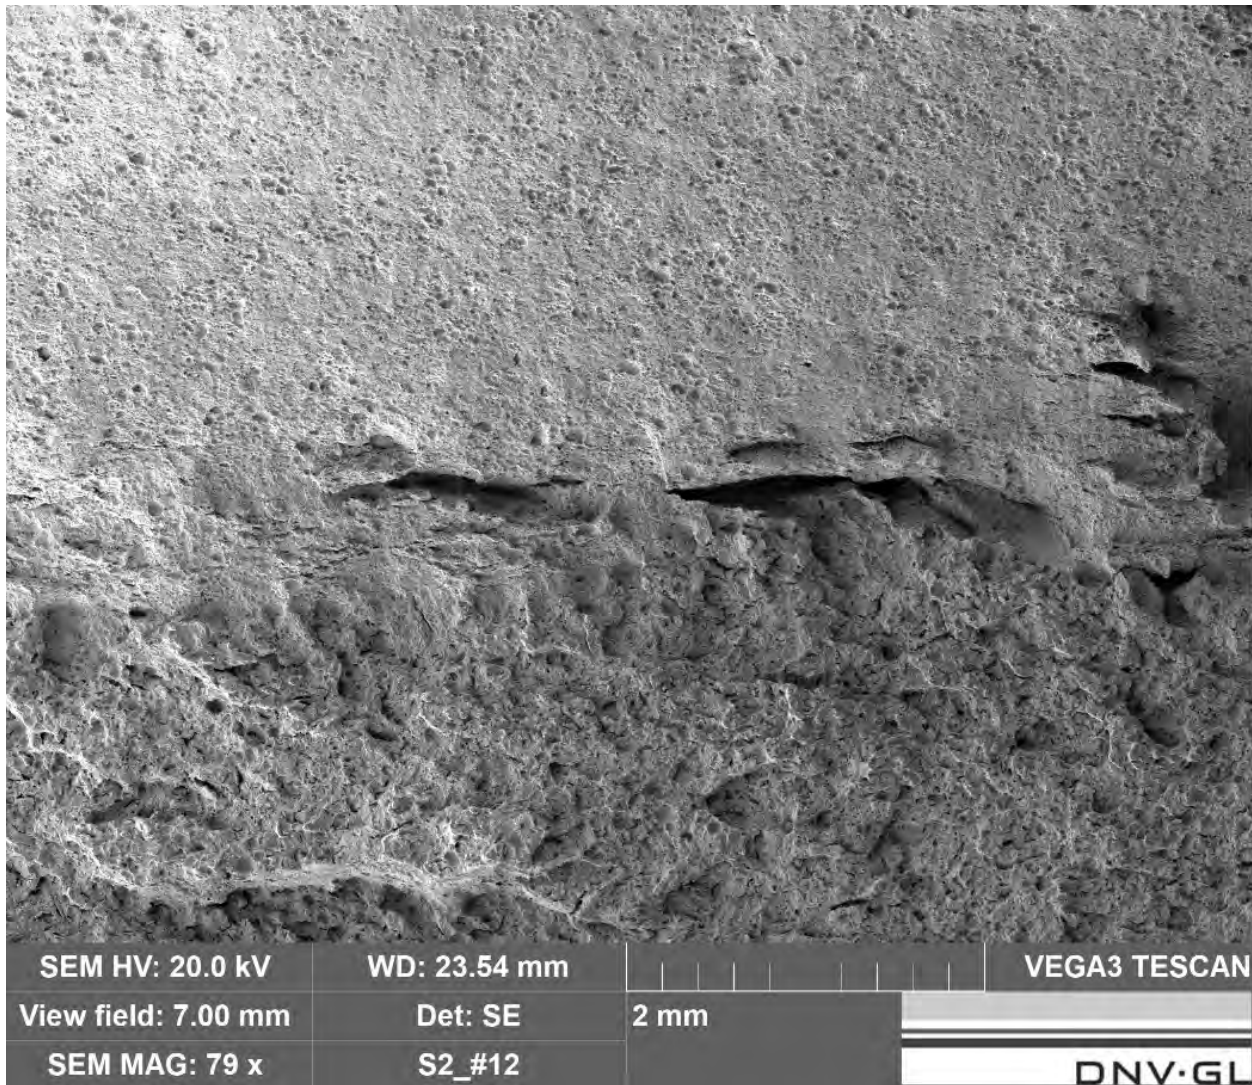
Figure 38. Sample S2 – Tears Mid-Wall (Smooth Region)

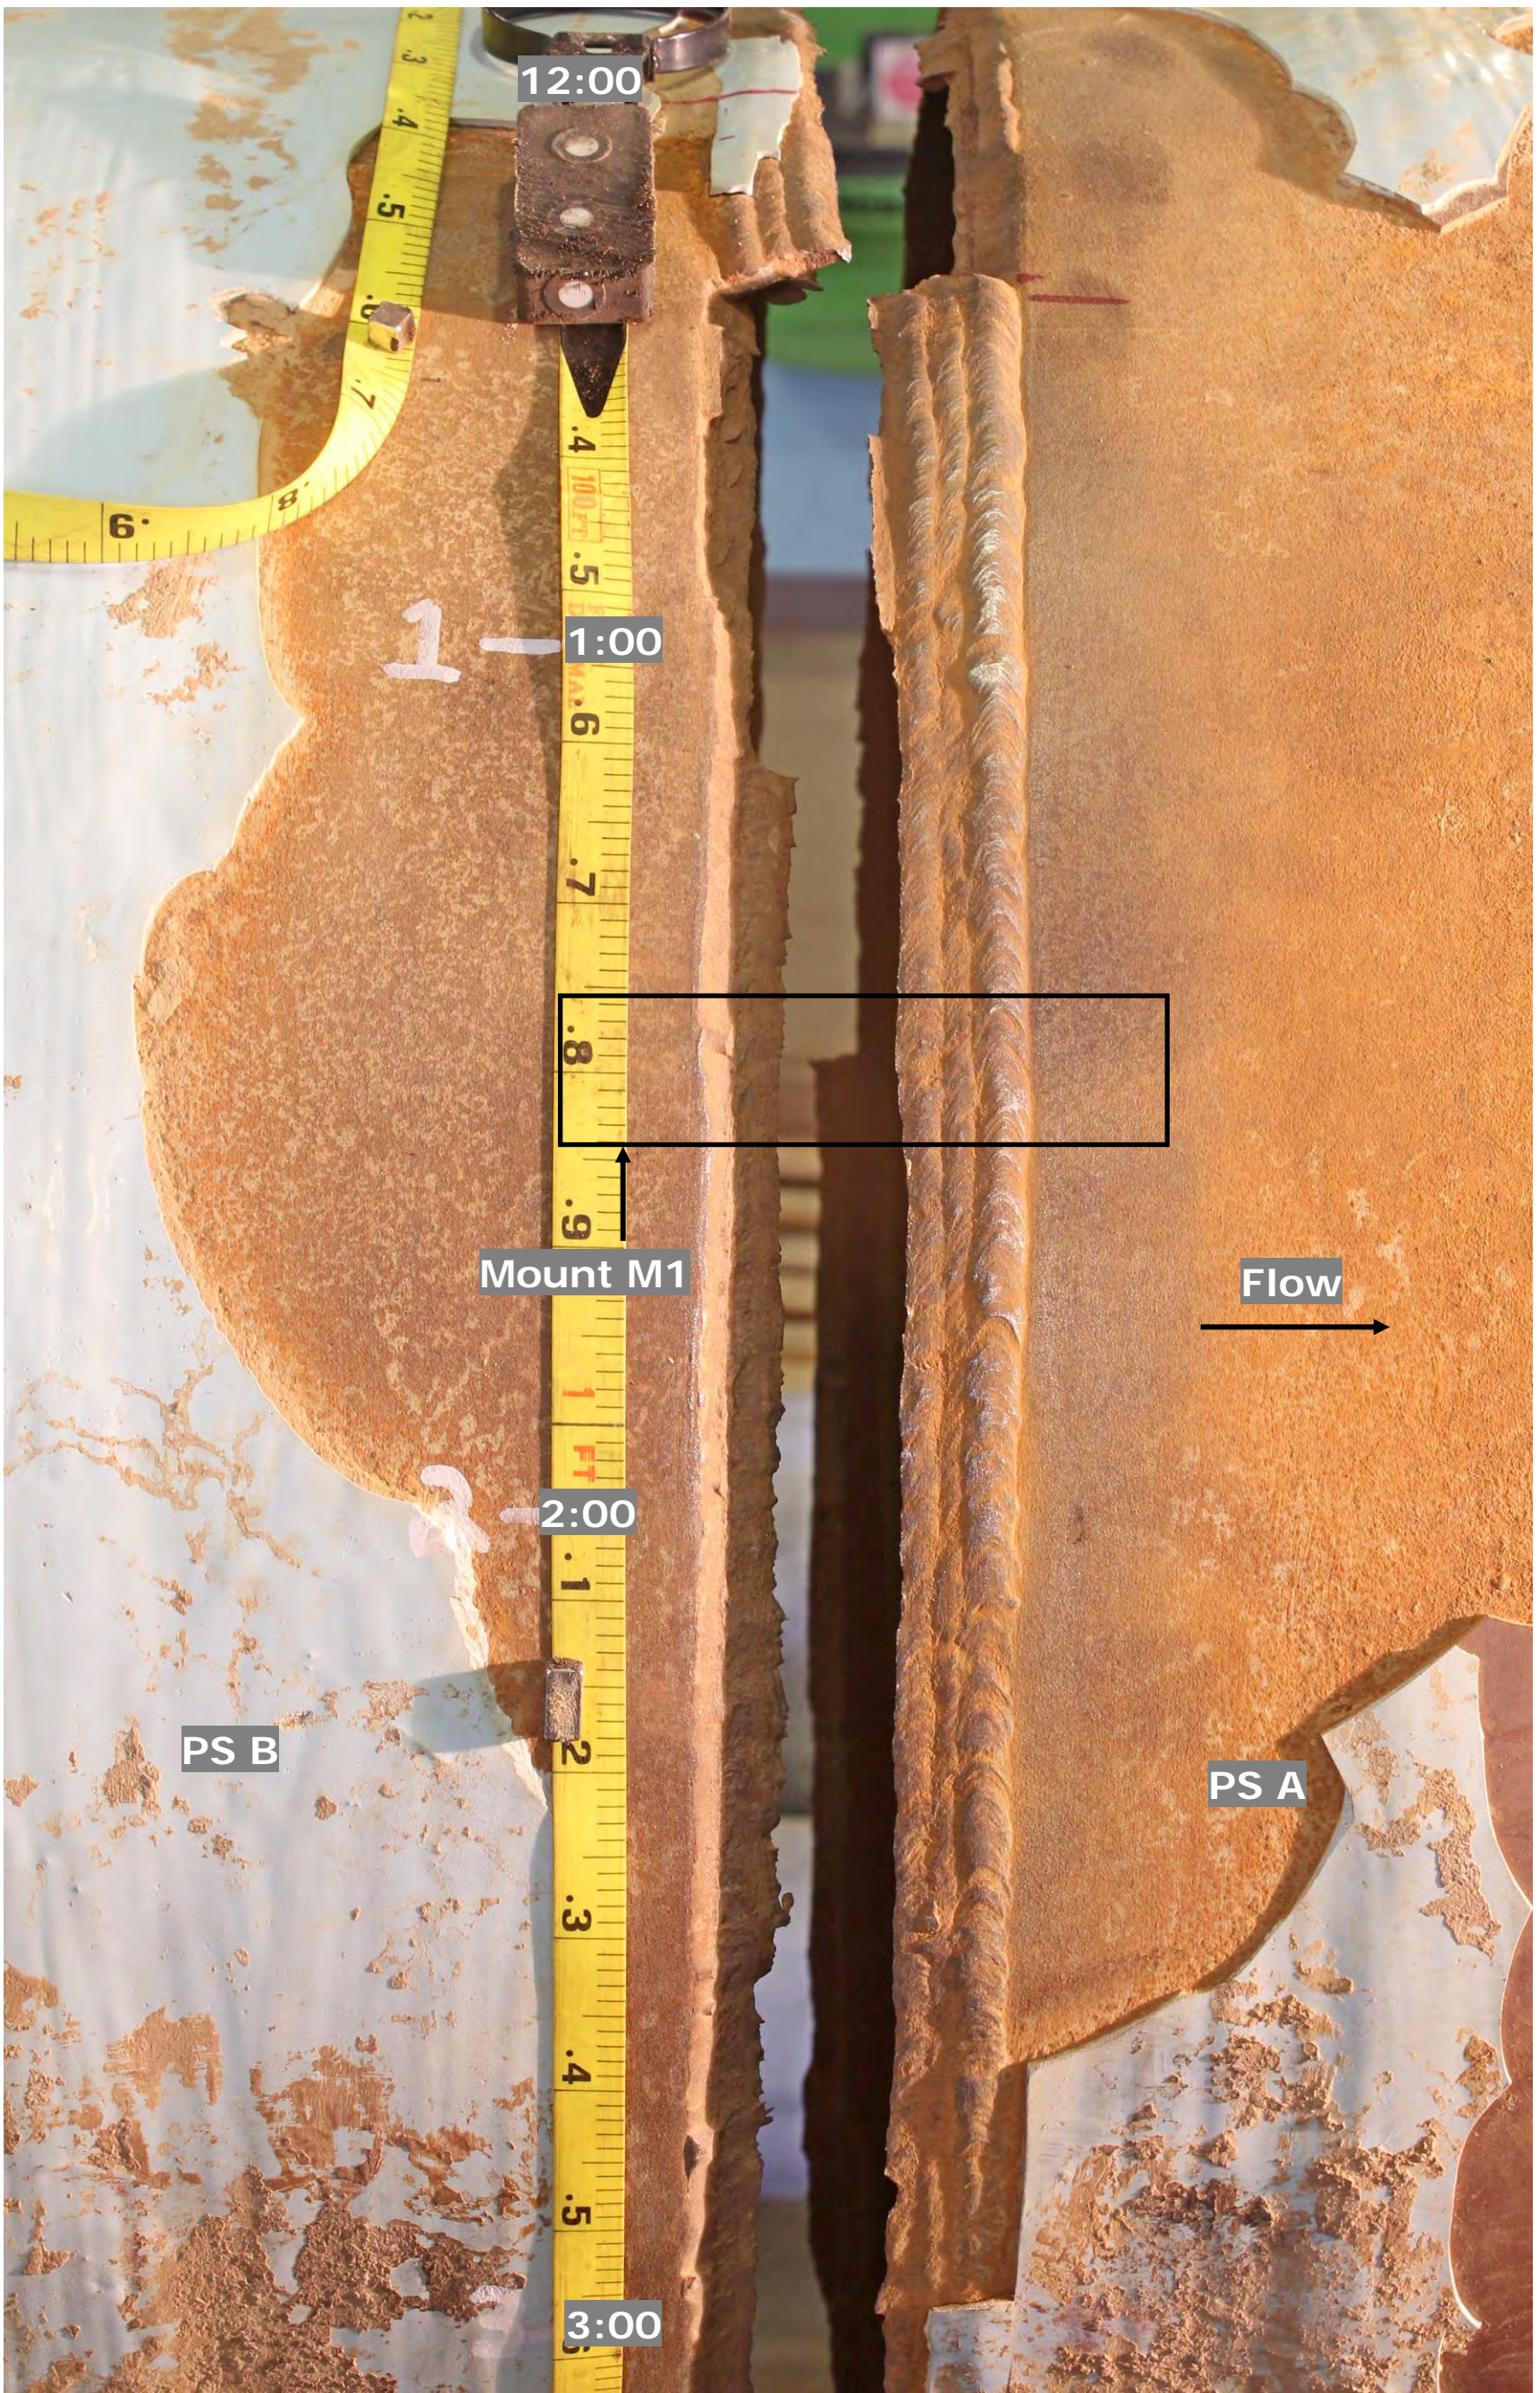
Figure 11. Photograph of the external of surfaces of PSs A and B adjacent to the fracture surfaces, between the 12 and 3 o'clock orientations, showing the failed girth weld and the morphology of the coating. The tape measure indicates the approximate distance CW of TDC (looking D/S convention).
