DOT US Department of Transportation  
PHMSA Pipeline and Hazardous Materials Safety Administration  
OPS Office of Pipeline Safety – Accident Investigation Division

**Principal Investigator** Wesley Mathews  
**Acting Accident Investigation Director** Chris Ruhl  
**Date of Report** May 26, 2022  
**Subject** Failure Investigation Report - Denbury Gulf Coast  
Pipelines, LLC – Pipeline Rupture/ Natural Force Damage

**Failure Investigation Report – Denbury Gulf Coast Pipelines LLC**  
**Pipeline Rupture/Natural Force Damage**  
February 22, 2020

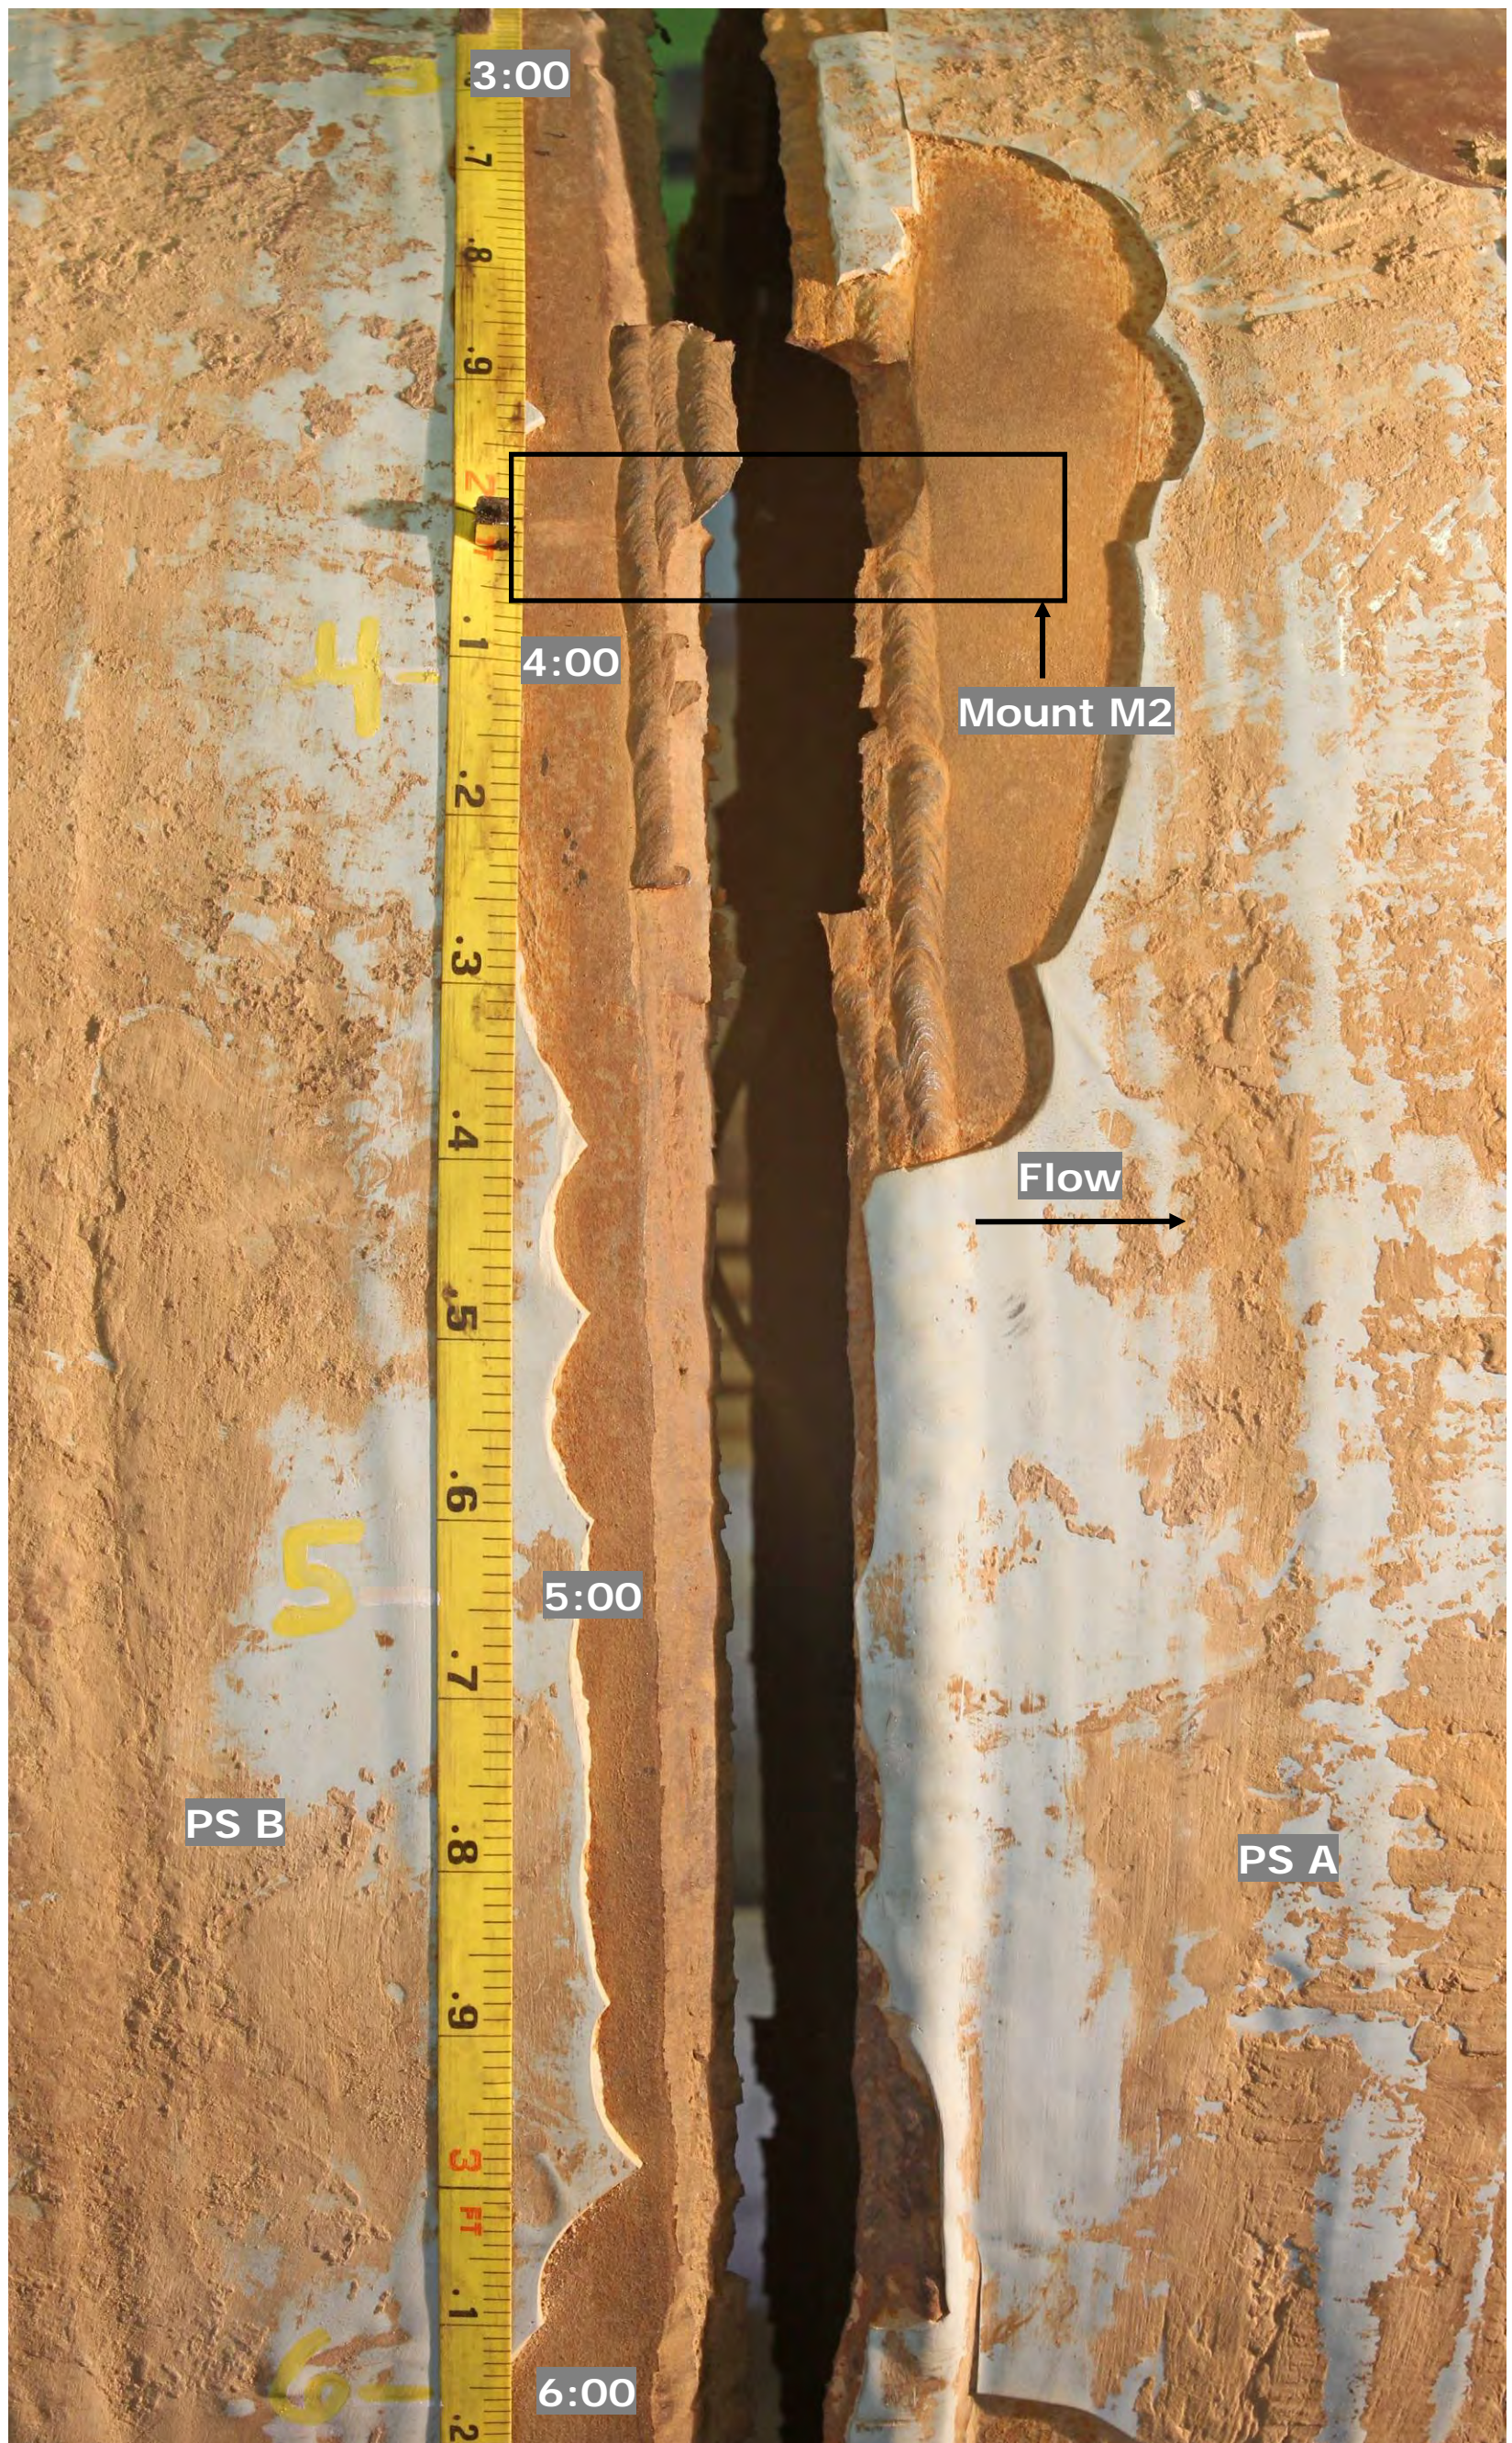
Figure 12. Photograph of the external of surfaces of PSs A and B adjacent to the fracture surfaces, between the 3 and 6 o'clock orientations, showing the failed girth weld and the morphology of the coating. The tape measure indicates the approximate distance CW of TDC (looking D/S convention).

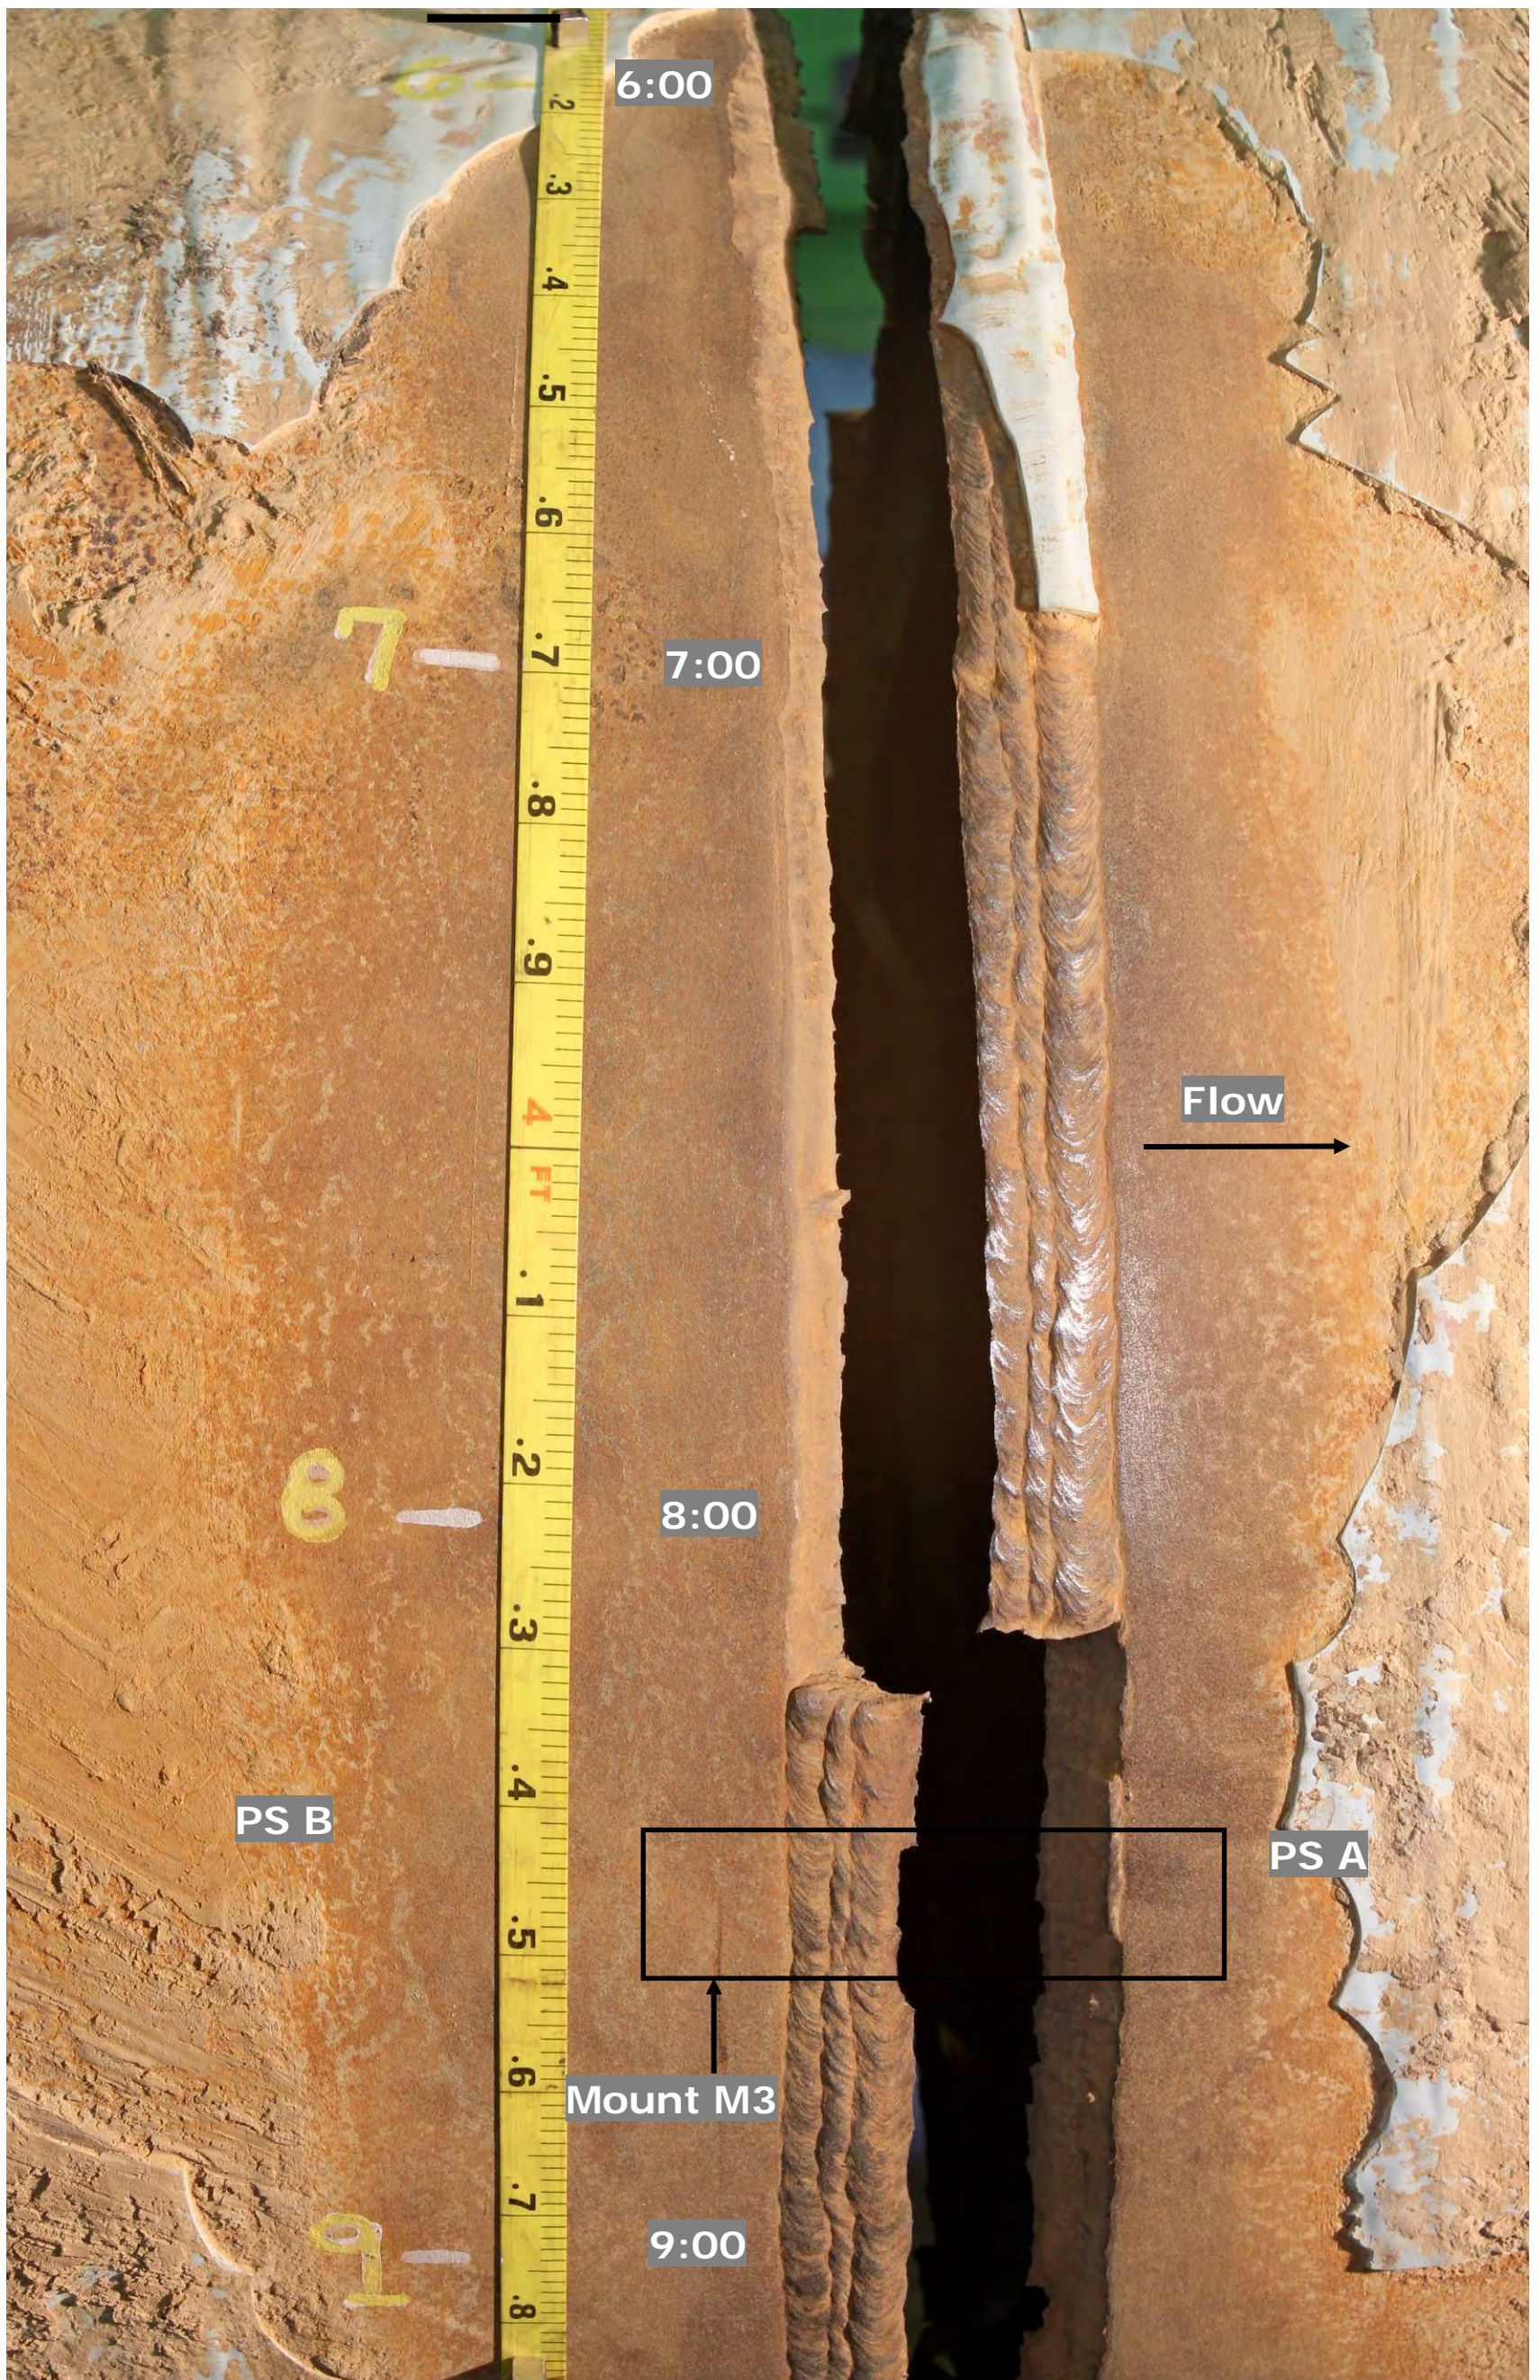
Figure 13. Photograph of the external of surfaces of PSs A and B adjacent to the fracture surfaces, between the 6 and 9 o'clock orientations, showing the failed girth weld and the morphology of the coating. The tape measure indicates the approximate distance CW of TDC (looking D/S convention).

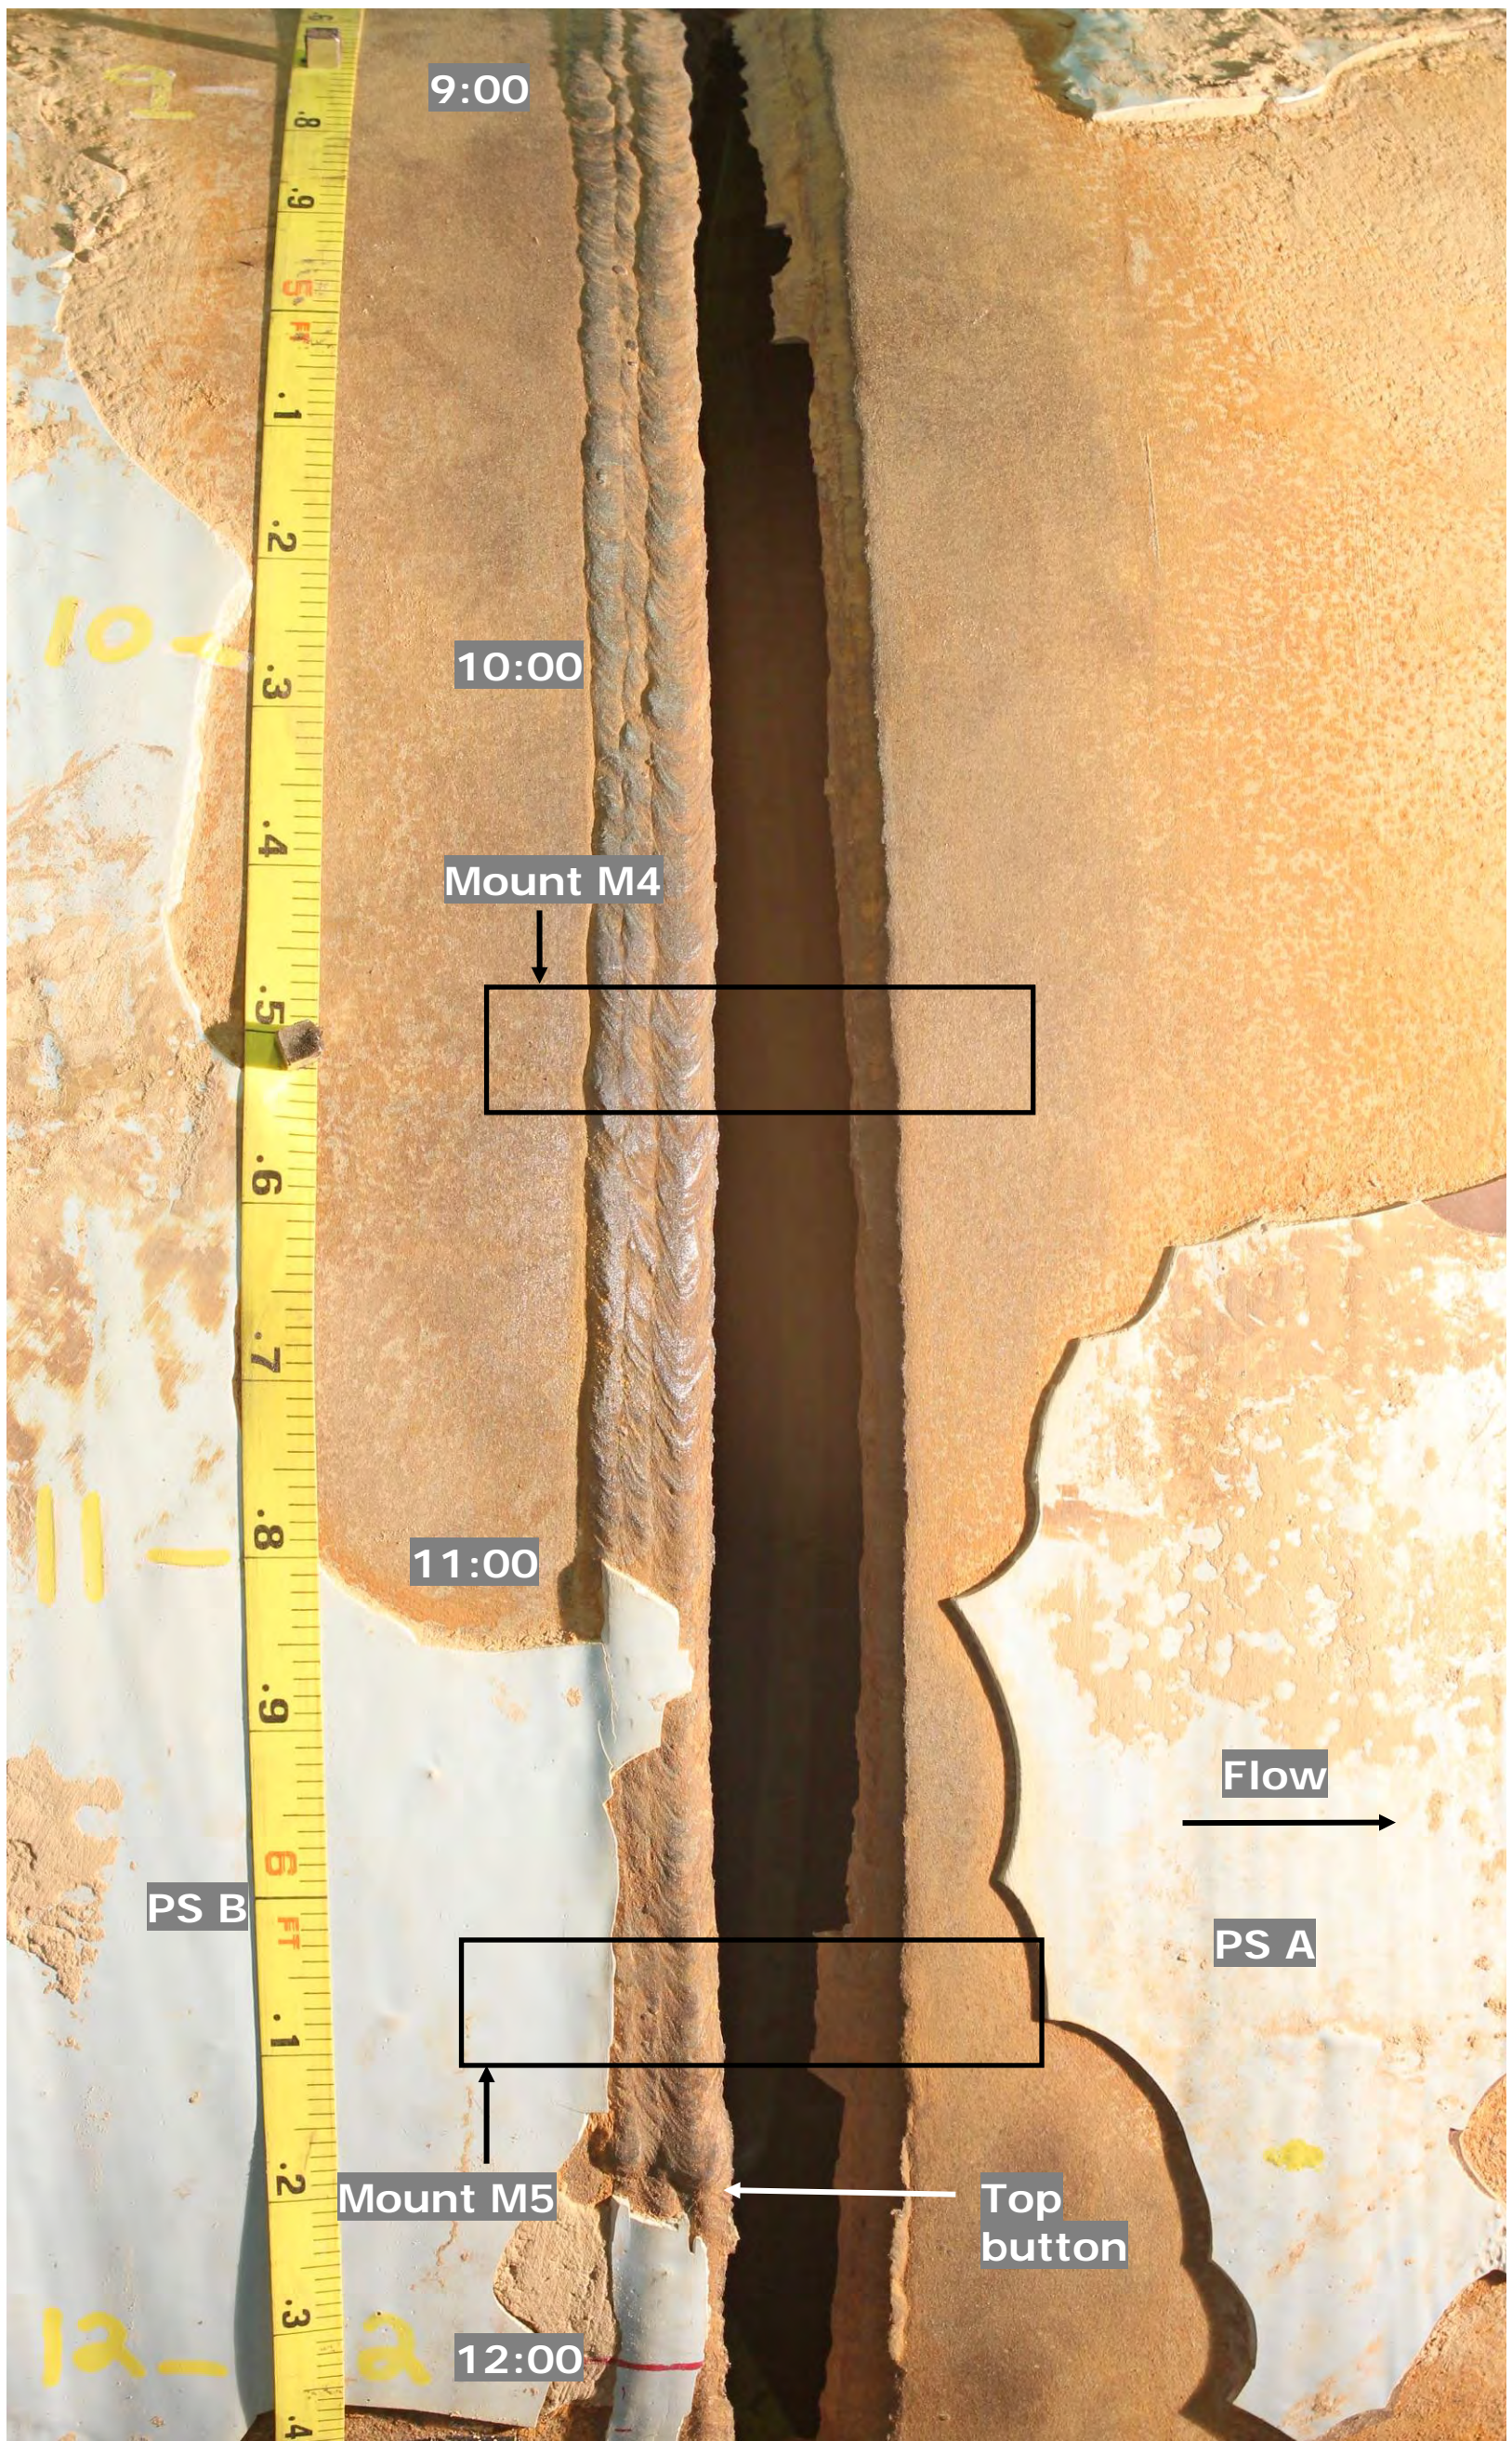
Figure 14. Photograph of the external of surfaces of PSs A and B adjacent to the fracture surfaces, between the 9 and 12 o'clock orientations, showing the failed girth weld and the morphology of the coating. The tape measure indicates the approximate distance CW of TDC (looking D/S convention).

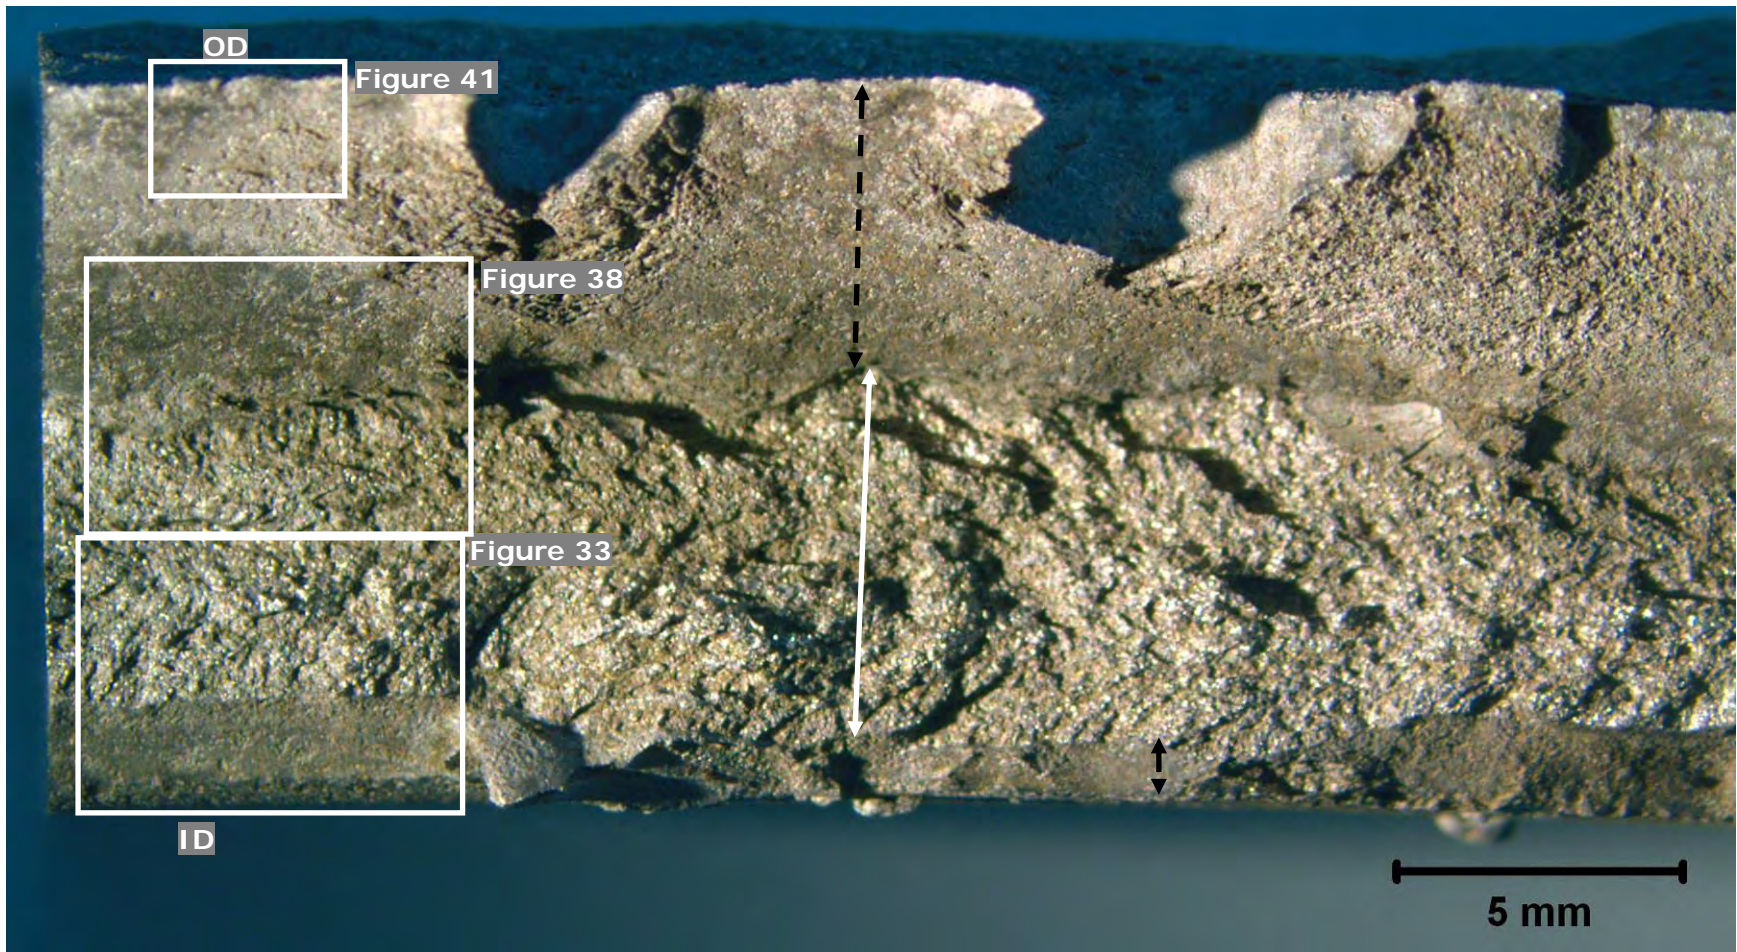
Figure 32. Light photomicrograph of the fracture surface of Sample S2, following cleaning in ENPREP® 214. The sample was removed near the 4:00 orientation from PSA; area indicated in Figure 23. The black, dashed double arrows indicate smooth regions and the white double arrow indicates a rough region.

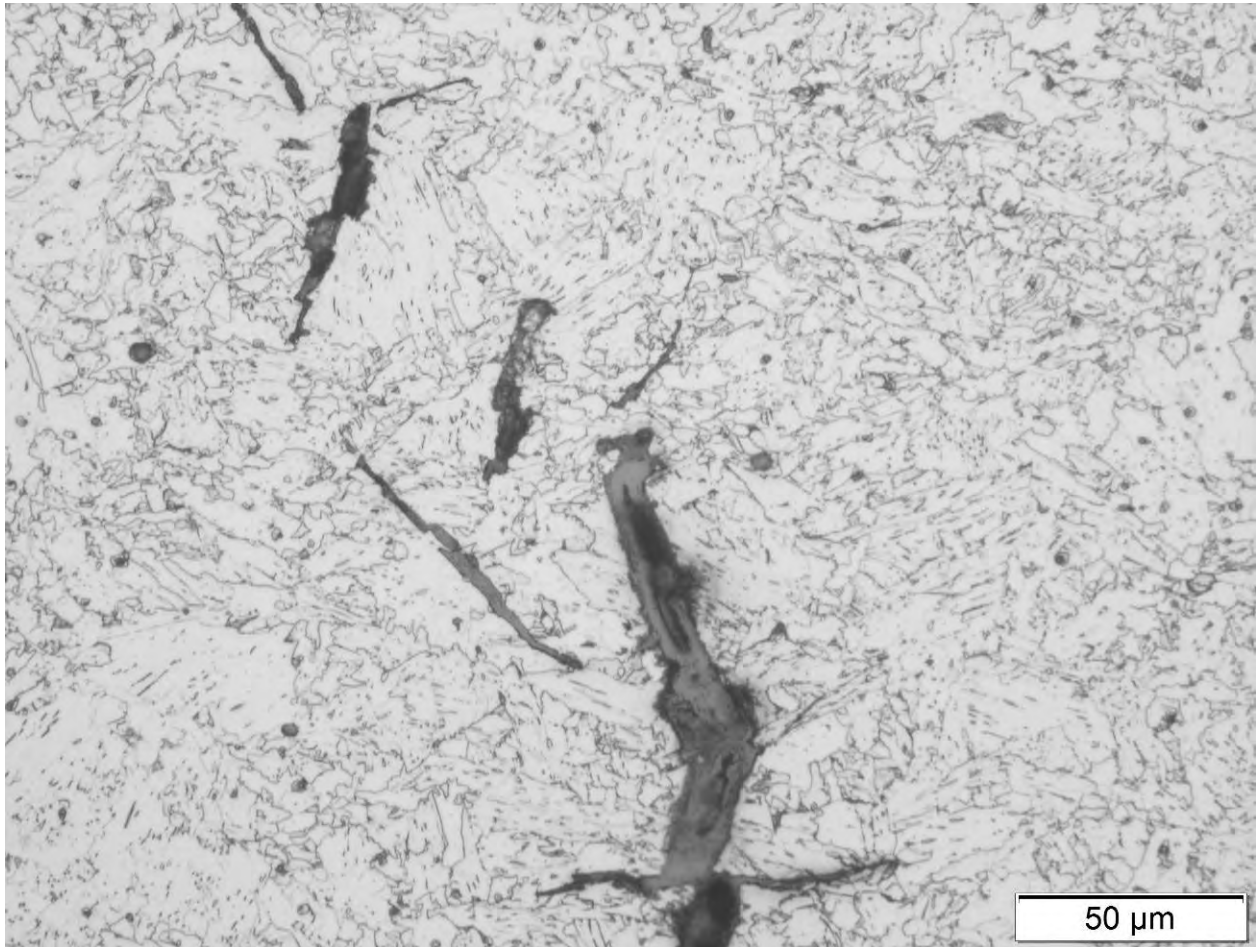
Figure 60. High magnification light photomicrograph of Mount M2 at fissures (2% Nital Etchant); area indicated in Figure 59.
