DOT US Department of Transportation  
PHMSA Pipeline and Hazardous Materials Safety Administration  
OPS Office of Pipeline Safety – Accident Investigation Division

**Principal Investigator** Wesley Mathews  
**Acting Accident Investigation Director** Chris Ruhl  
**Date of Report** May 26, 2022  
**Subject** Failure Investigation Report - Denbury Gulf Coast  
Pipelines, LLC – Pipeline Rupture/ Natural Force Damage

**Failure Investigation Report – Denbury Gulf Coast Pipelines LLC**  
**Pipeline Rupture/Natural Force Damage**  
February 22, 2020

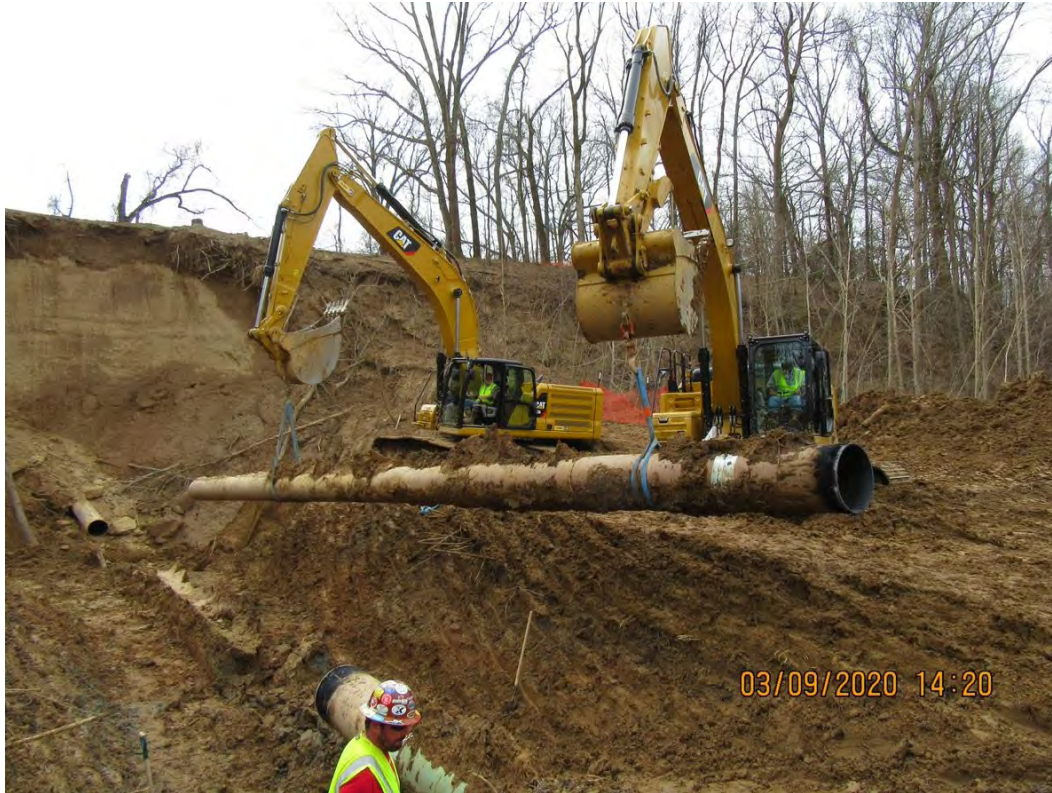
**Figure 9. Upstream Pipe Section During Removal**

Figure 9 shows the upstream pipe section being removed from the site.

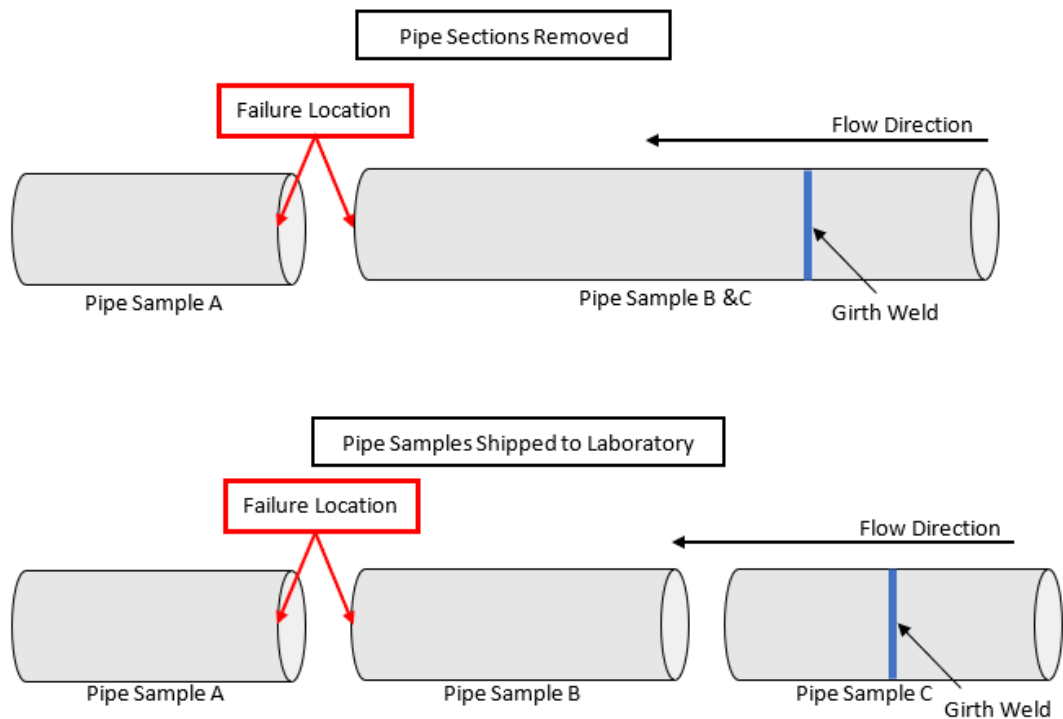
**Figure 10. Overview of Pipe Sections and Samples**

Once moved to an accessible location, the pipe sections were documented, samples were cut and prepared for shipment to the laboratory. Figure 10 provides an overview of the pipe sections as removed and prepared for shipment.

Visual inspection of the external surface of the pipe sections identified an area of coating damage near the failure, which appeared to have occurred as a result of the failure (no pitting, attached solids, and apparent adhesive failure). No external corrosion was observed and the pipe coating on the remainder of the section appeared to be in excellent condition.

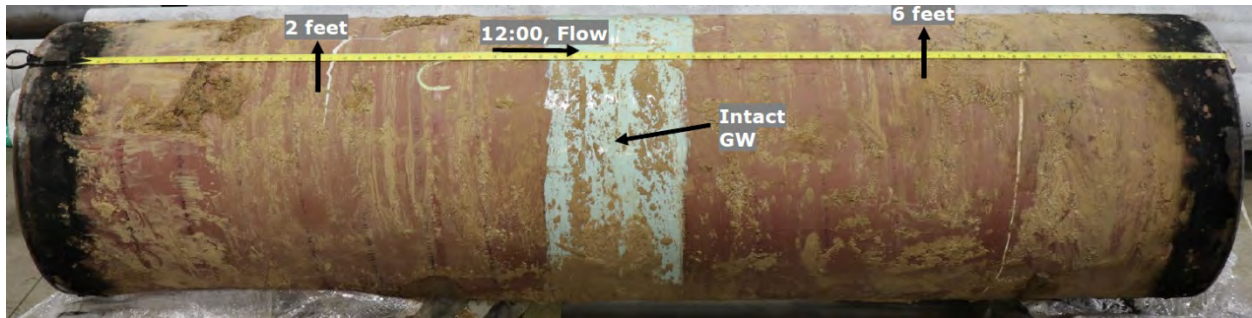
**Figure 14. Pipe Sample C (PS C)**

The intact girth weld (PS C) was grit blasted and MPI was conducted on the external and internal surfaces. No crack-like indications were identified.

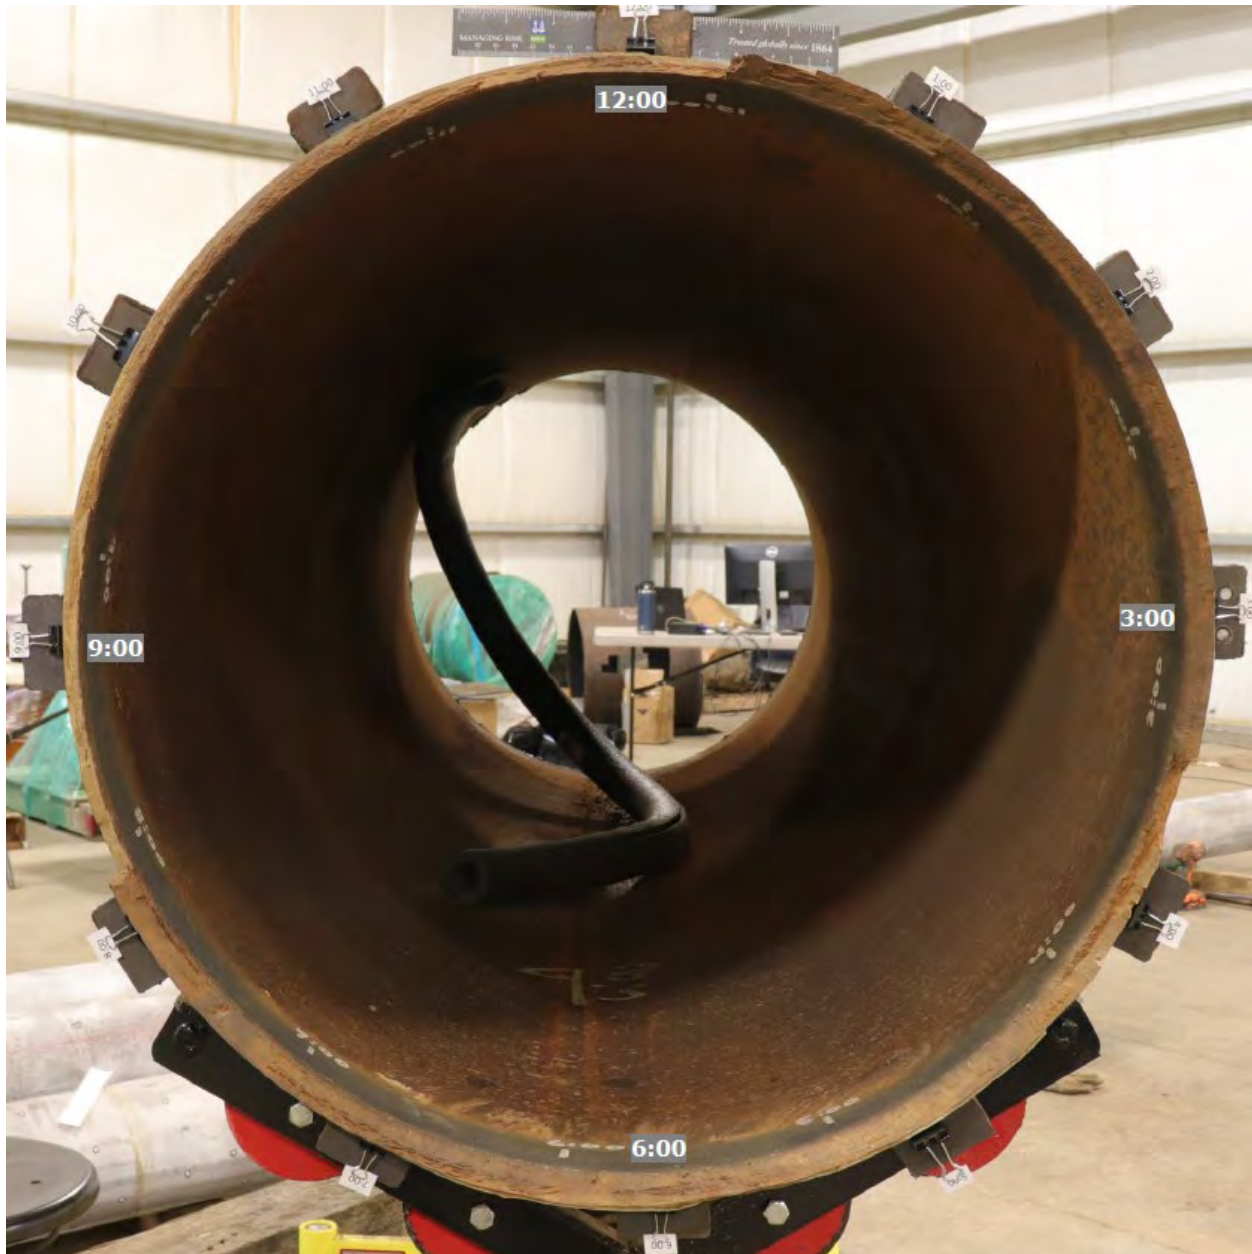
**Figure 15. PS A Fracture Surface (Upstream to Downstream)**

A photograph of the fracture surface of PS A is provided in Figure 15.

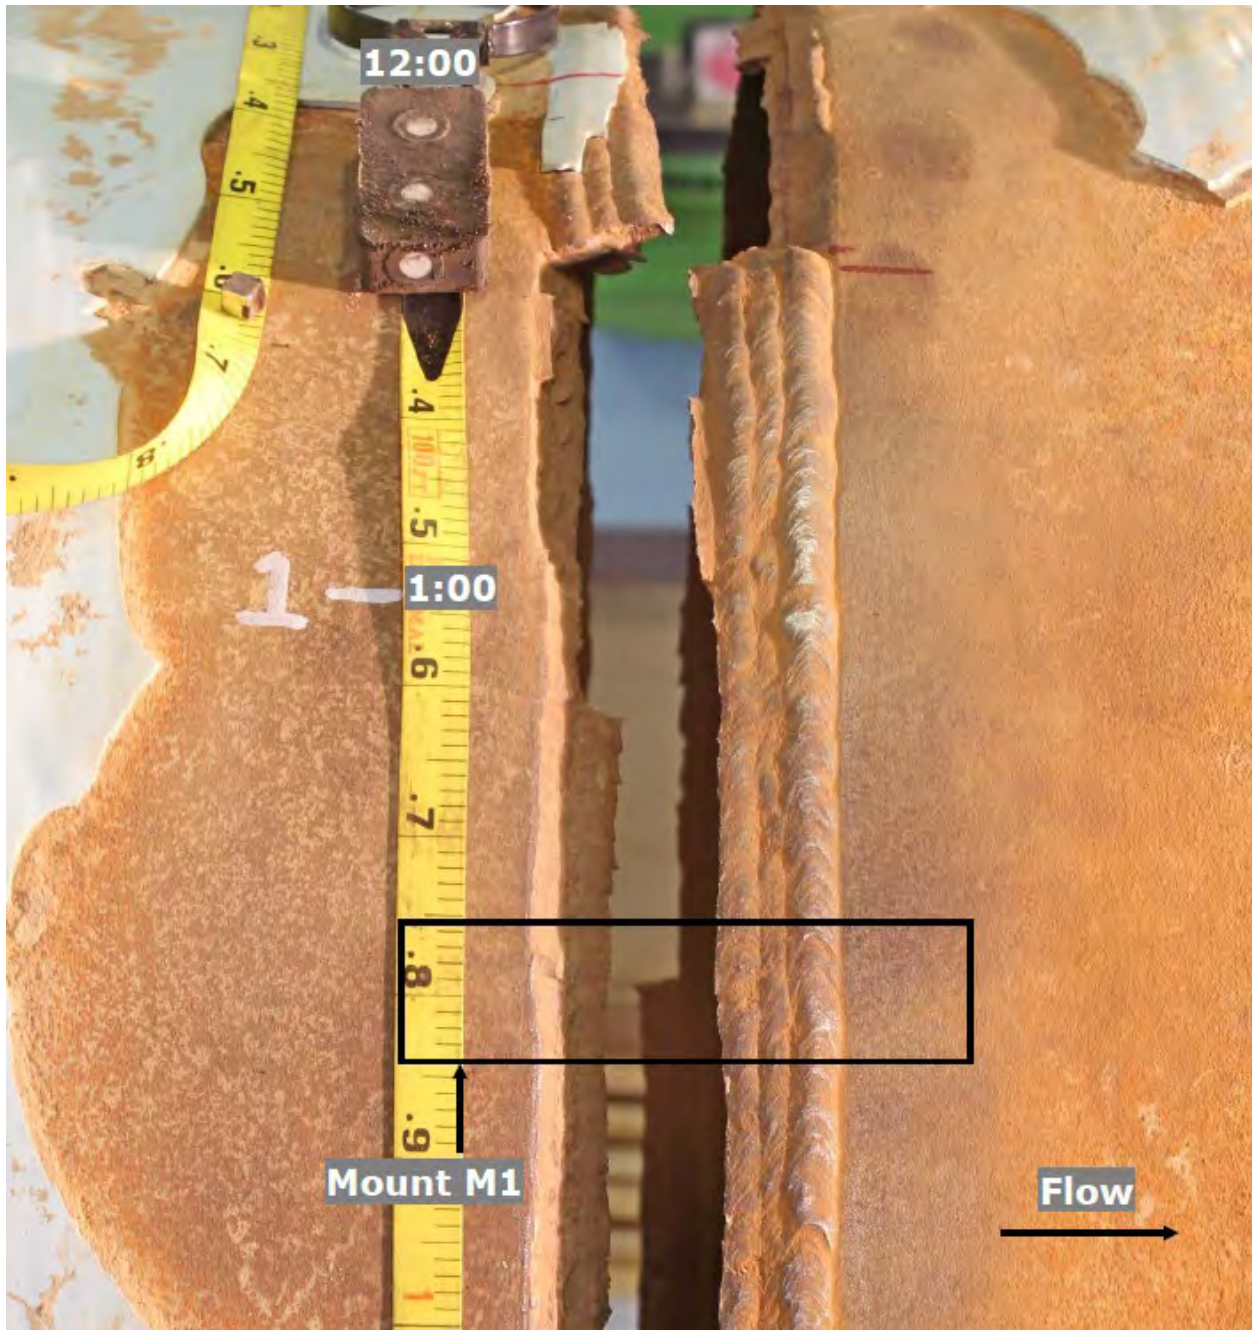
**Figure 19. Overview of Mount M1**

Sample M1 contains a fracture path at a shear angle. This sample was removed from the girth weld at the 1:35 o'clock orientation (see Figure 19).

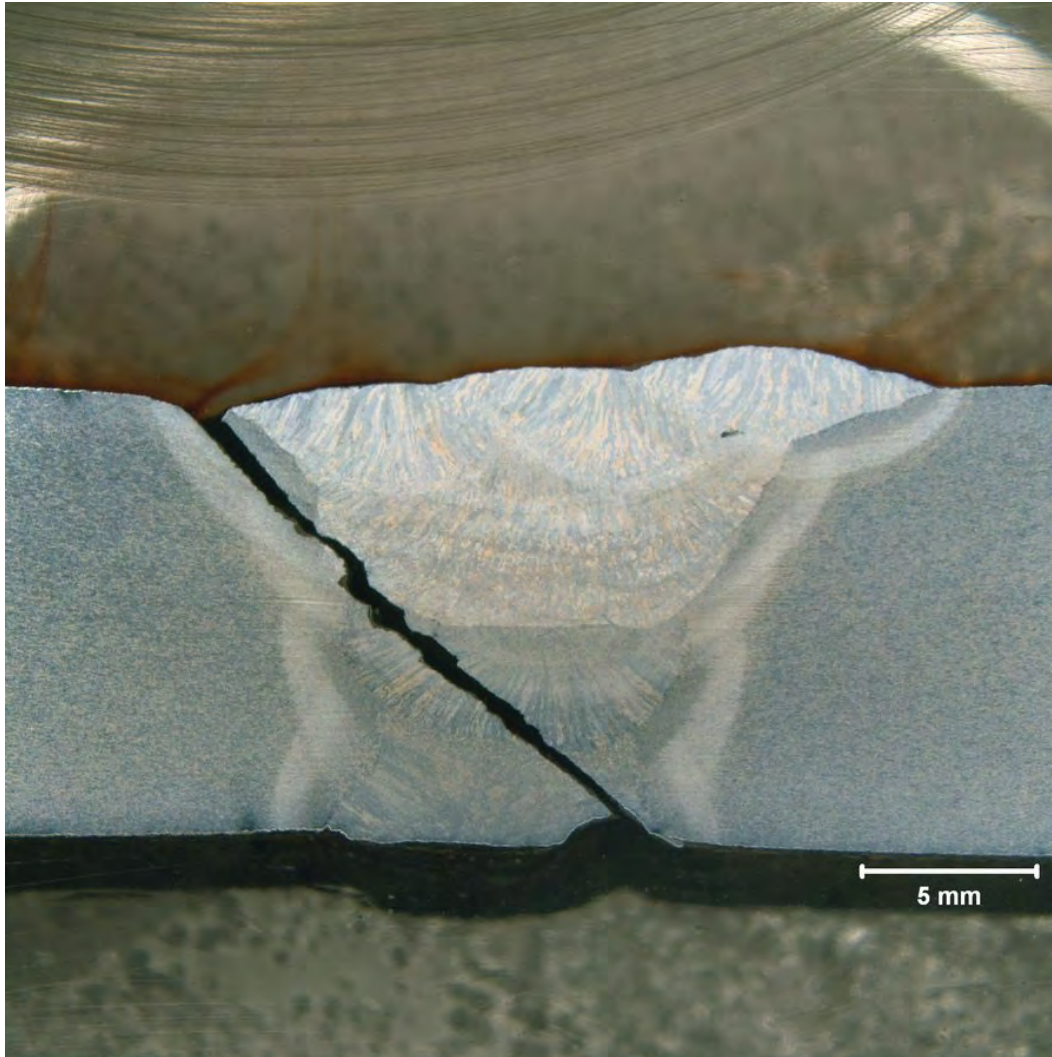
**Figure 20. Representative Cross-Section from Sample M1**

The fracture path of this sample is located in the HAZ near the toe of the weld at the OD surface. An image of the cross section of sample M1 is provided in Figure 20.

There is no indication of excessive porosity and/or inclusions. It shows a slight misalignment of the high-low weld of approximately 4.3% of the NWT. Higher magnifications are provided in the laboratory report which show grain elongation due to the cold work that took place during the rupture process. This is consistent with ductile overloading. The microstructure is typical of modern X80 line pipe. A close-up of sample M1 is provided in Figure 21.

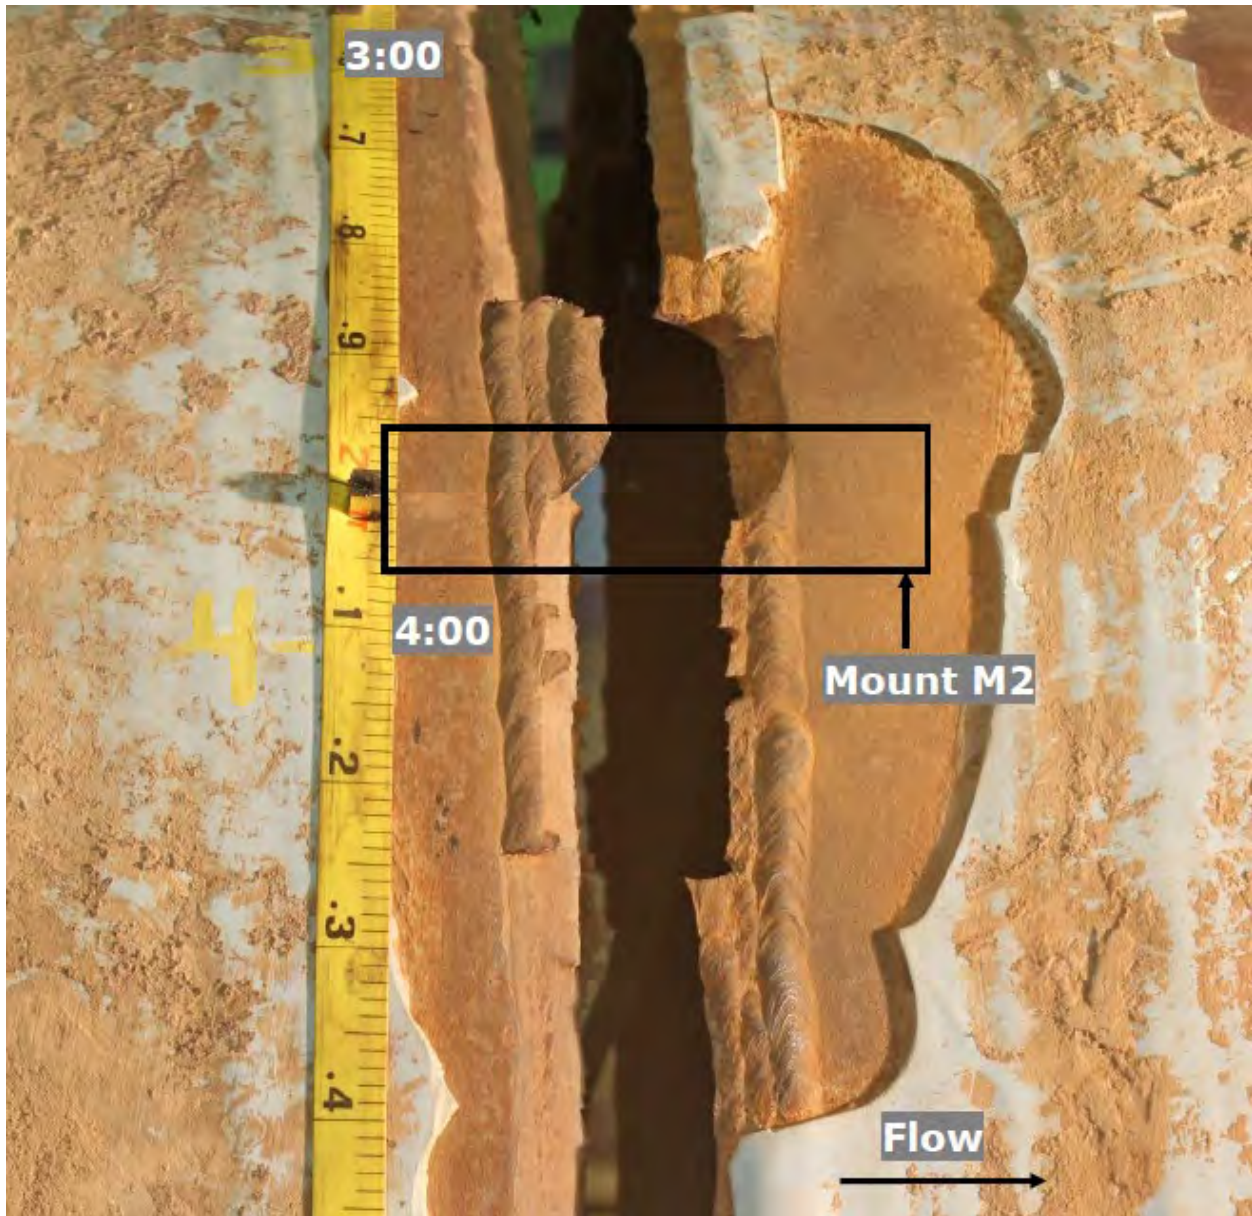
Figure 22. Overview of Mount M2

Sample 2 contains regions where the fracture path is perpendicular to the free surface and regions of shear failure. This sample was taken from the GW at the 3:55 o'clock orientation (see Figure 22).

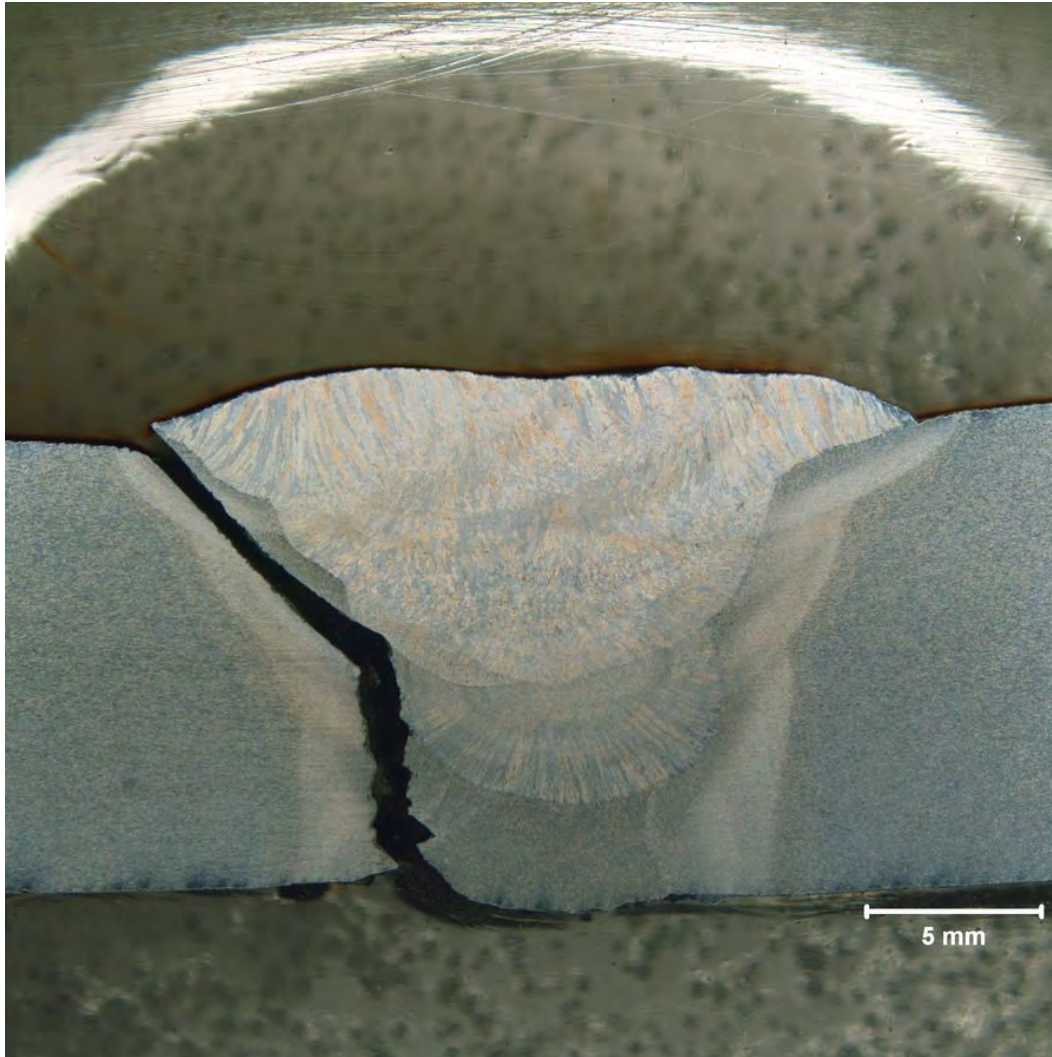
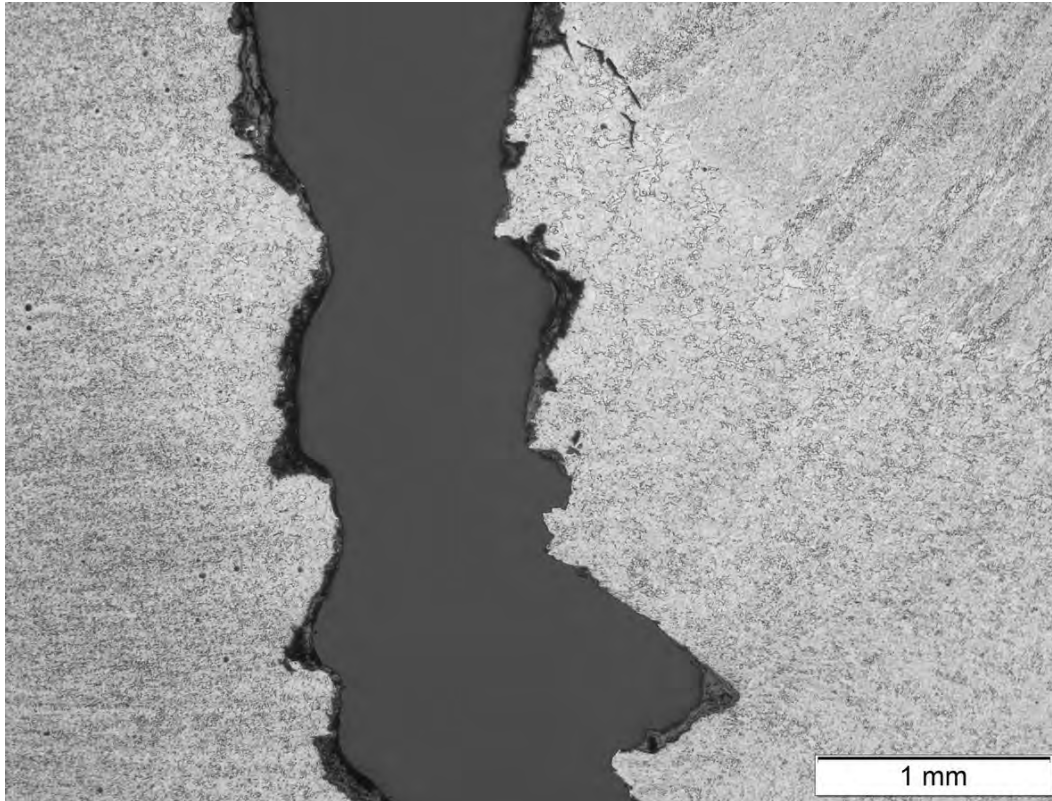
**Figure 23. Representative Cross-Section from Sample M2**

There are both smooth and rough regions in this sample. The high-low weld misalignment at this location is approximately 6.9% of the NWT. The fracture path at this location was mainly located at the HAZ. Fractography in the SEM shows the presence of a smooth region containing dimples (typical of ductile behavior) and cleavage facets (typical of brittle behavior) in the rough region. Some fissures were also found in the area where cleavage facets were located. These fissures are usually seen in girth weld overload areas (see Figure 24).

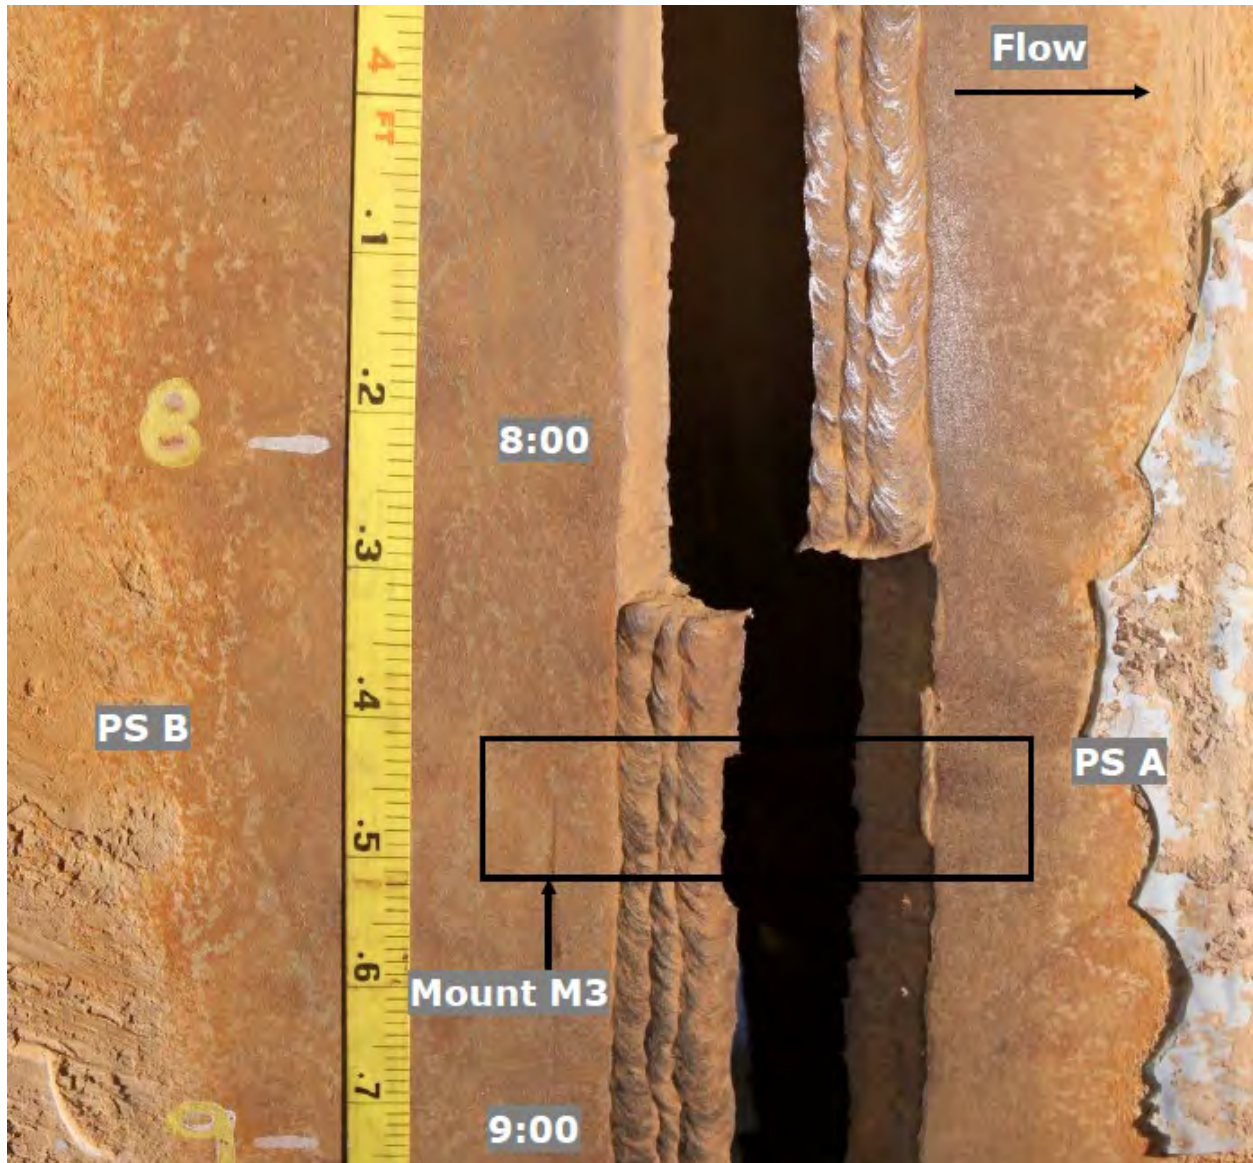
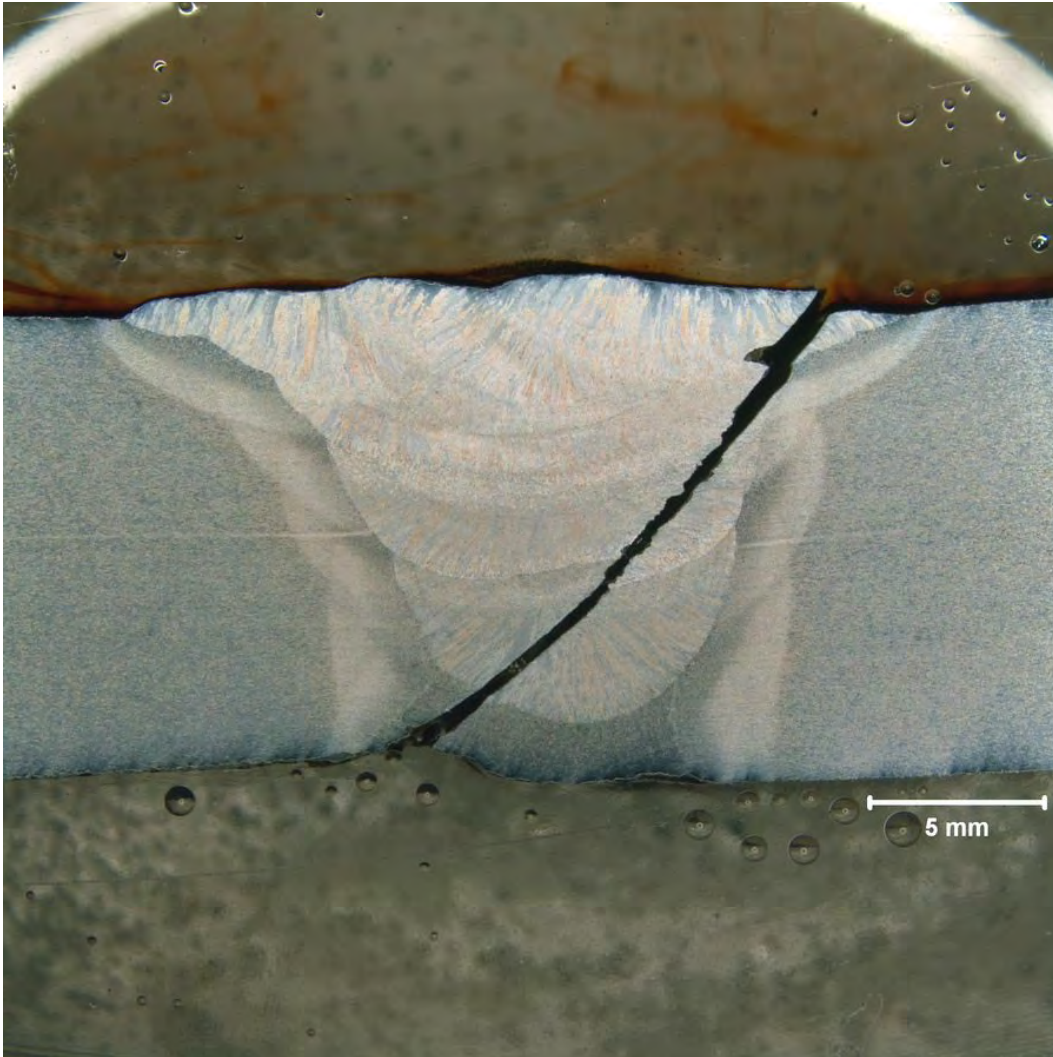
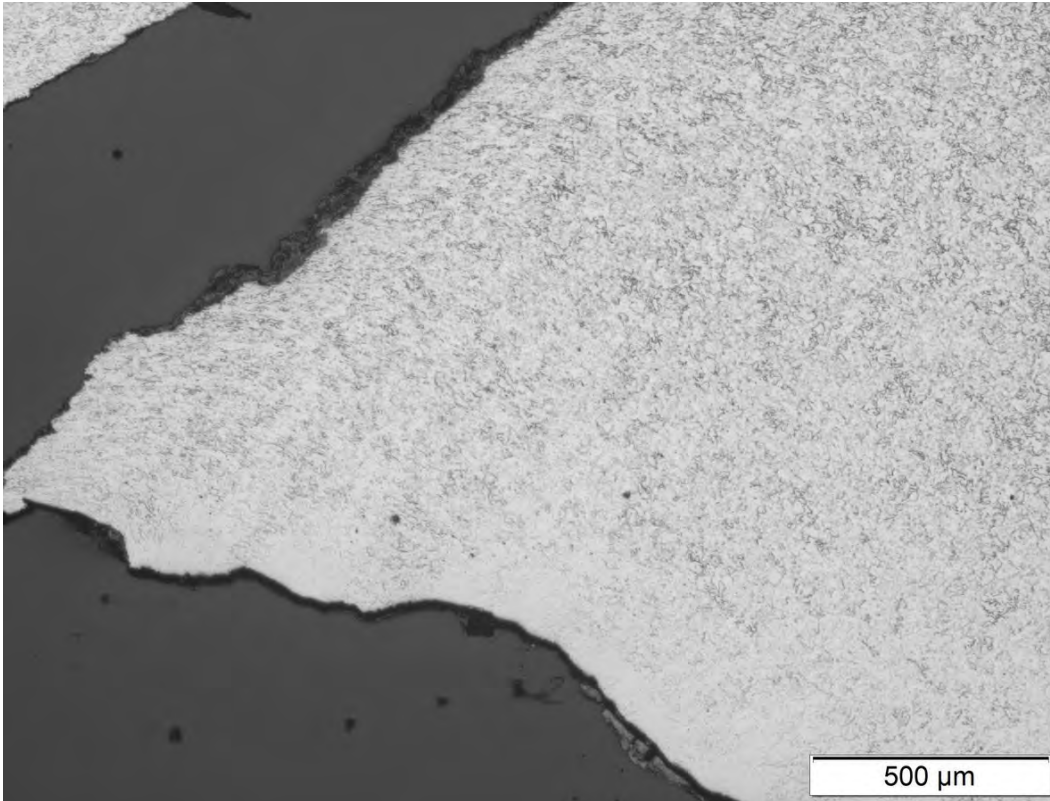
Figure 25. Overview of Mount M3

This sample was removed from the failed GW at the 8:35 o'clock orientation (Figure 25).

The fracture path is at a shear angle and mainly located in the weld metal. The morphology of the weld is similar to samples M1 and M2. The high-low weld misalignment at this location was approximately 2.6% of the NWT. The microstructure is consistent with the findings in samples M1 and M2 (see Figure 26 and Figure 27).

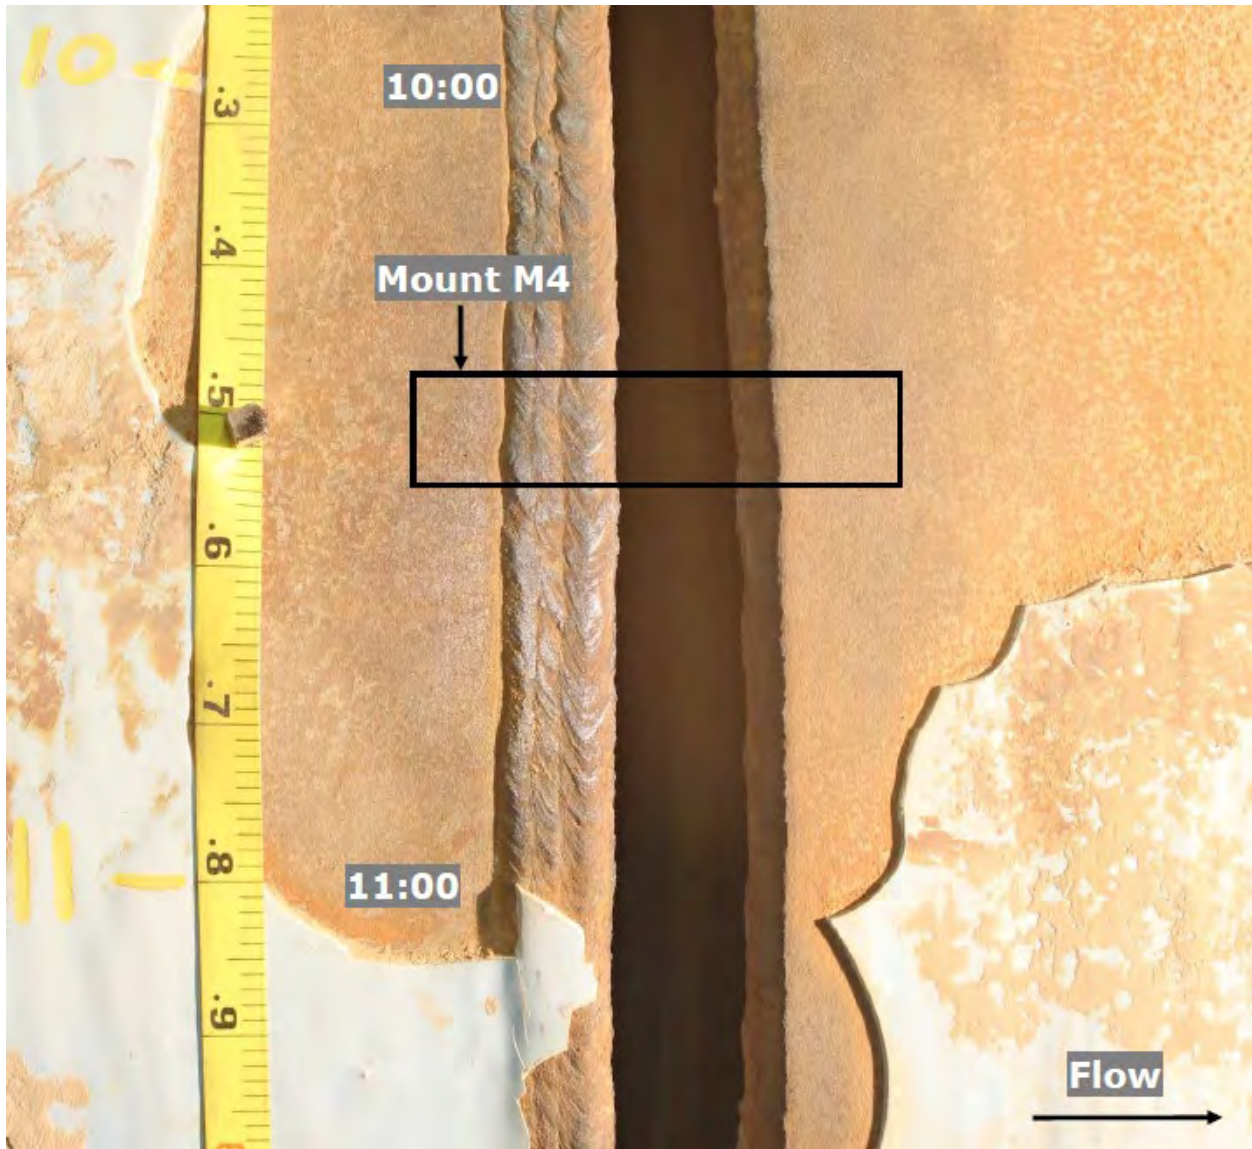
**Figure 28. Overview of Mount M4**

Sample M4 was removed from the failed GW at the 10:24 o'clock orientation. An overview of sample M4 is provided in Figure 28.

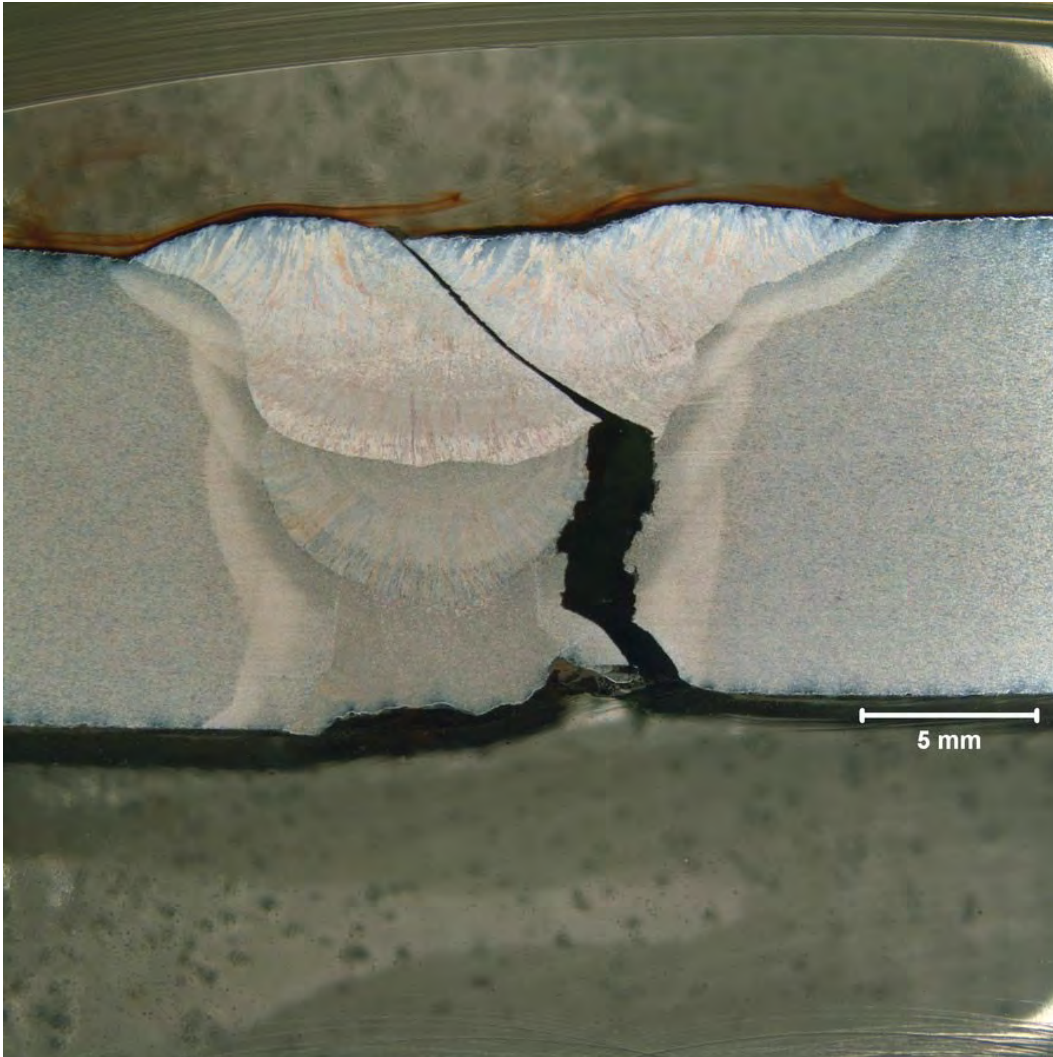
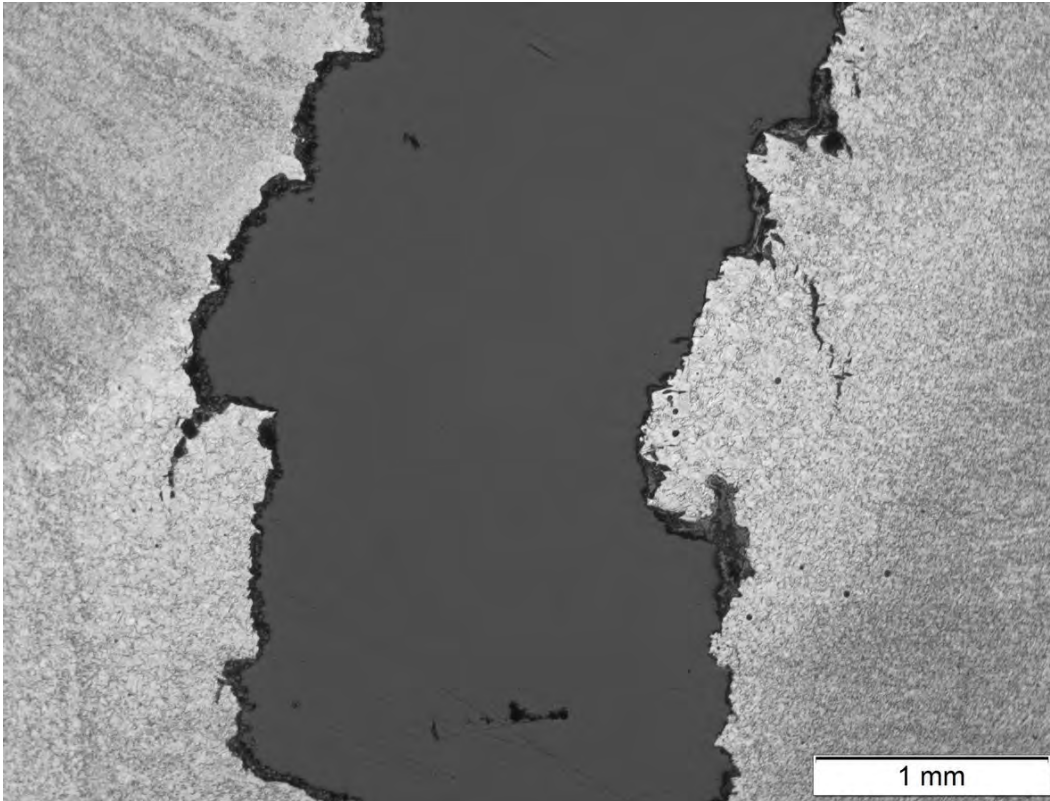
**Figure 29. Representative Cross-Section from Sample M4**

There is a smooth shear angle region and a rough region. The fracture path at this location is mainly in the HAZ. (see Figure 29).

The sample shows grain elongation and an inclusion orientated parallel to the fracture surface which is consistent with ductile overload. There are also fissures in this sample that have the same morphology shown in M2 sample. A close-up of the M4 sample is provided in Figure 30.

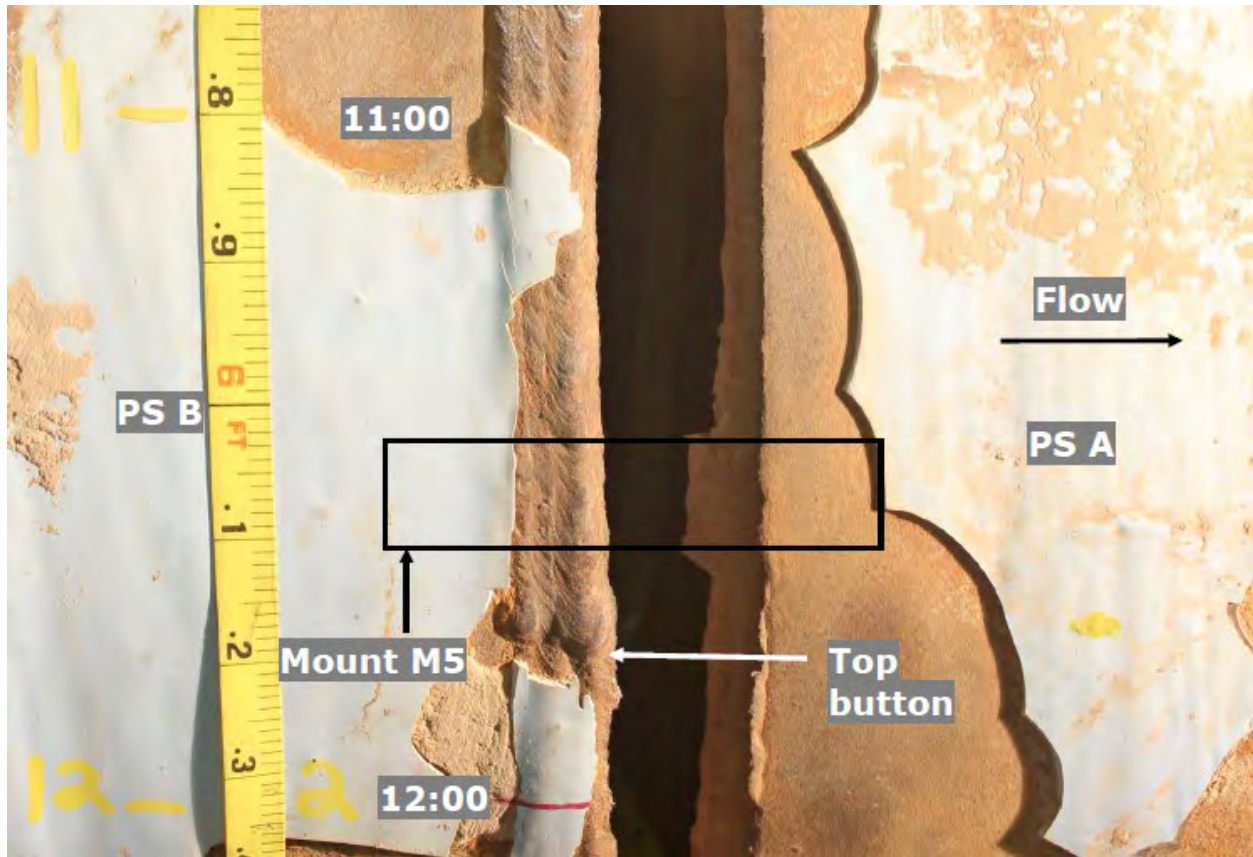
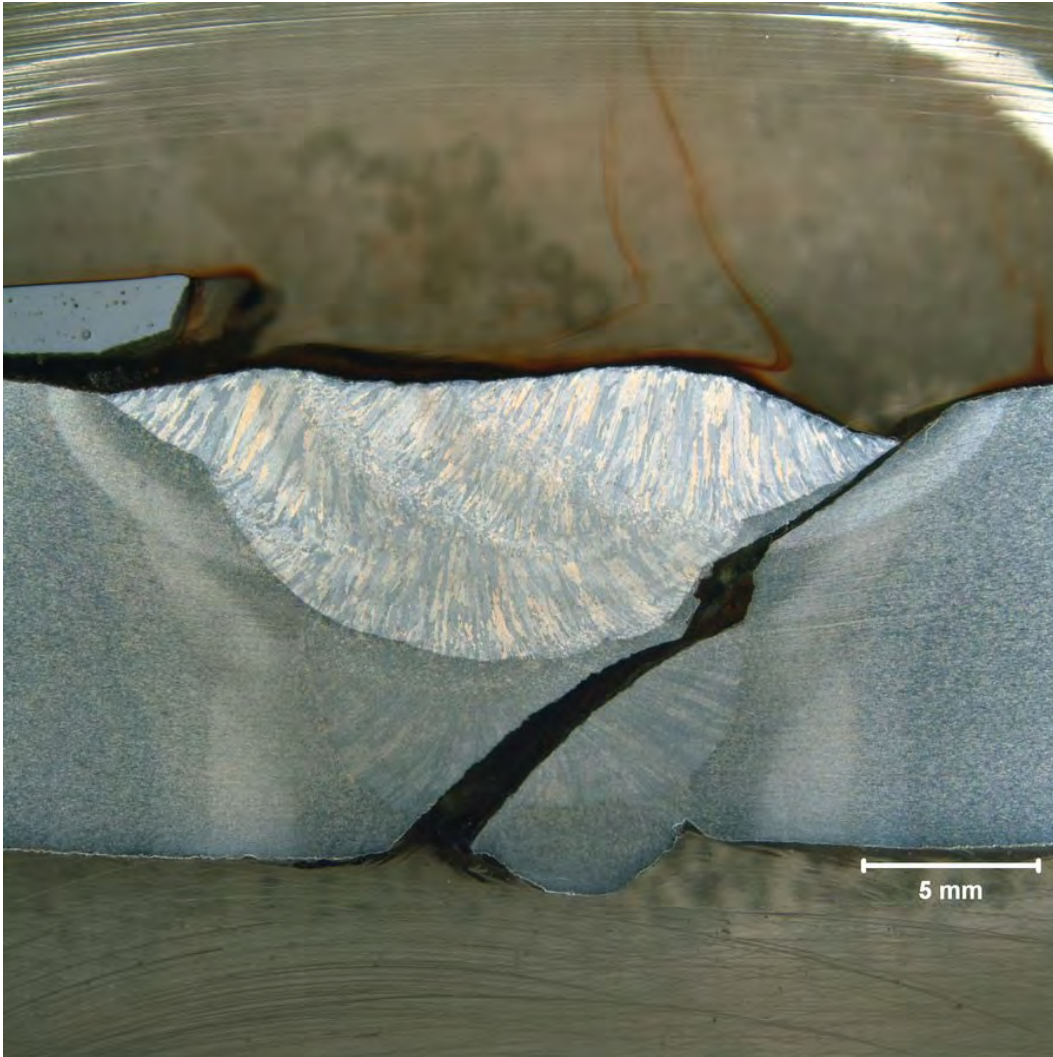
**Figure 31. Overview of Mount M5**

Sample 5 was removed from the failed GW at the 11:37 o'clock orientation (see Figure 31).

This sample has a smooth shear region on most of the fracture surface, located in both the weld metal and base metal. There is a shallow flaw between the weld metal and HAZ which is consistent with incomplete fusion. The high-low weld misalignment at this location was approximately 4.6% of the NWT. There is no evidence of crack extension at the flaw in this sample. A view of the cross section of sample M5 is provided in Figure 32.

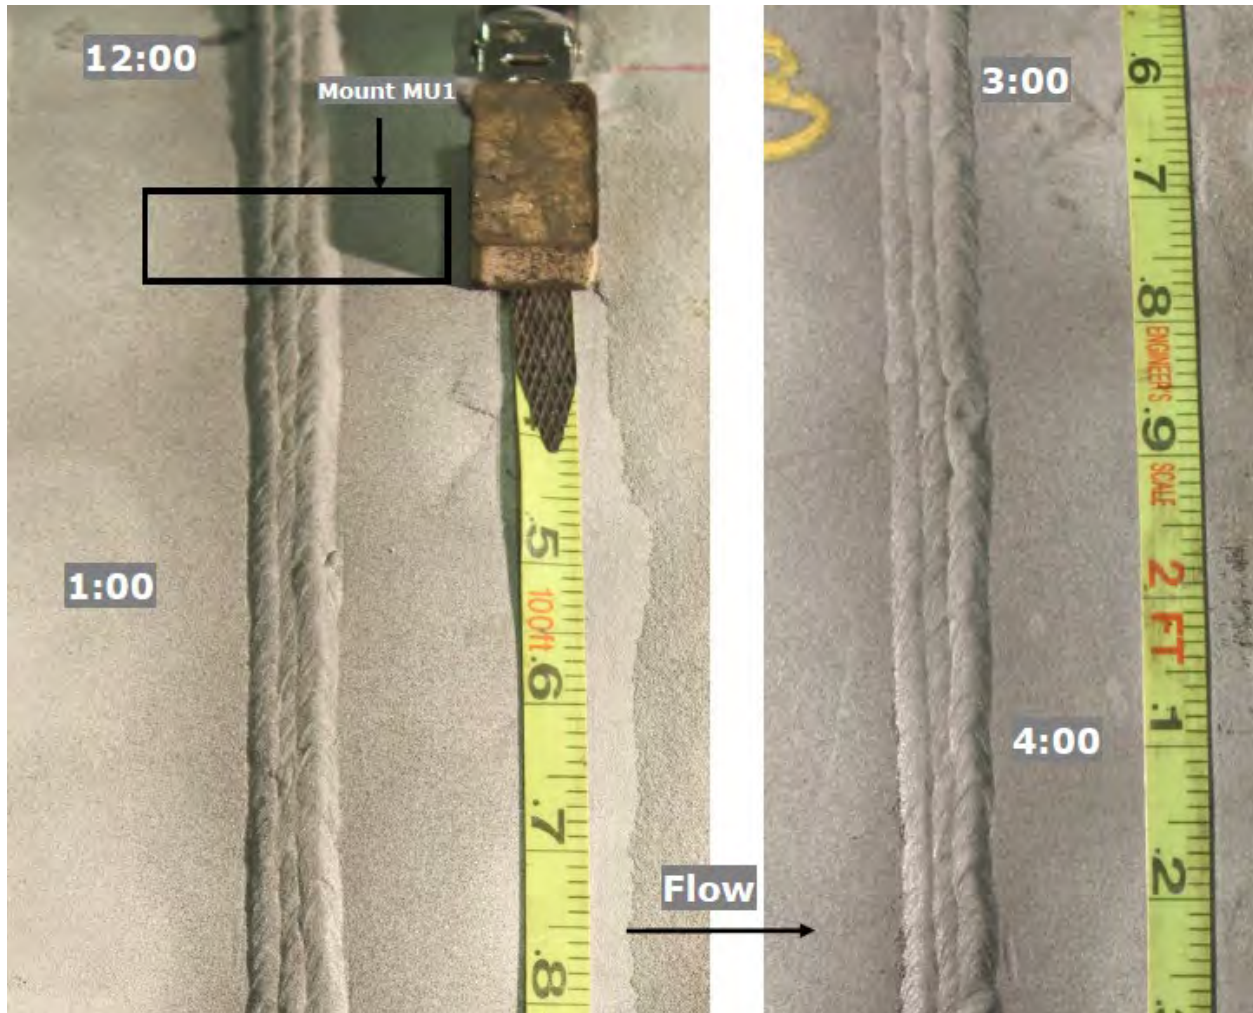
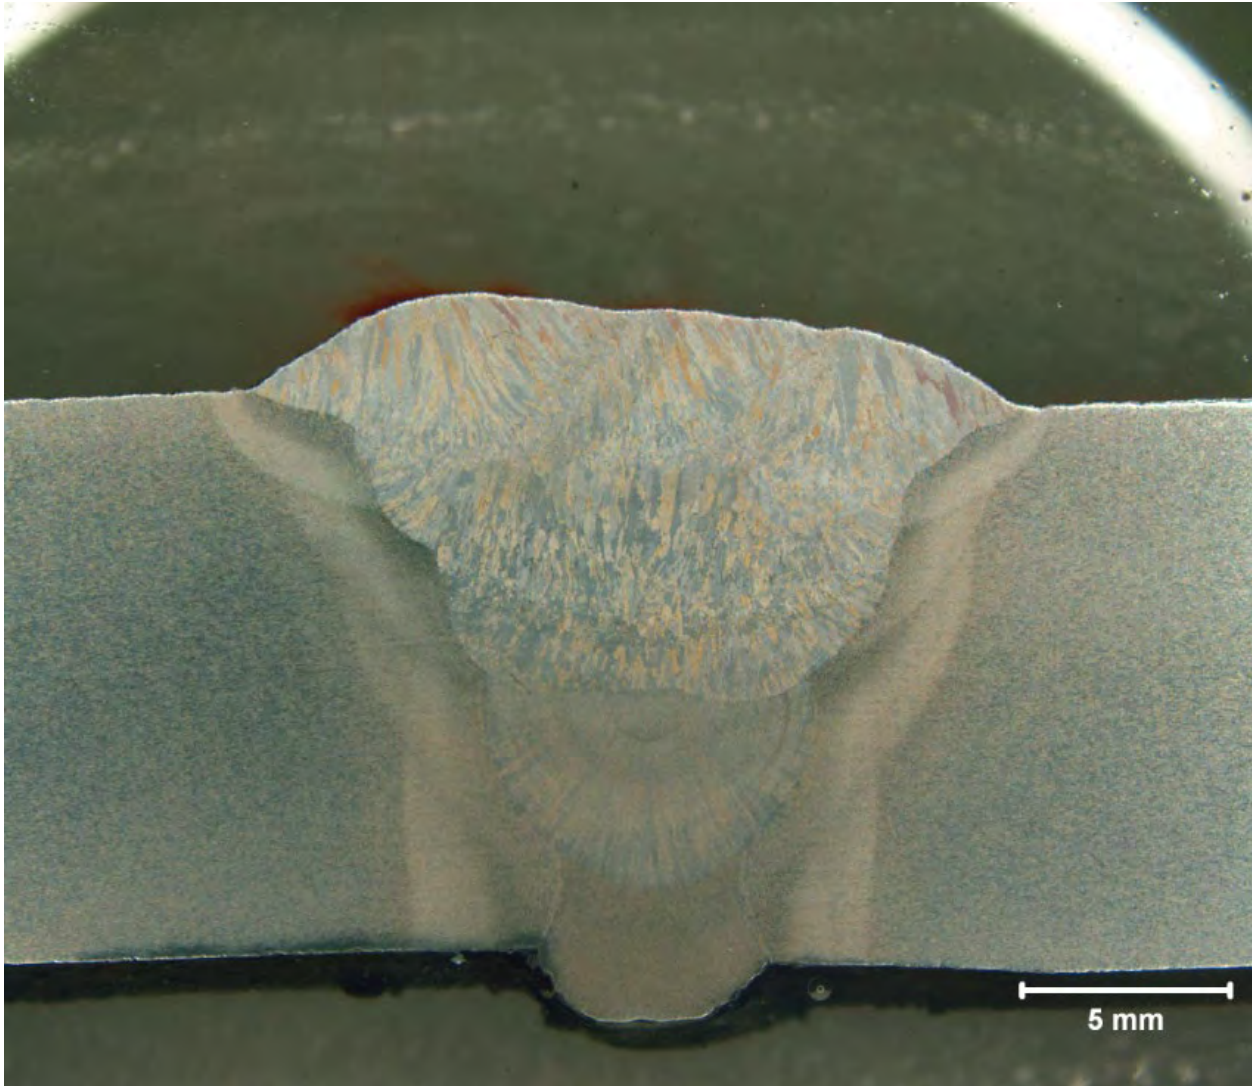
**Figure 33. Overview of Mount MU1**

Sample MU1 was removed from the intact girth weld. An overview of this sample is provided in Figure 33.

This sample was removed from the intact GW at the 12:24 o'clock position. The morphology is similar to the previous mounts. The high-low weld misalignment at this location is approximately 4.6% of the NWT. The figure shows a shallow incomplete fusion flaw (1.9% of the NWT) between the weld metal and the HAZ. An image of the cross section of sample MU1 is provided in Figure 34.

A shallow flaw was identified between the weld metal and HAZ, with no evidence of cracking or extension of the flaw. A close up view of the flaw is provided in Figure 35.
