DOT US Department of Transportation  
PHMSA Pipeline and Hazardous Materials Safety Administration  
OPS Office of Pipeline Safety – Accident Investigation Division

**Principal Investigator** Wesley Mathews  
**Acting Accident Investigation Director** Chris Ruhl  
**Date of Report** May 26, 2022  
**Subject** Failure Investigation Report - Denbury Gulf Coast  
Pipelines, LLC – Pipeline Rupture/ Natural Force Damage

**Failure Investigation Report – Denbury Gulf Coast Pipelines LLC**  
**Pipeline Rupture/Natural Force Damage**  
February 22, 2020

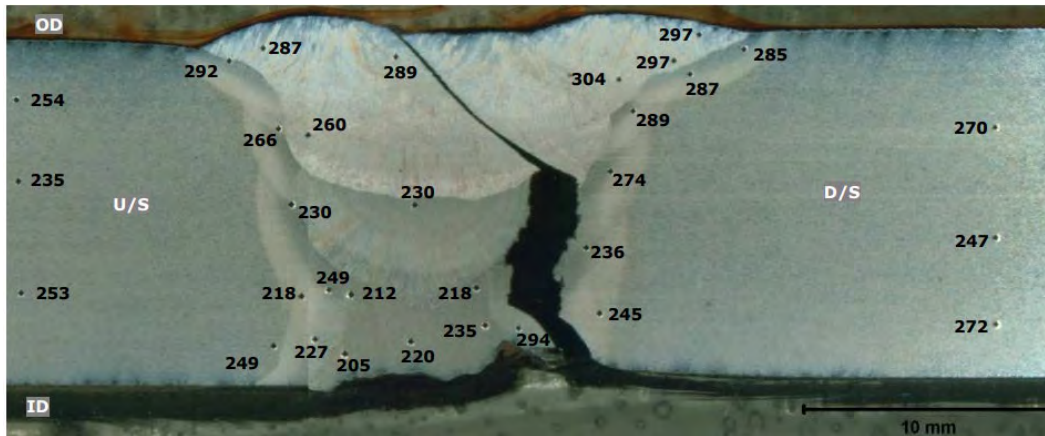
Figure 39: Light Photomicrograph of M2 Axial Cross-Section Showing Hardness Levels in HV

Vickers hardness testing was conducted on all six metallographic cross sections. No areas of unusually high hardness were identified. Hardness testing of the failed girth weld exhibit variability that is likely associated with cold work sustained during the failure. The hardness testing of the intact weld are the best representation of the base hardness of the welds preceding the failure. The results indicate a lower hardness of the weld metal compared to the pipe metal, which indicating that the weld metal is softer than the parent metal. Typically, the parent metal

is harder than the weld metal. The axial tensile tests on the intact girth weld show similar failure to the actual fracture, further indicating that the lower hardness typical of the weld was the preferred location for the overload failure under applied axial stress. Hardness levels at varying points on sample M2 from the failed girth weld are shown in Figure 39.

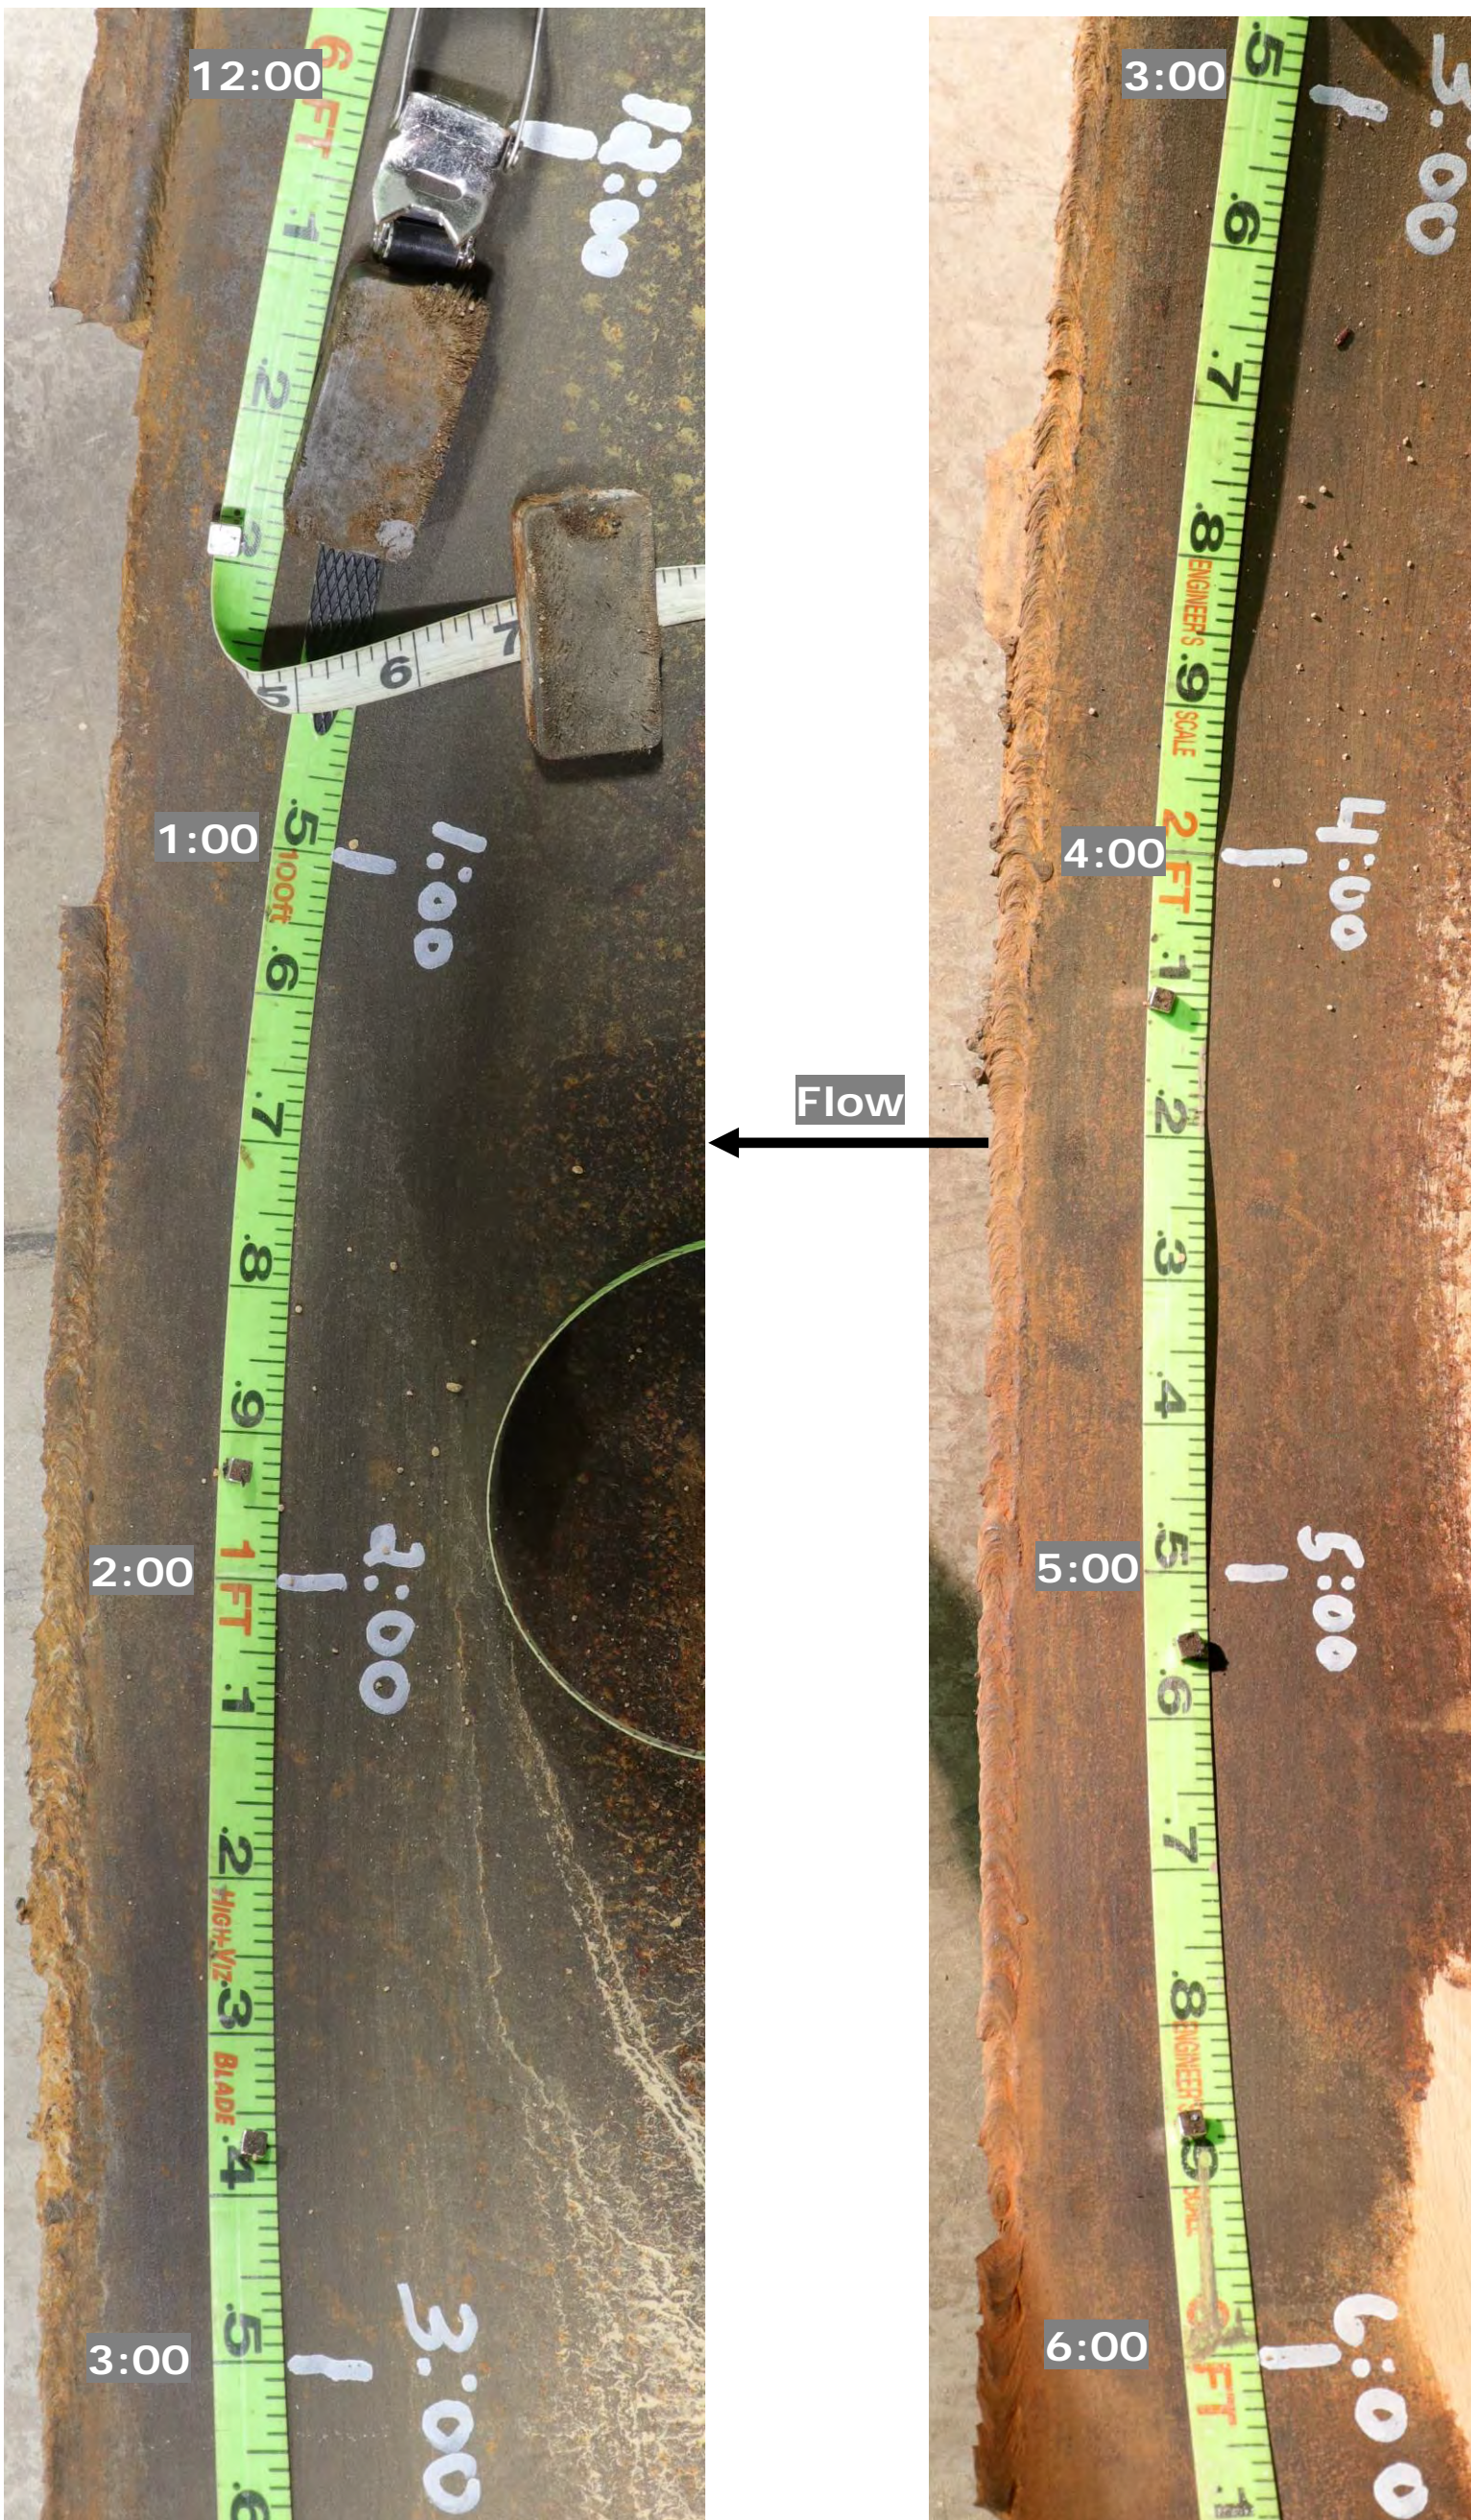
Figure 15. Photograph of the internal pipe surface adjacent to the fracture surface of PS B, between the 12 and 6 o'clock orientations. The tape measure indicates the approximate distance CW of TDC (looking D/S convention).

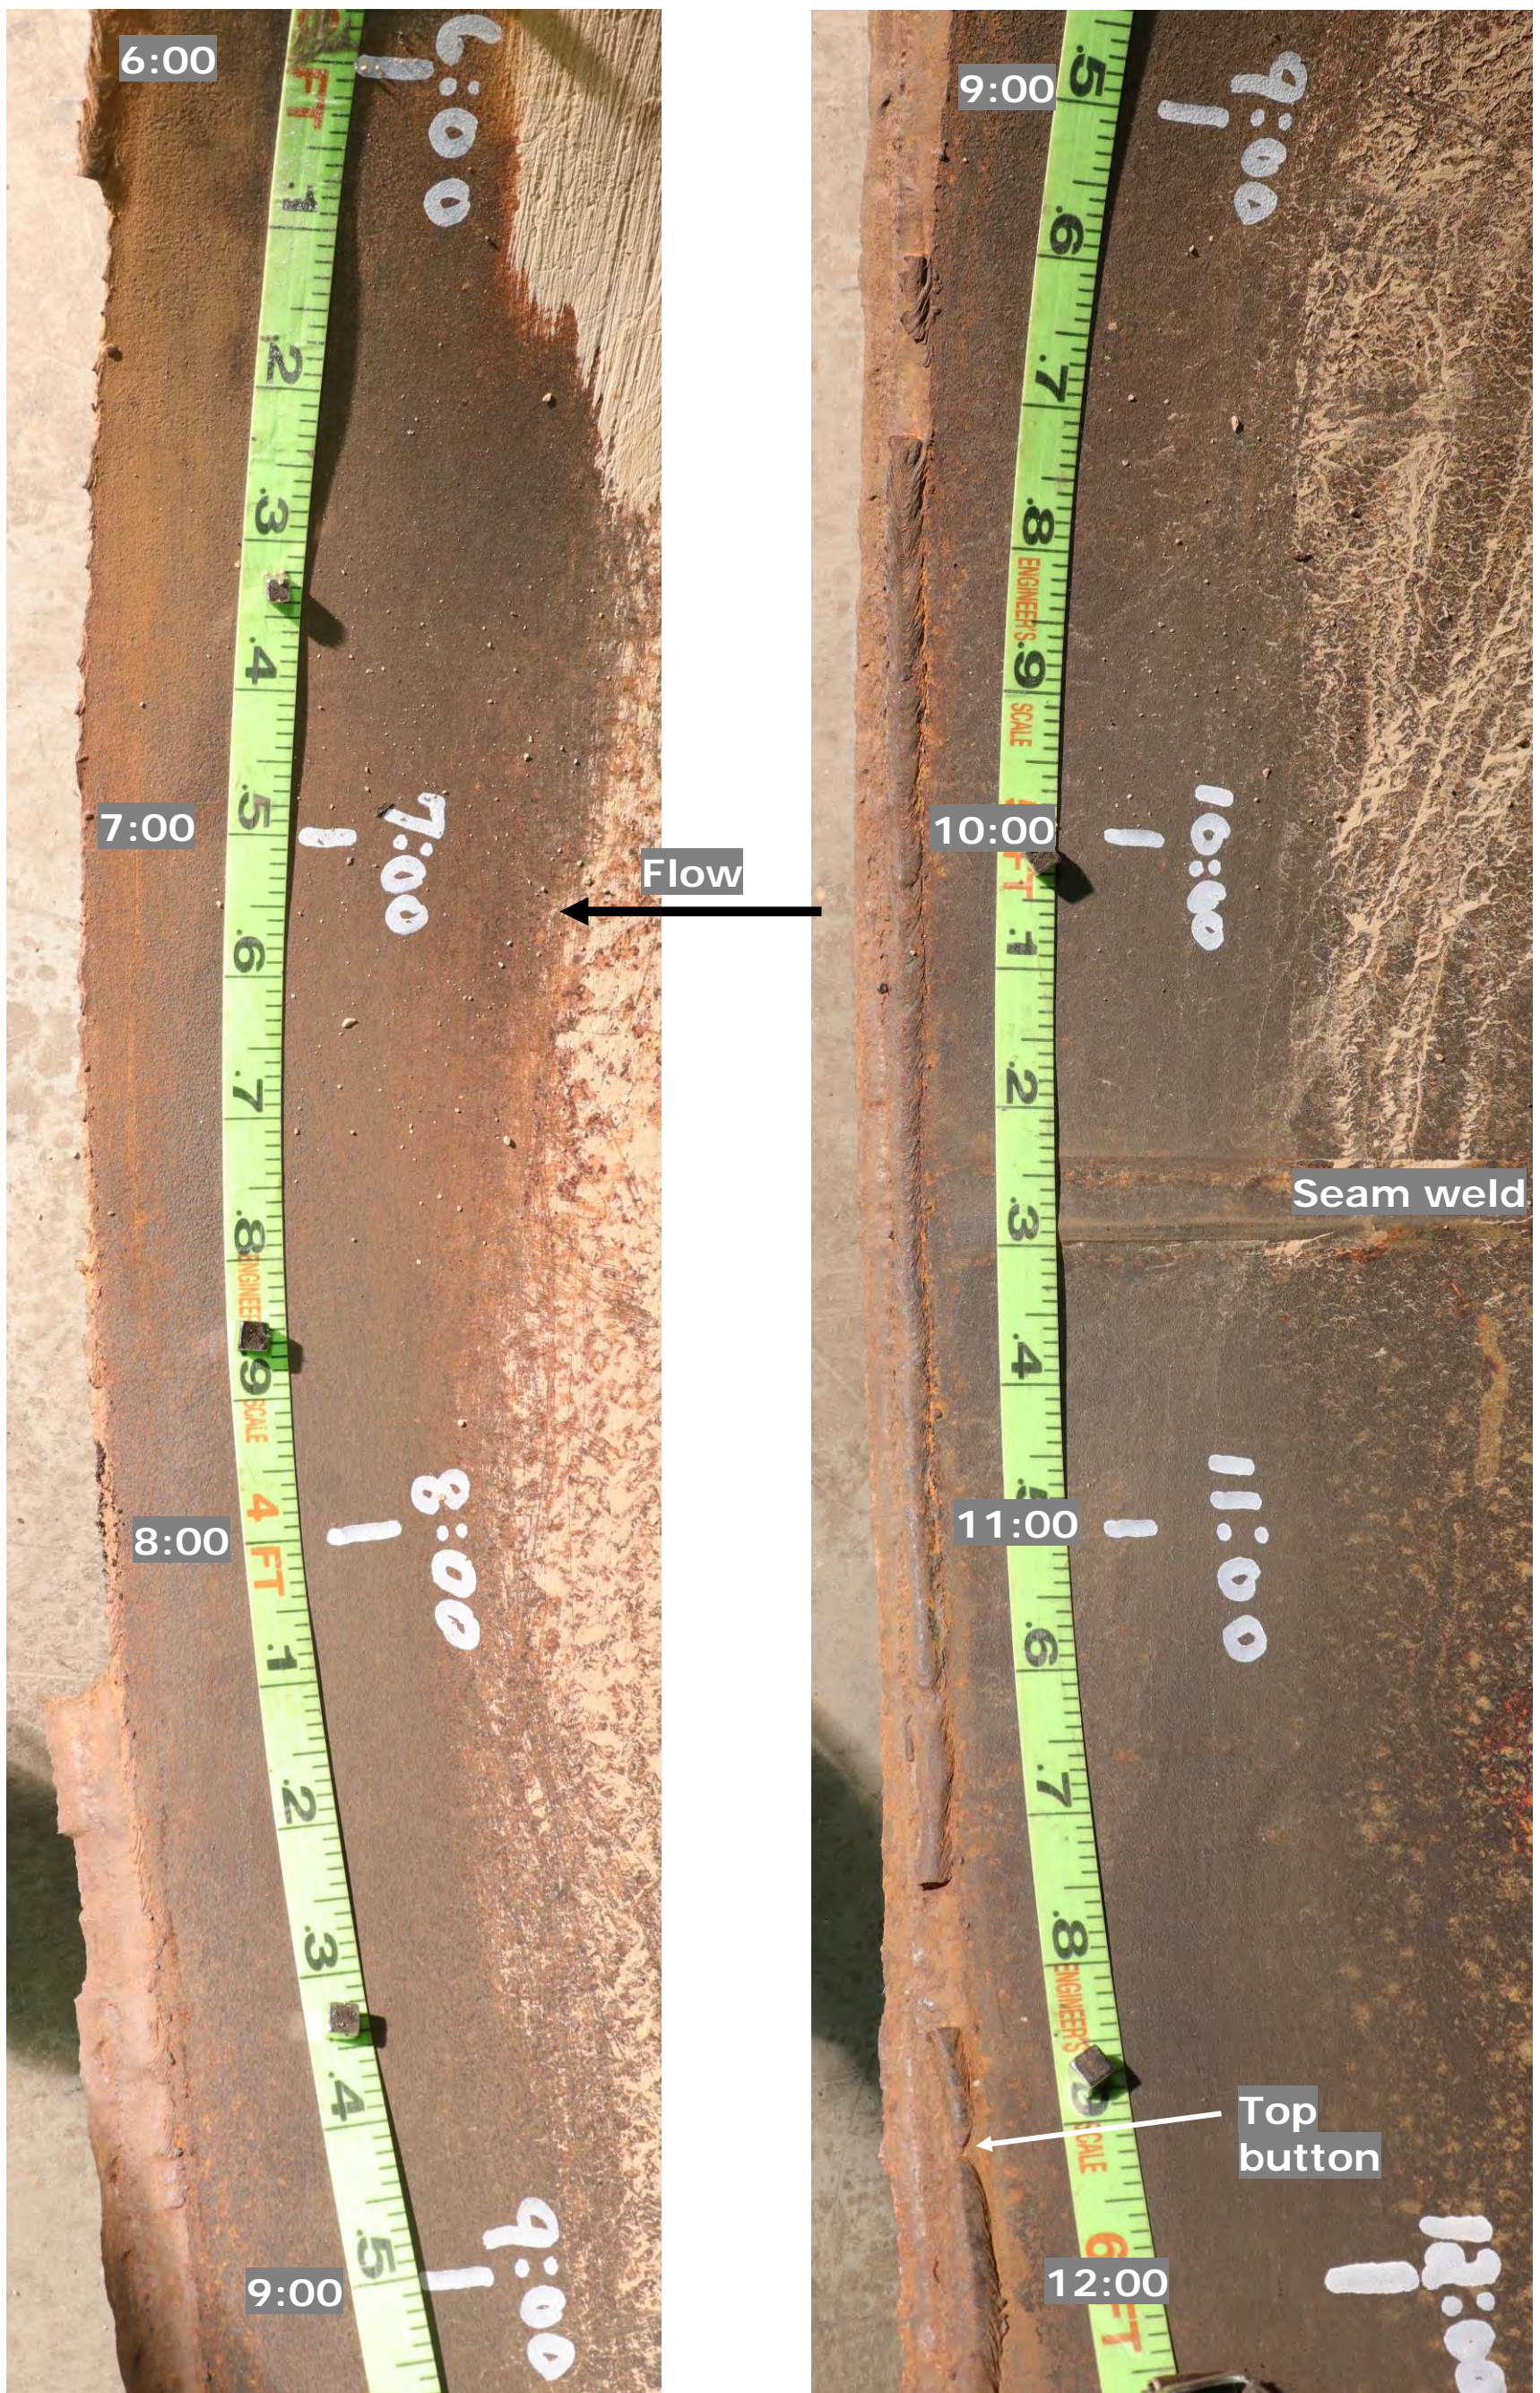
Figure 16. Photographs of the internal pipe surface adjacent to the fracture surface of PS B, between the 6 and 12 o'clock orientations. The tape measure indicates the approximate distance CW of TDC (looking D/S convention).

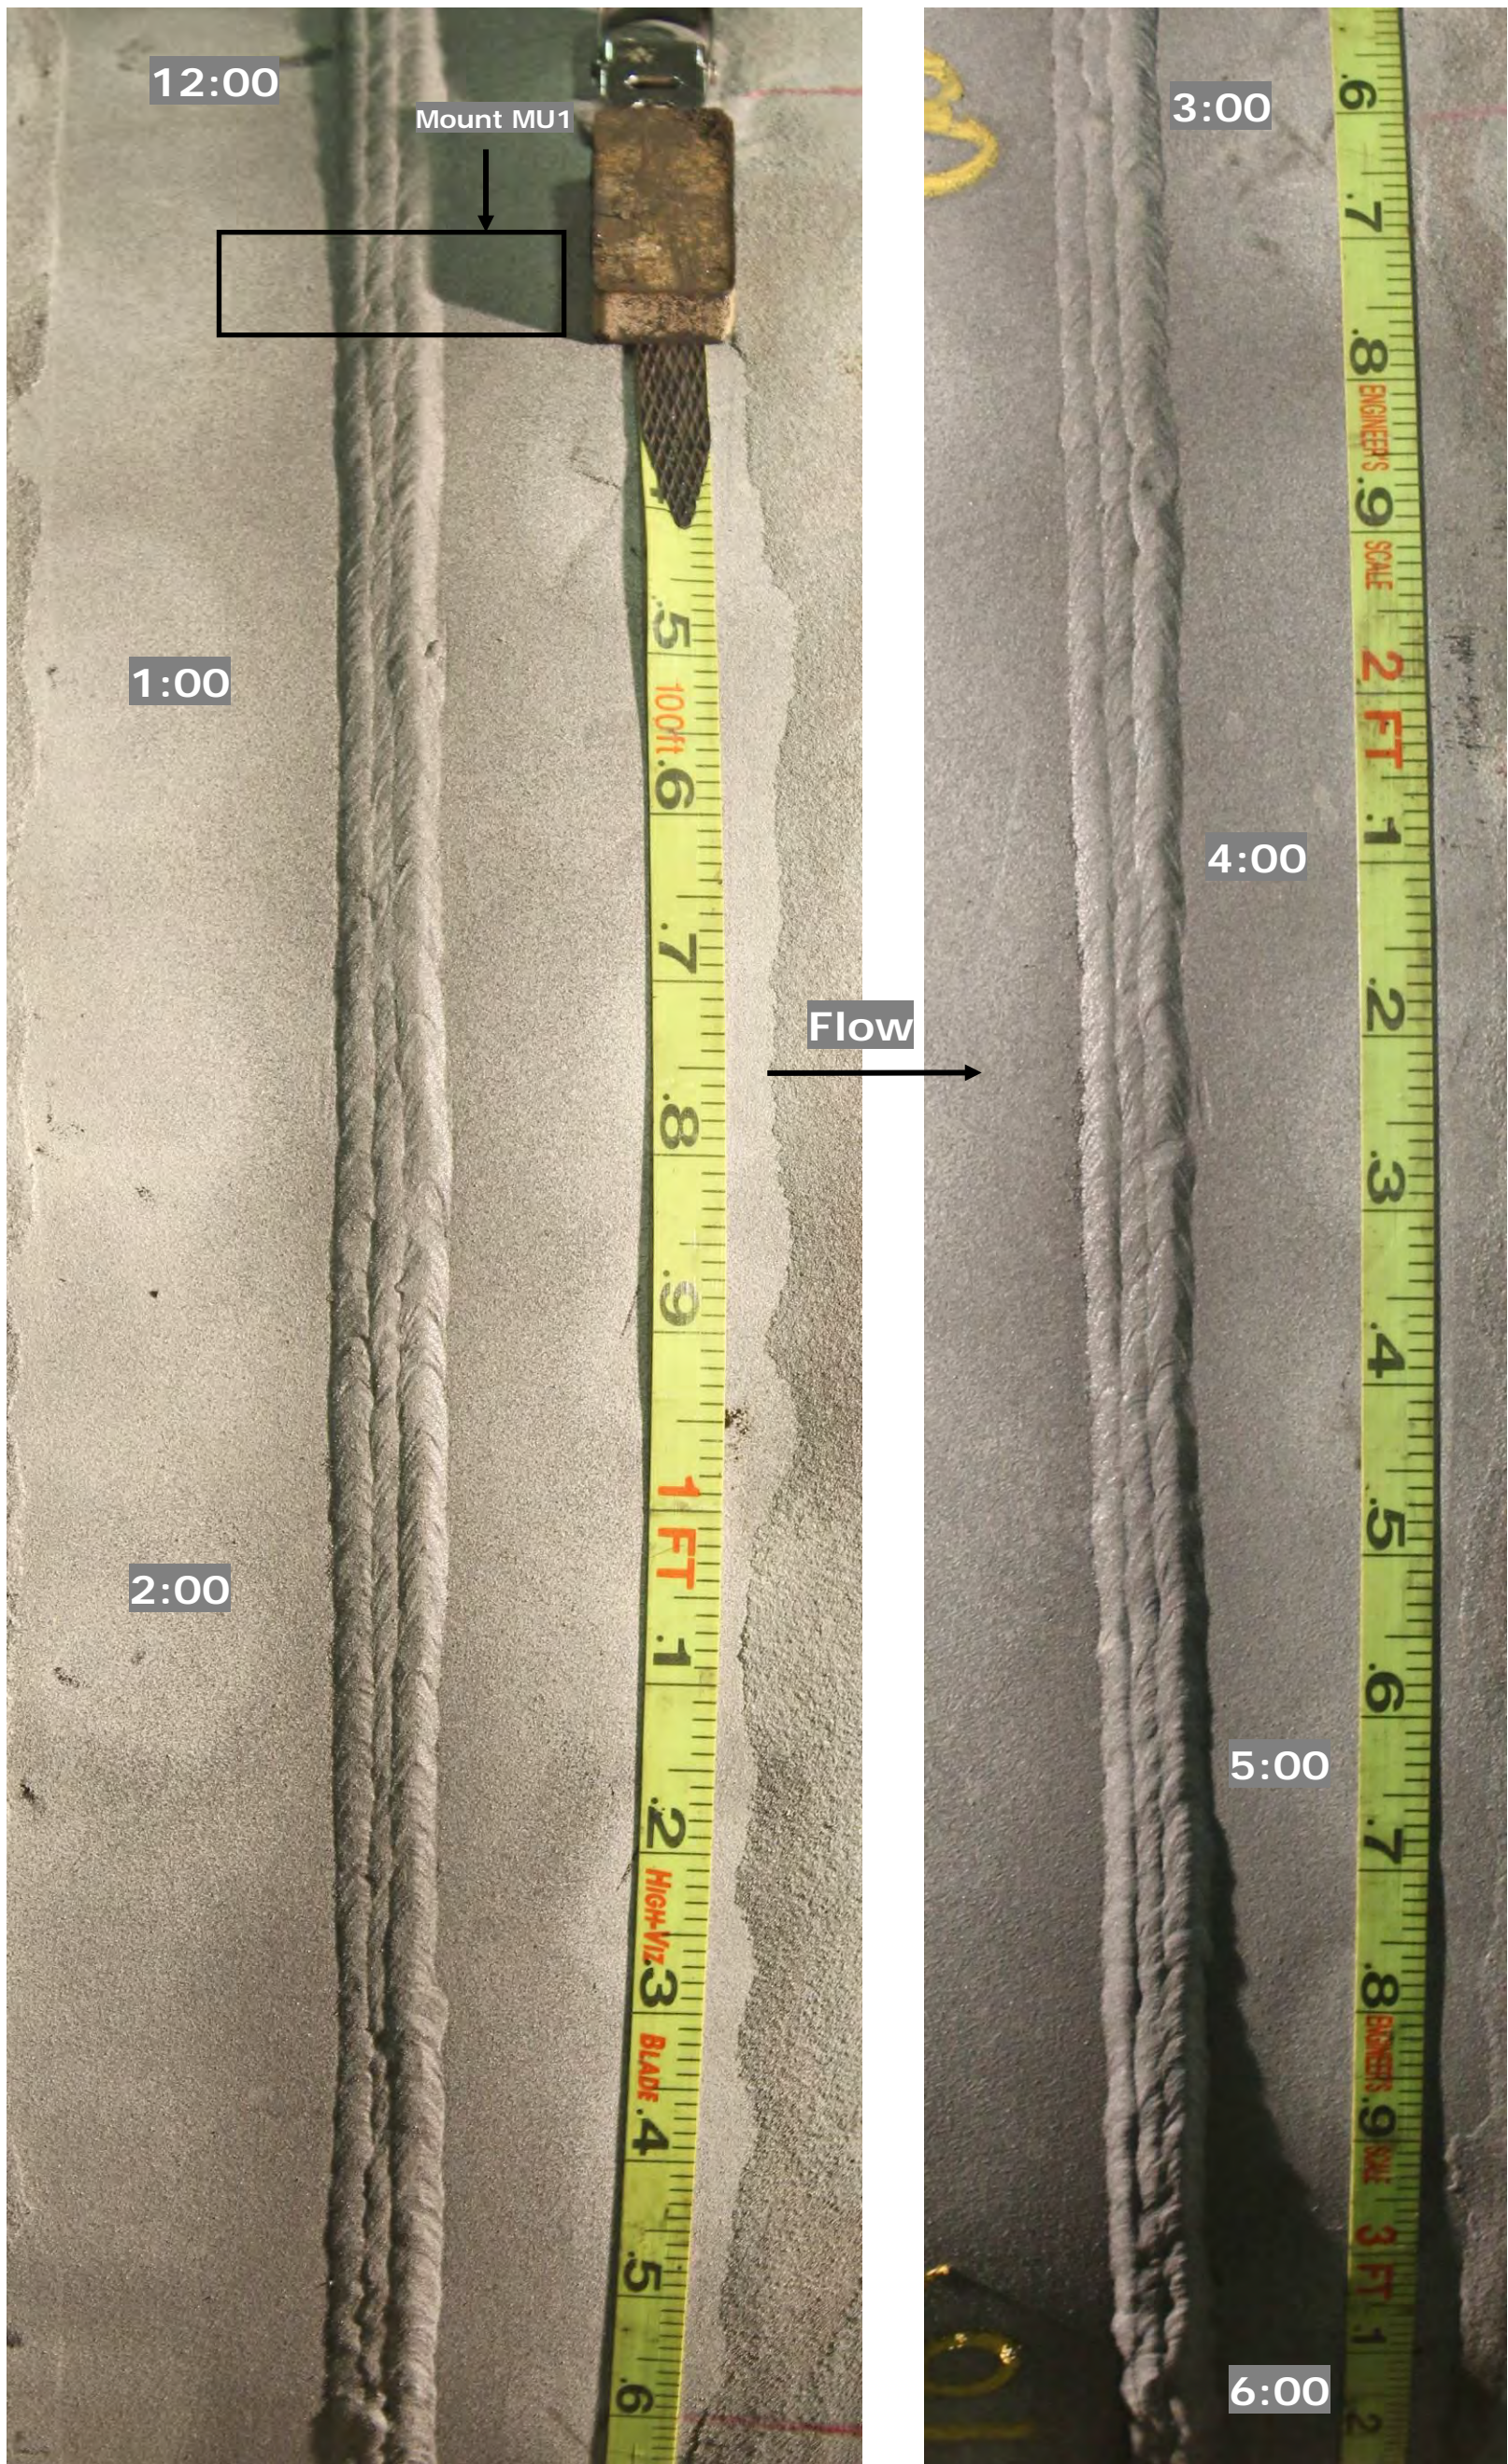
No excessively high hardness areas were identified in the girth weld cross-sections. The weld metal of the intact girth weld had a lower hardness than the surrounding pipe material, indicating that the weld metal is weaker than the surrounding pipe material. This trend was somewhat followed for the failed girth weld, although cold work from the failure likely skewed some of the data. The softest regions in all the mounts was the weld metal root pass. The lower overall hardness values of the weld metal compared to the surrounding pipe material is consistent with the axial tensile results. The ultimate tensile strength for the girth weld of 103.3 ksi is less than the axial tensile strength of 109.7 ksi and 106 ksi for the joint's D/S and U/S, respectively, of the failed girth weld. The axial tensile tests across the intact GW failed in the GW, similar to the actual failure. Therefore, a contributing factor to the failure was that the pipe steel was stronger than the girth weld.

Figure 17. Photograph of the external pipe surface at the intact girth weld following grit blasting and MPI, between the 12:00 and 6:00 orientations. The tape measure indicates the approximate distance CW of TDC (looking D/S convention).

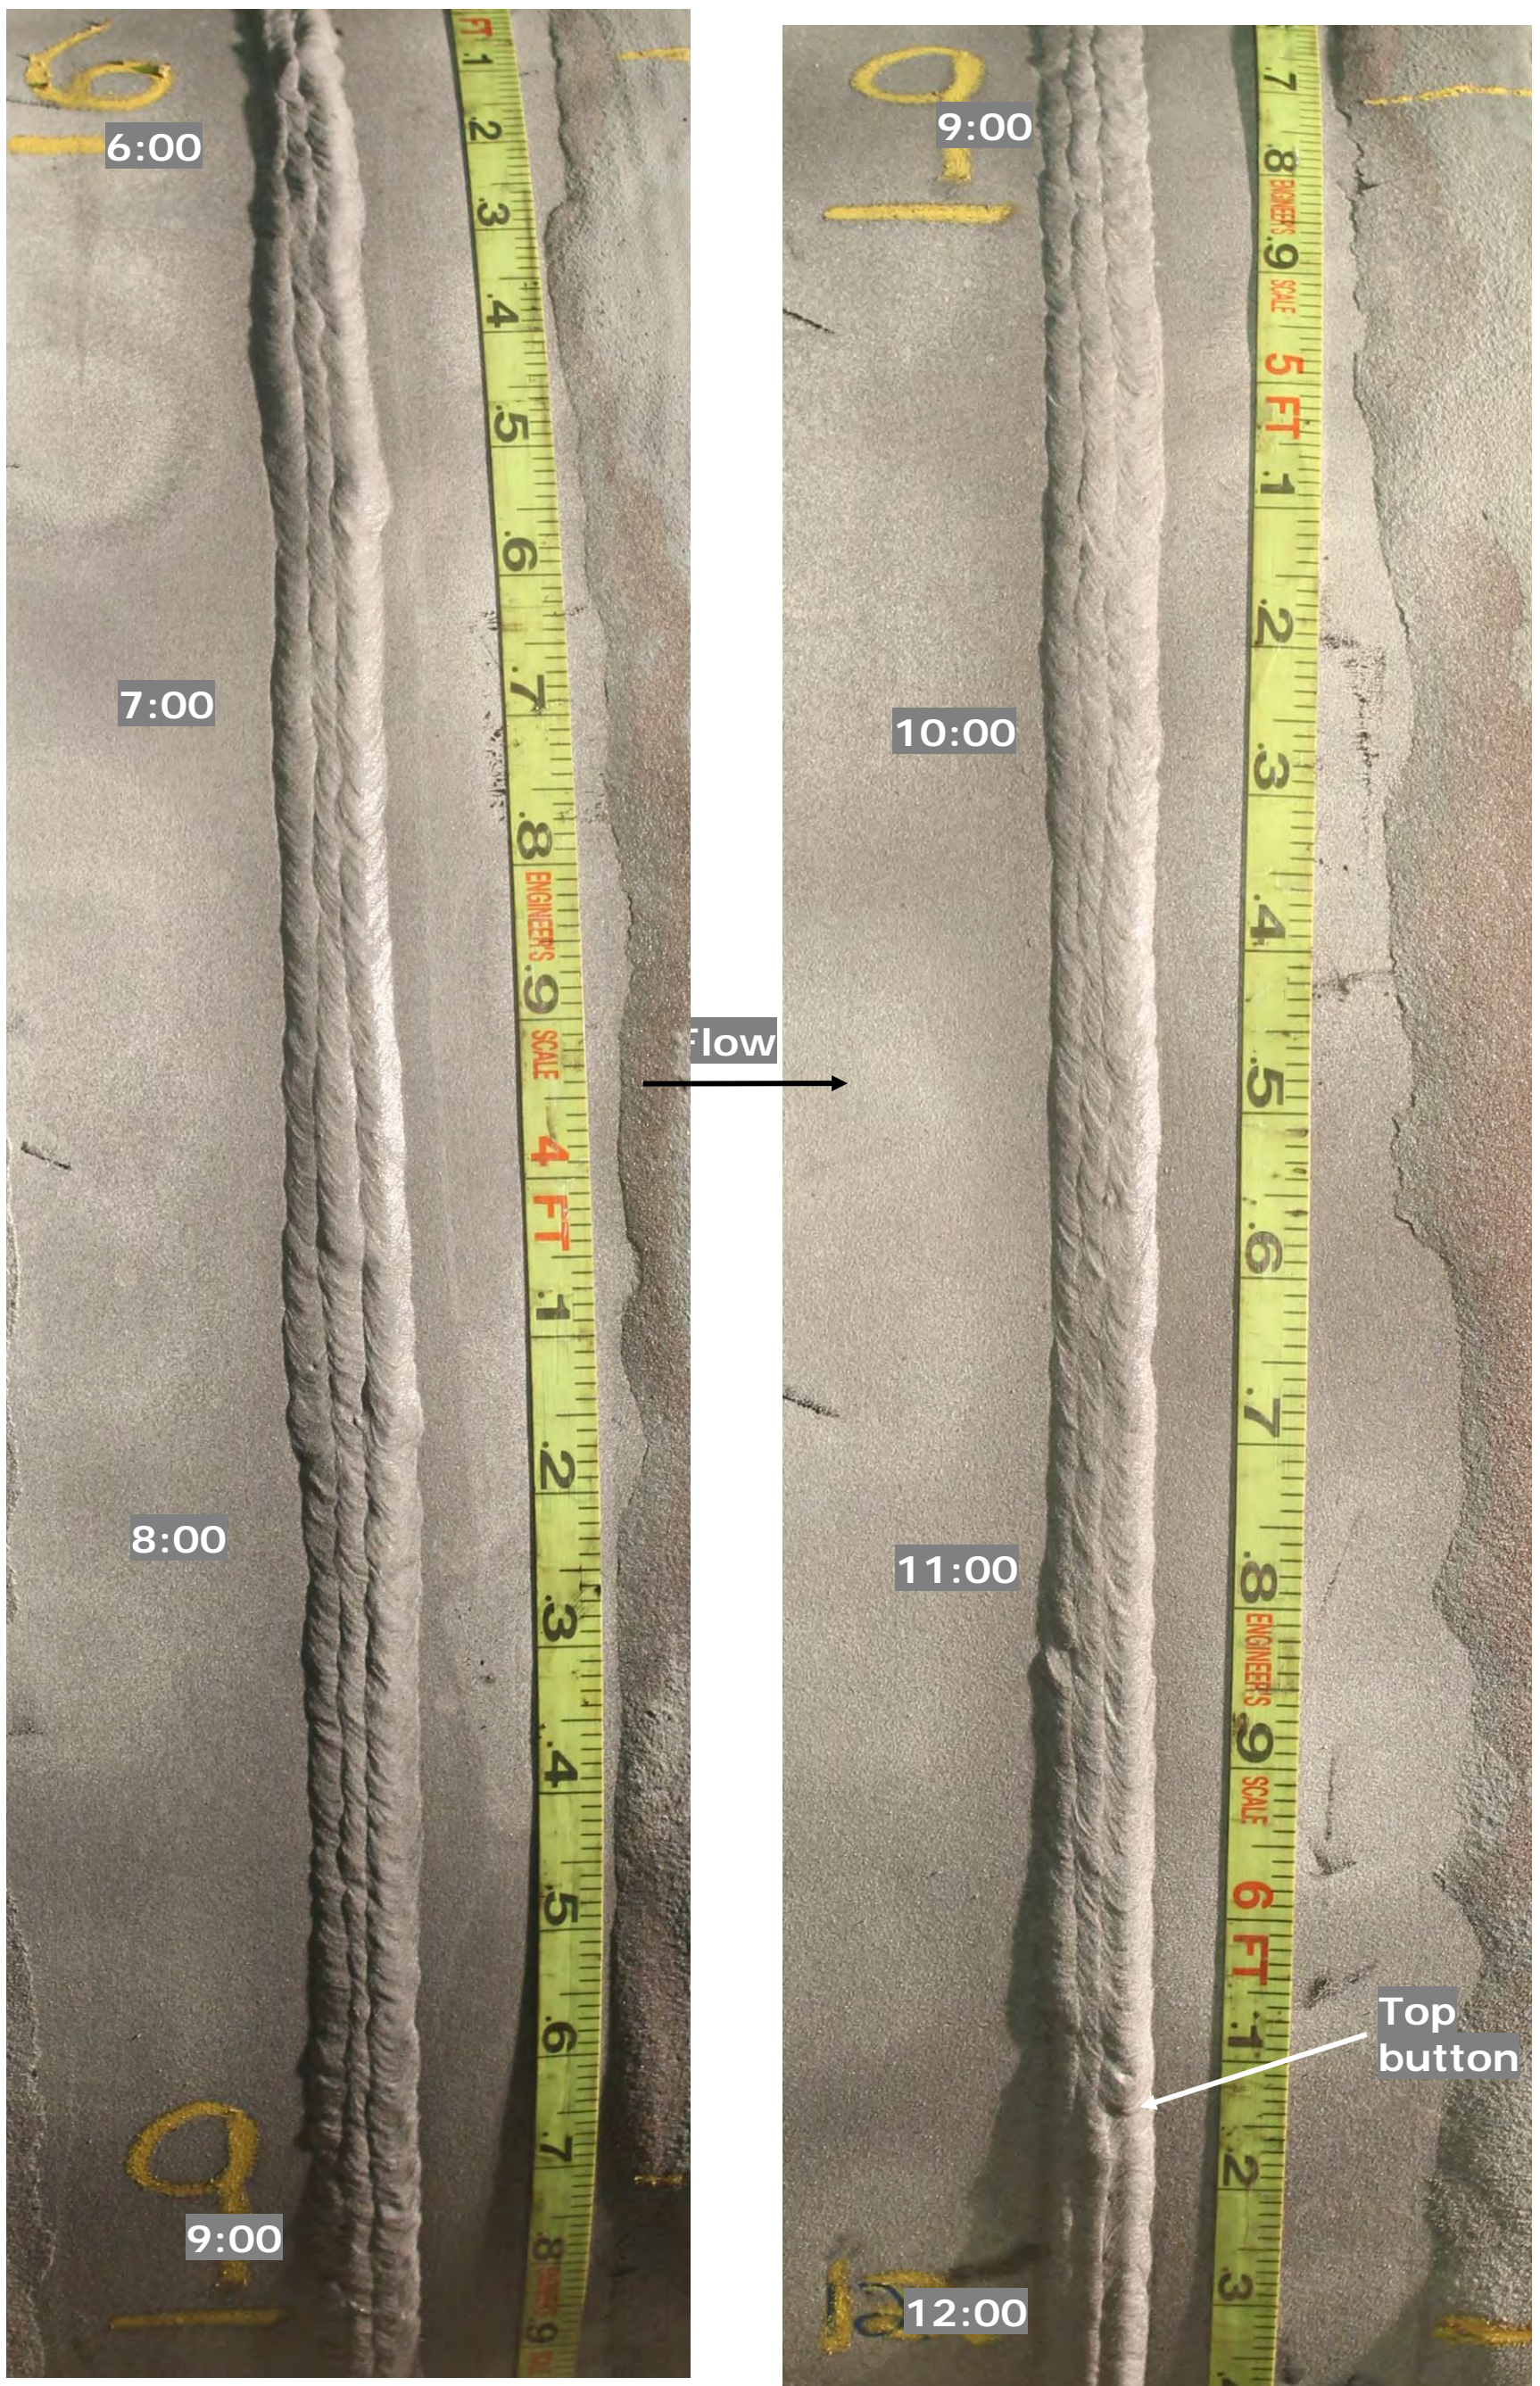
Figure 18. Photograph of the external pipe surface at the intact girth weld following grit blasting and MPI, between the 6:00 and 12:00 orientations. The tape measure indicates the approximate distance CW of TDC (looking D/S convention).

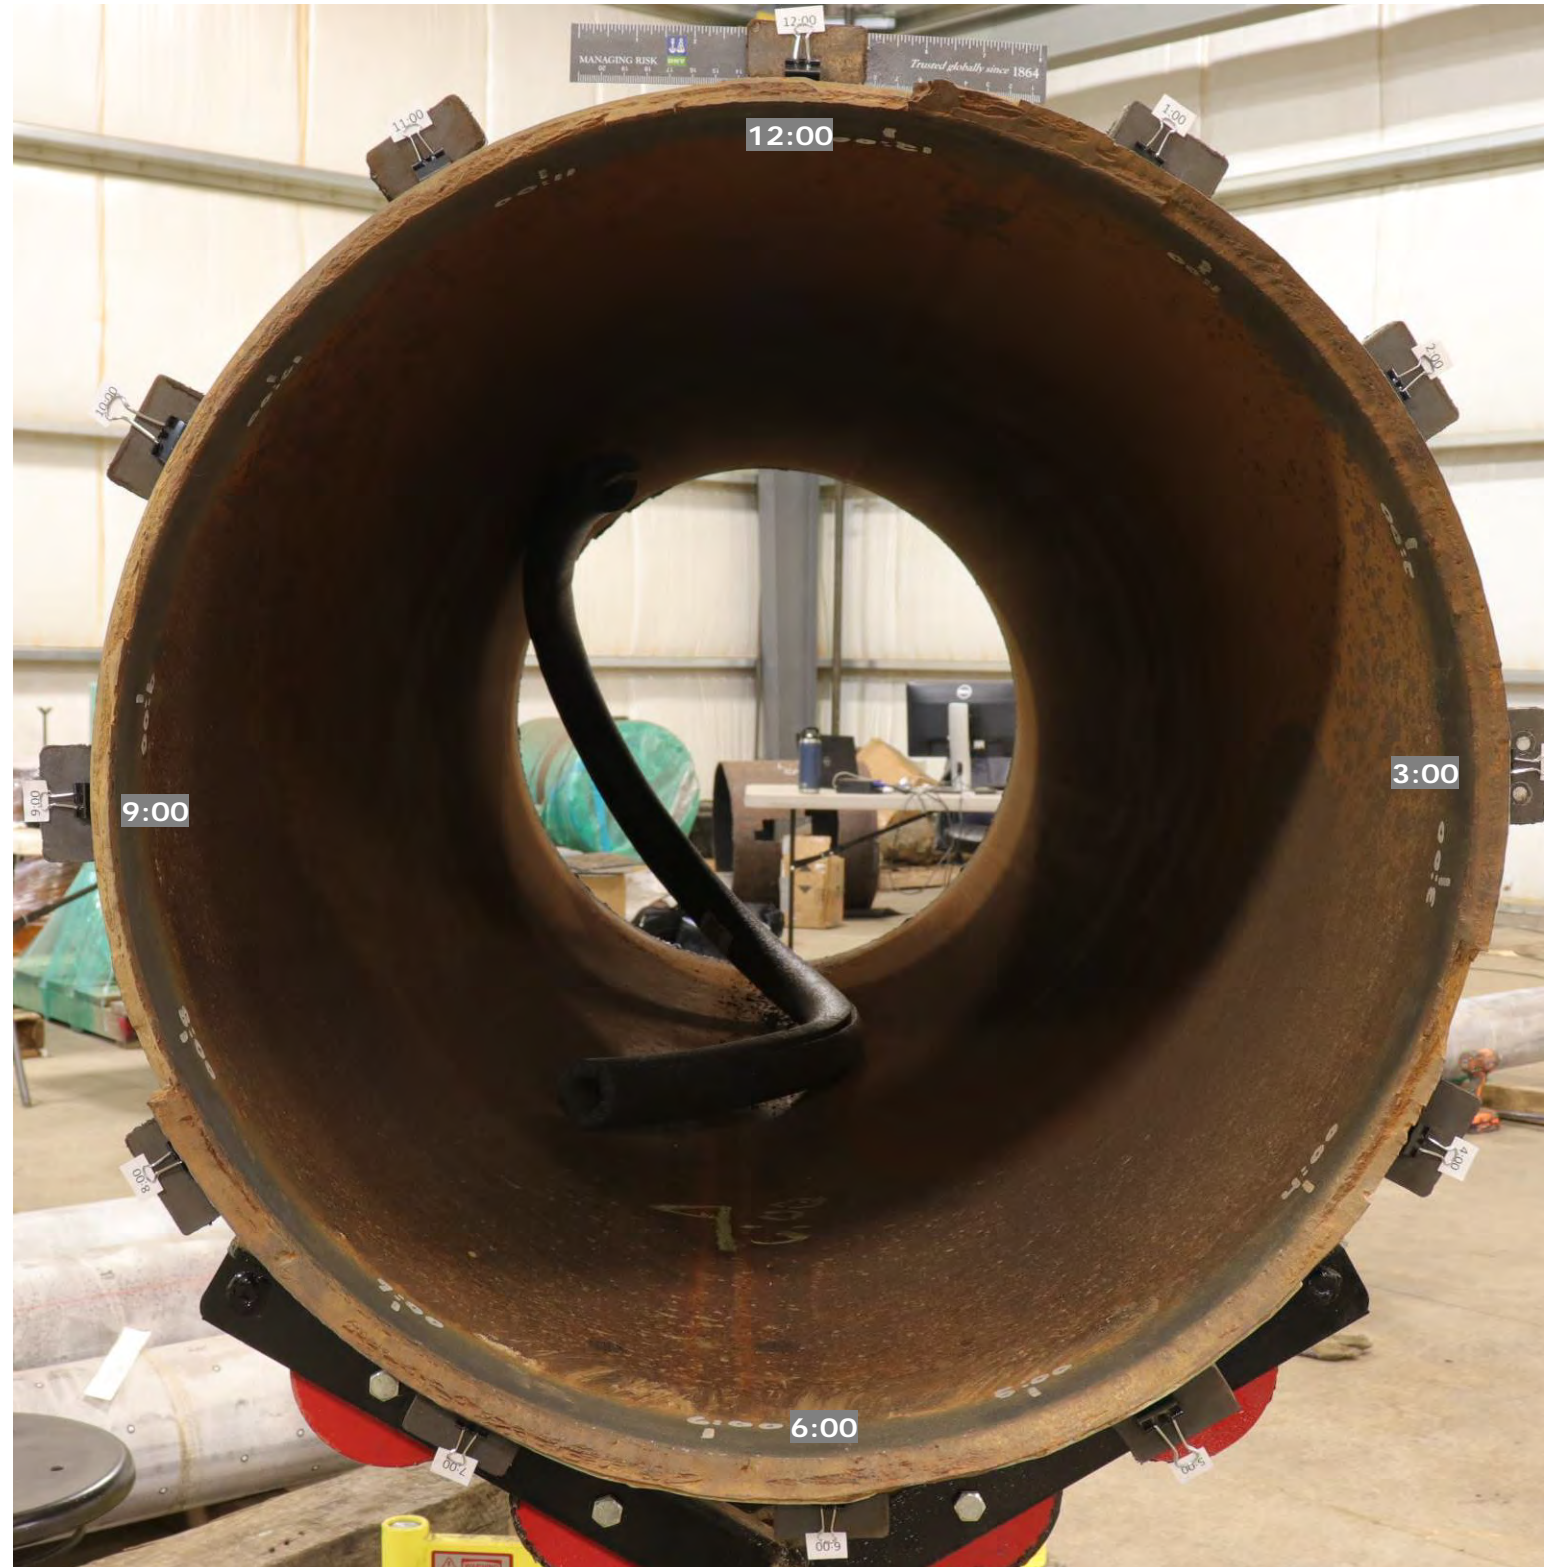
The results of the metallurgical analysis indicate that the failure initiated at a field girth weld, completely separating the girth weld. The exact location of the initiation could not be determined due to a lack of chevrons on the fracture surfaces and the fact that no significant pre-existing (prior to failure) cracks were identified. Microscopically, the fracture surface contained regions with dimples (ductile fracture) and cleavage facets (brittle fracture). The dimples were located where the fracture surface was at a shear angle and macroscopically smooth, and the cleavage facets were located where the fracture surface was perpendicular to the free surfaces and macroscopically rough. Both fractographic features are an indication of the overload nature on the fracture surface.

Figure 19. Photograph of the fracture surface and internal pipe surface of PS A. Flow direction is into the photograph. Labels on magnets indicate o'clock orientations.
