DOT US Department of Transportation  
PHMSA Pipeline and Hazardous Materials Safety Administration  
OPS Office of Pipeline Safety – Accident Investigation Division

**Principal Investigator** Wesley Mathews  
**Acting Accident Investigation Director** Chris Ruhl  
**Date of Report** May 26, 2022  
**Subject** Failure Investigation Report - Denbury Gulf Coast  
Pipelines, LLC – Pipeline Rupture/ Natural Force Damage

**Failure Investigation Report – Denbury Gulf Coast Pipelines LLC**  
**Pipeline Rupture/Natural Force Damage**  
February 22, 2020

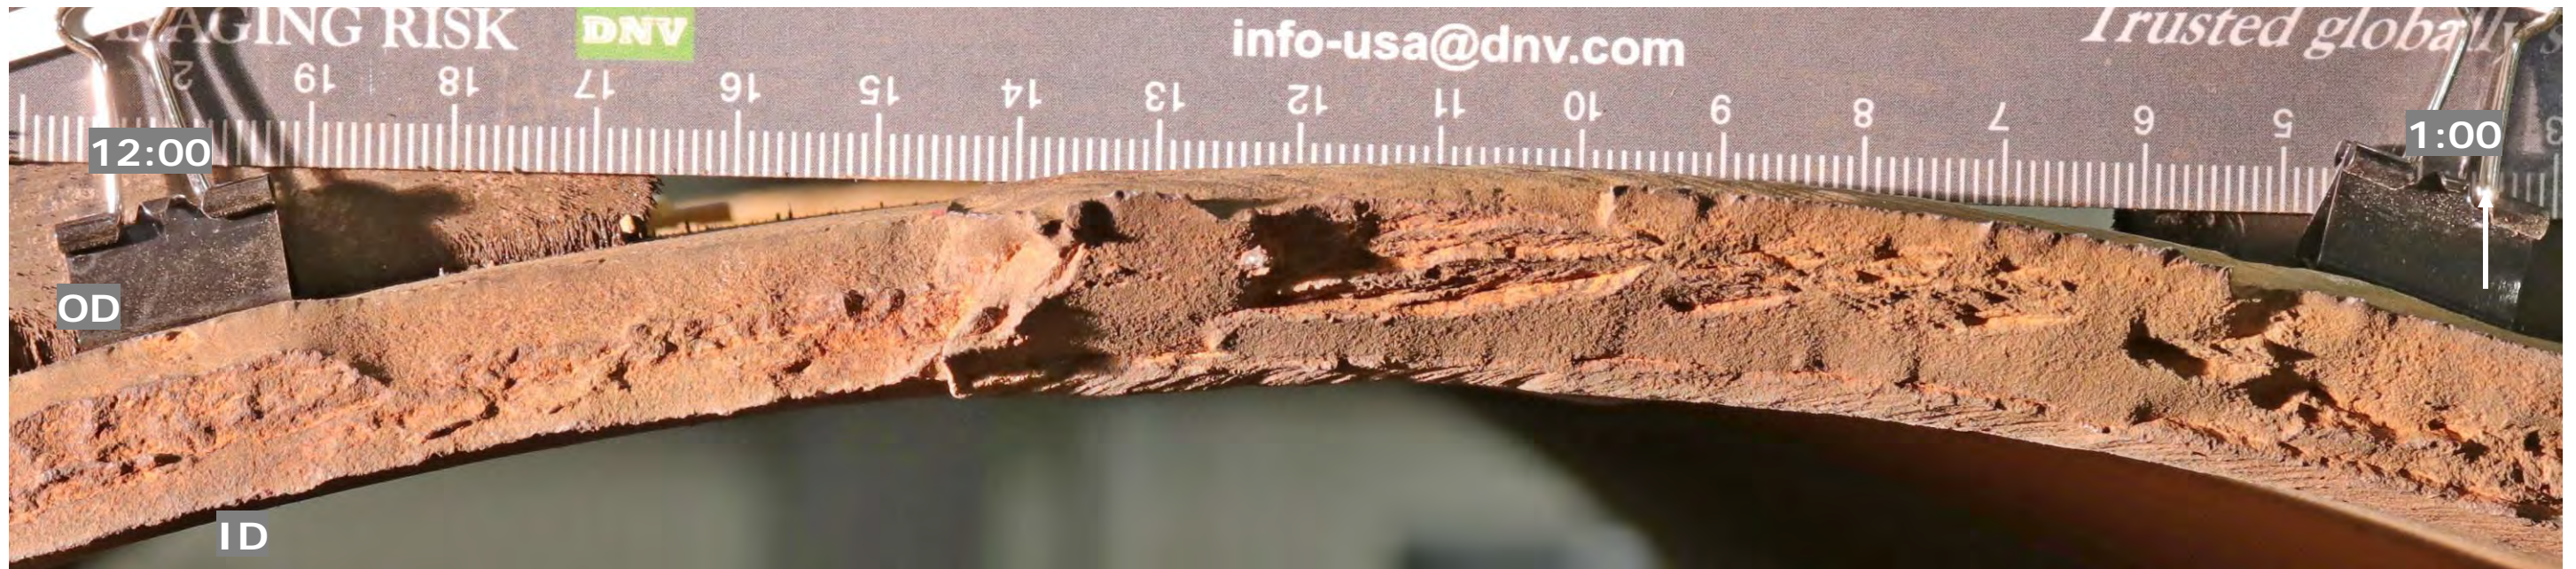
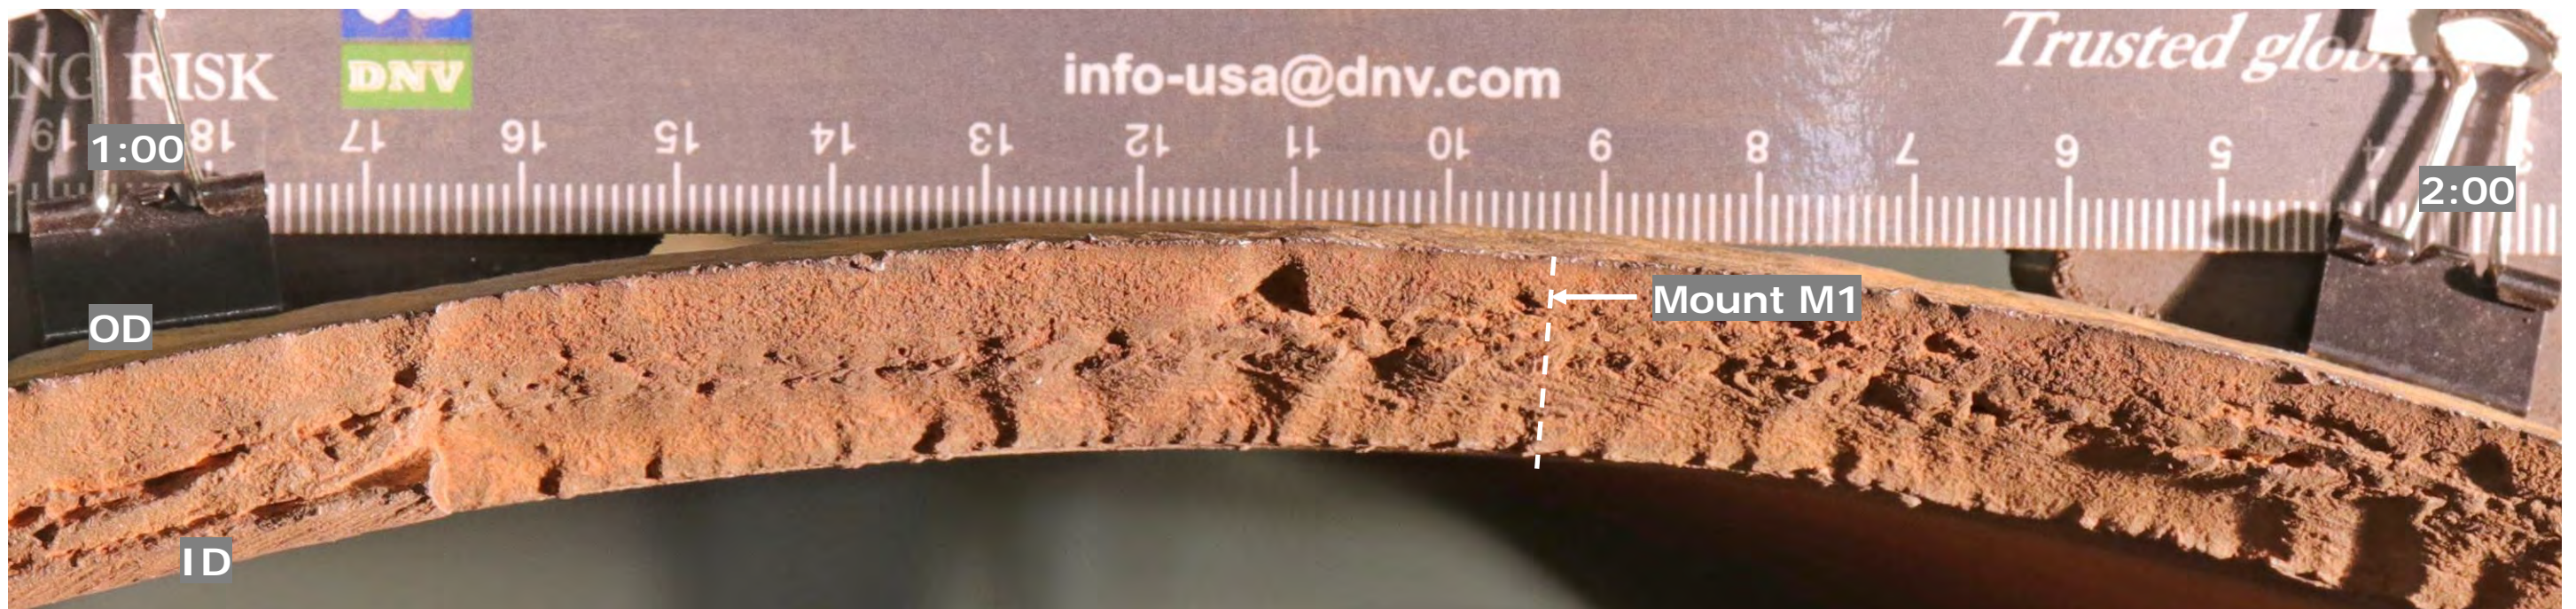
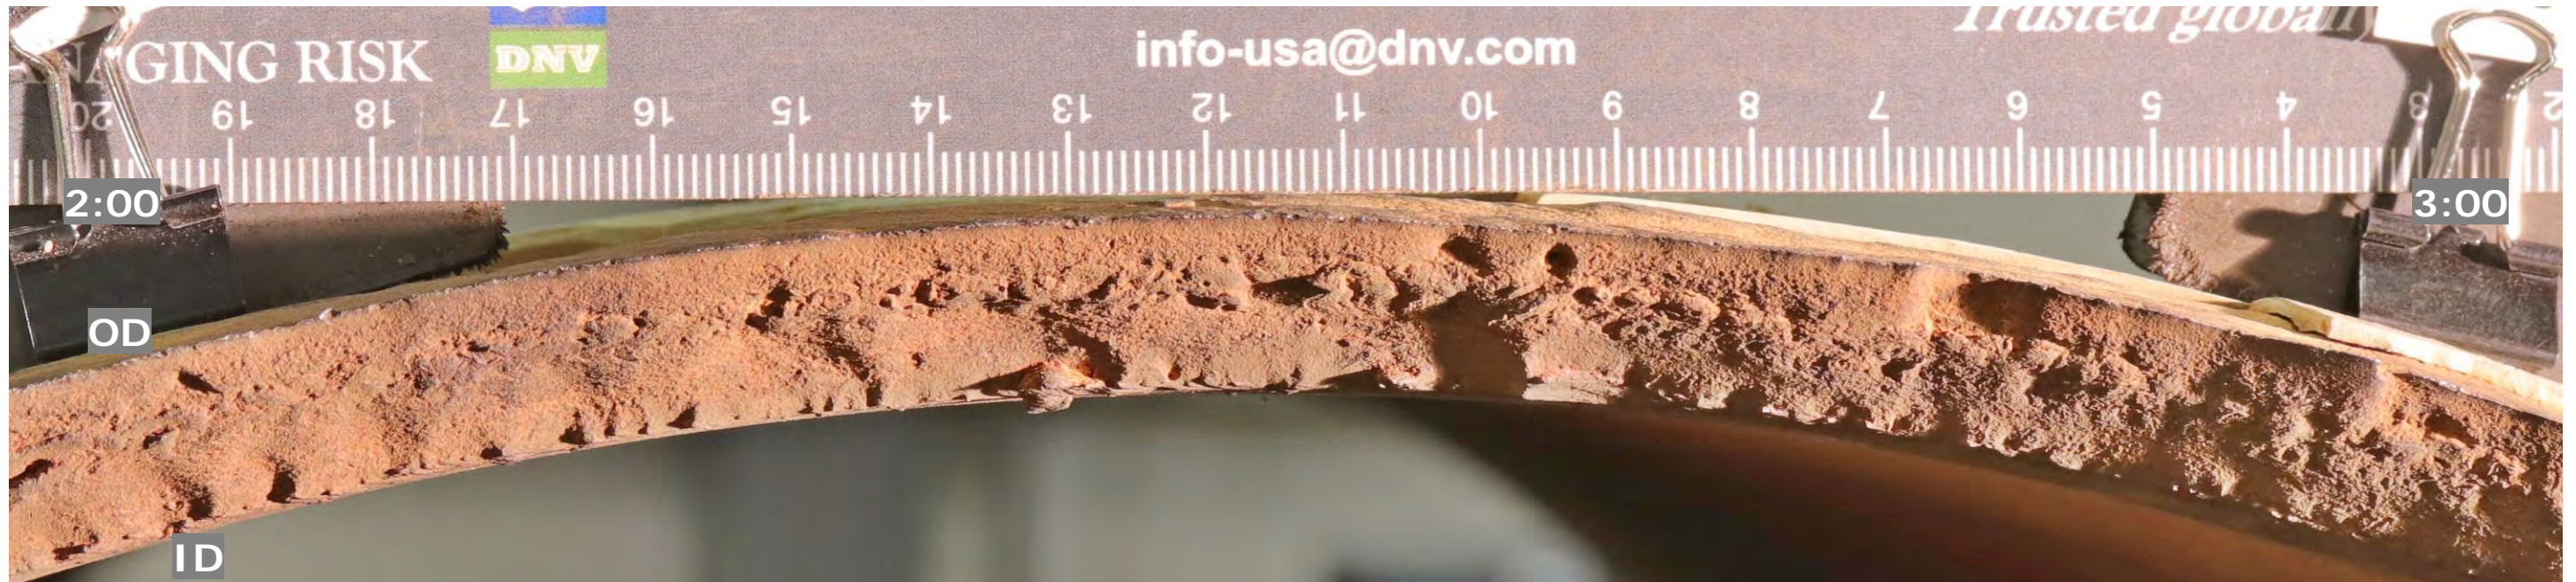
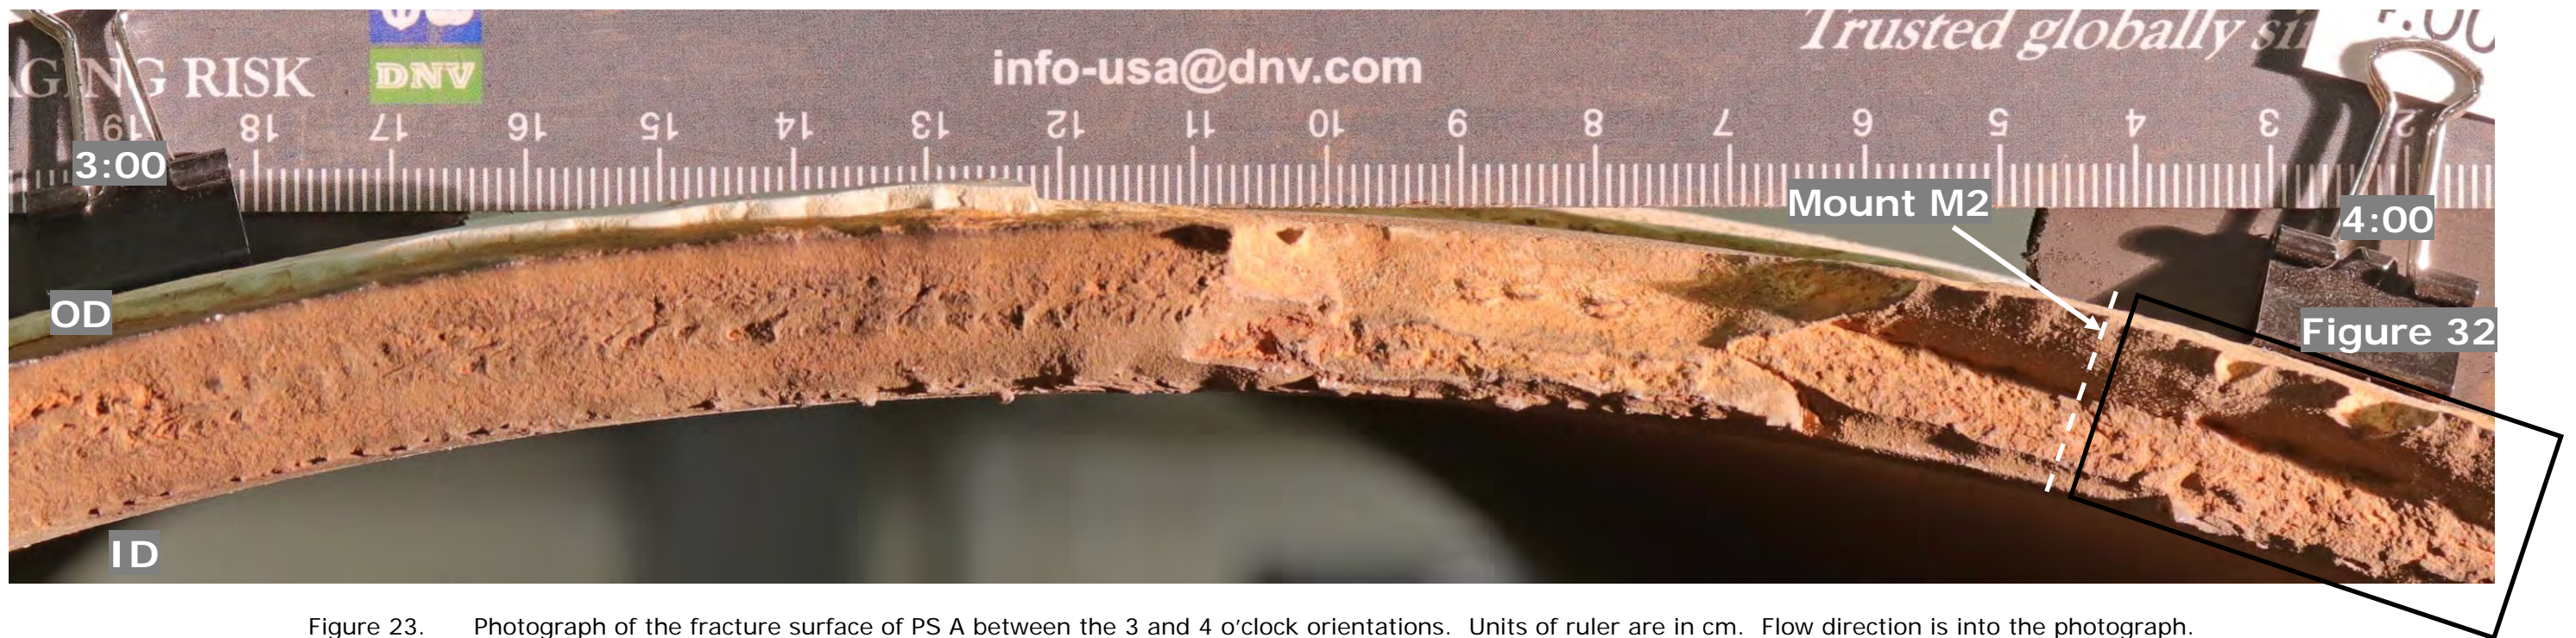
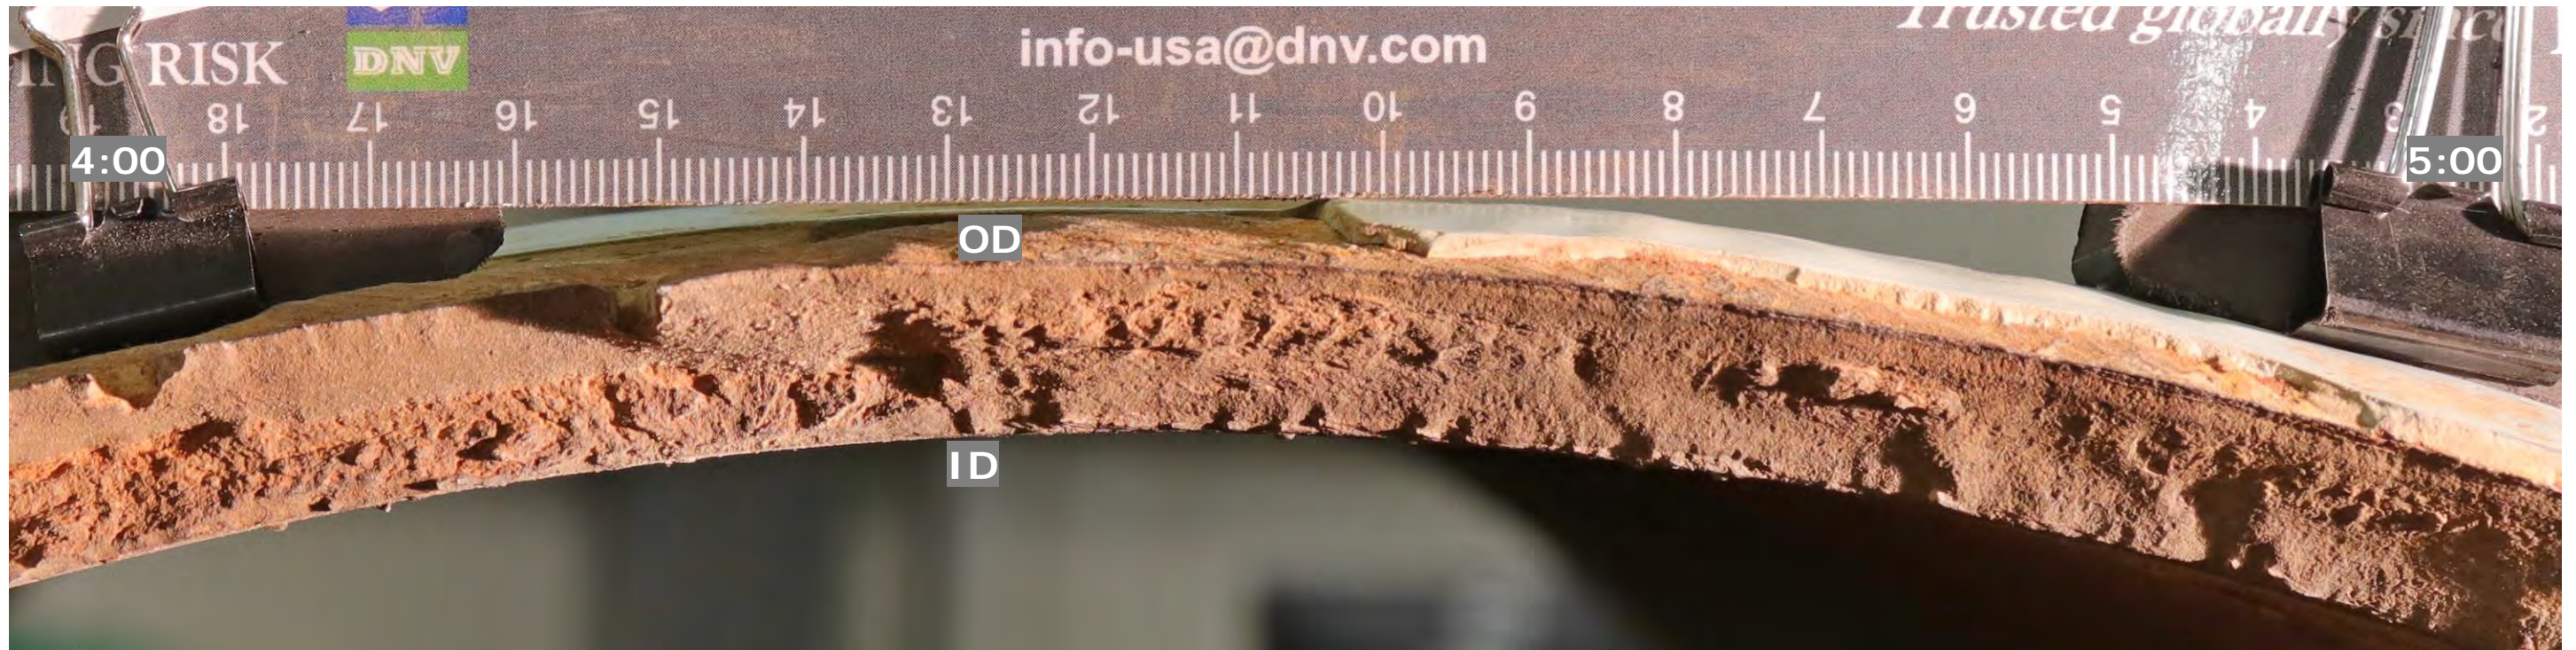
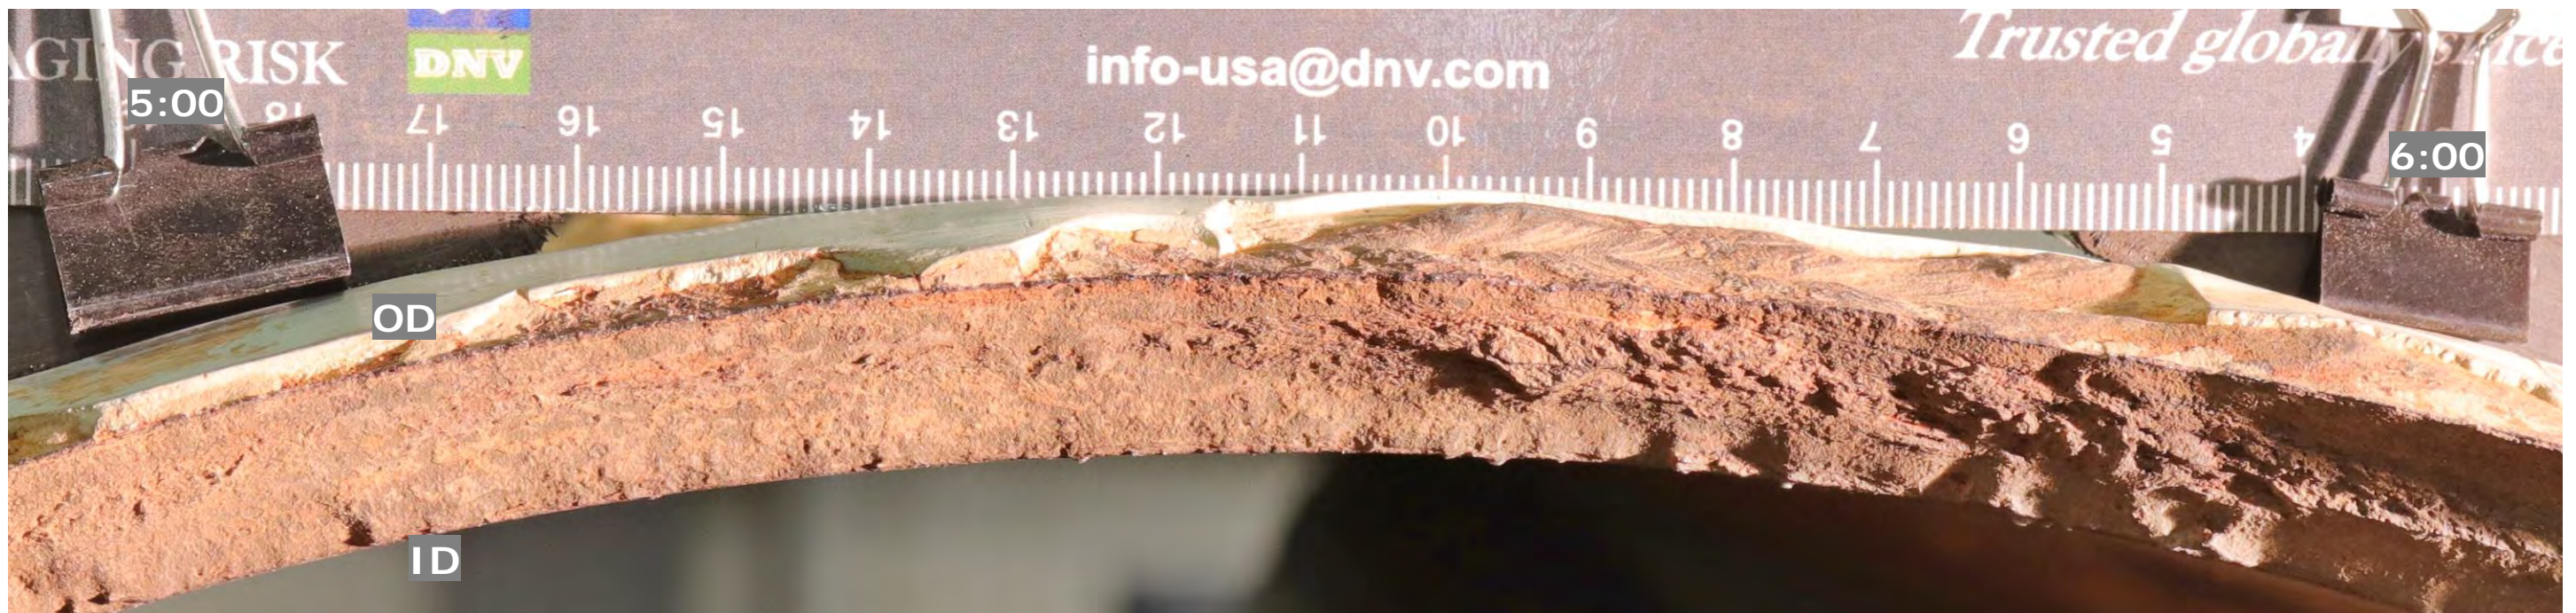
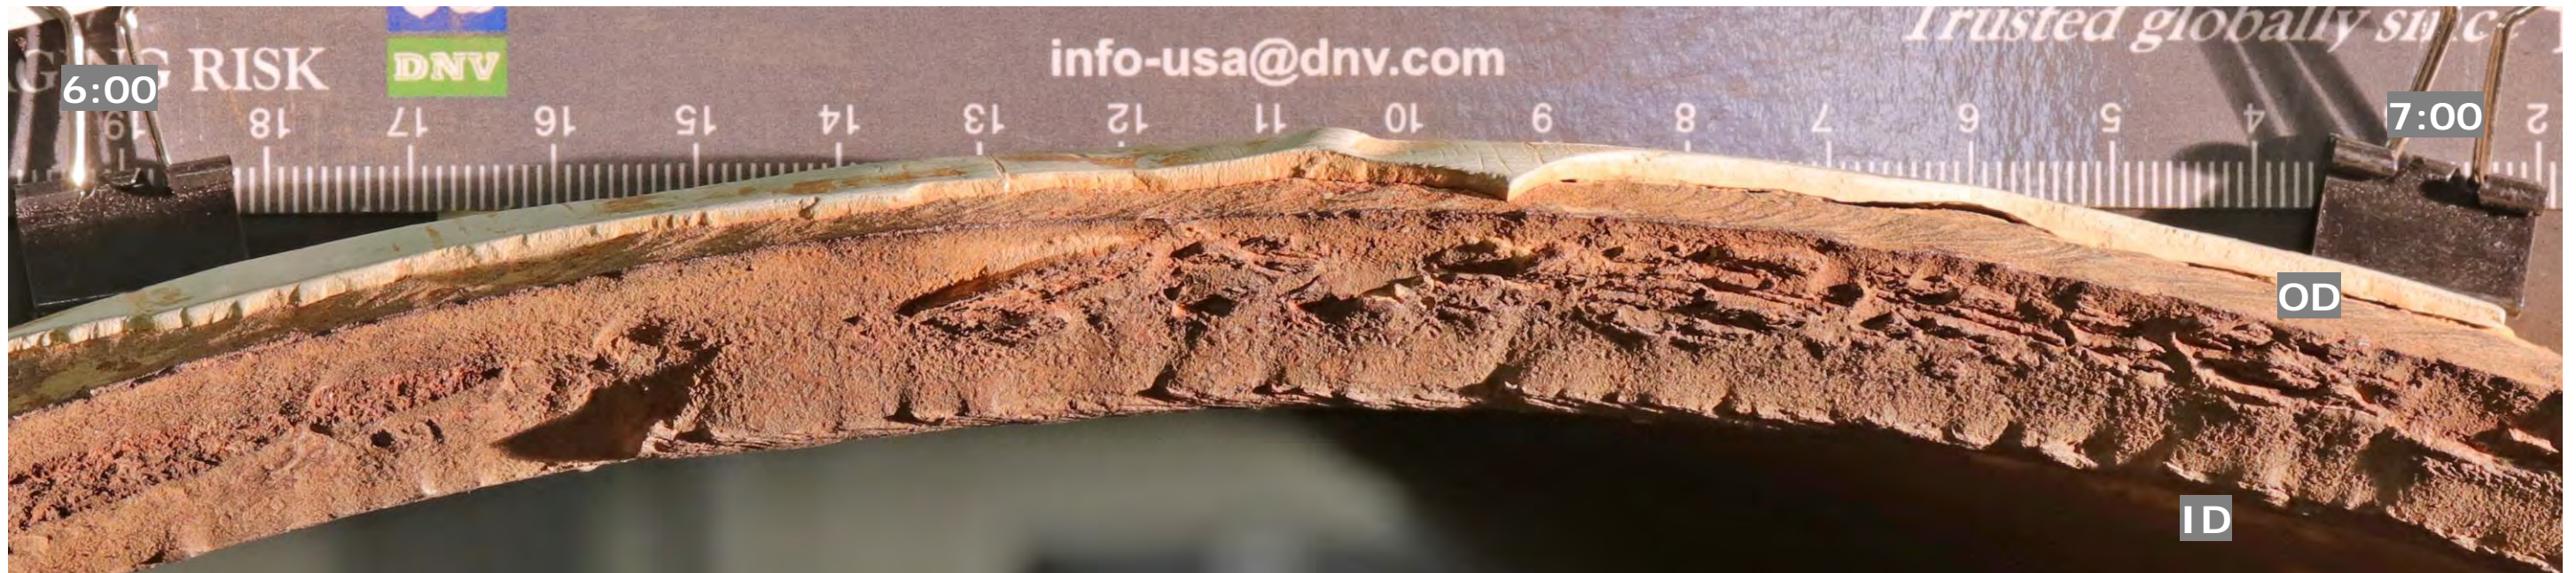
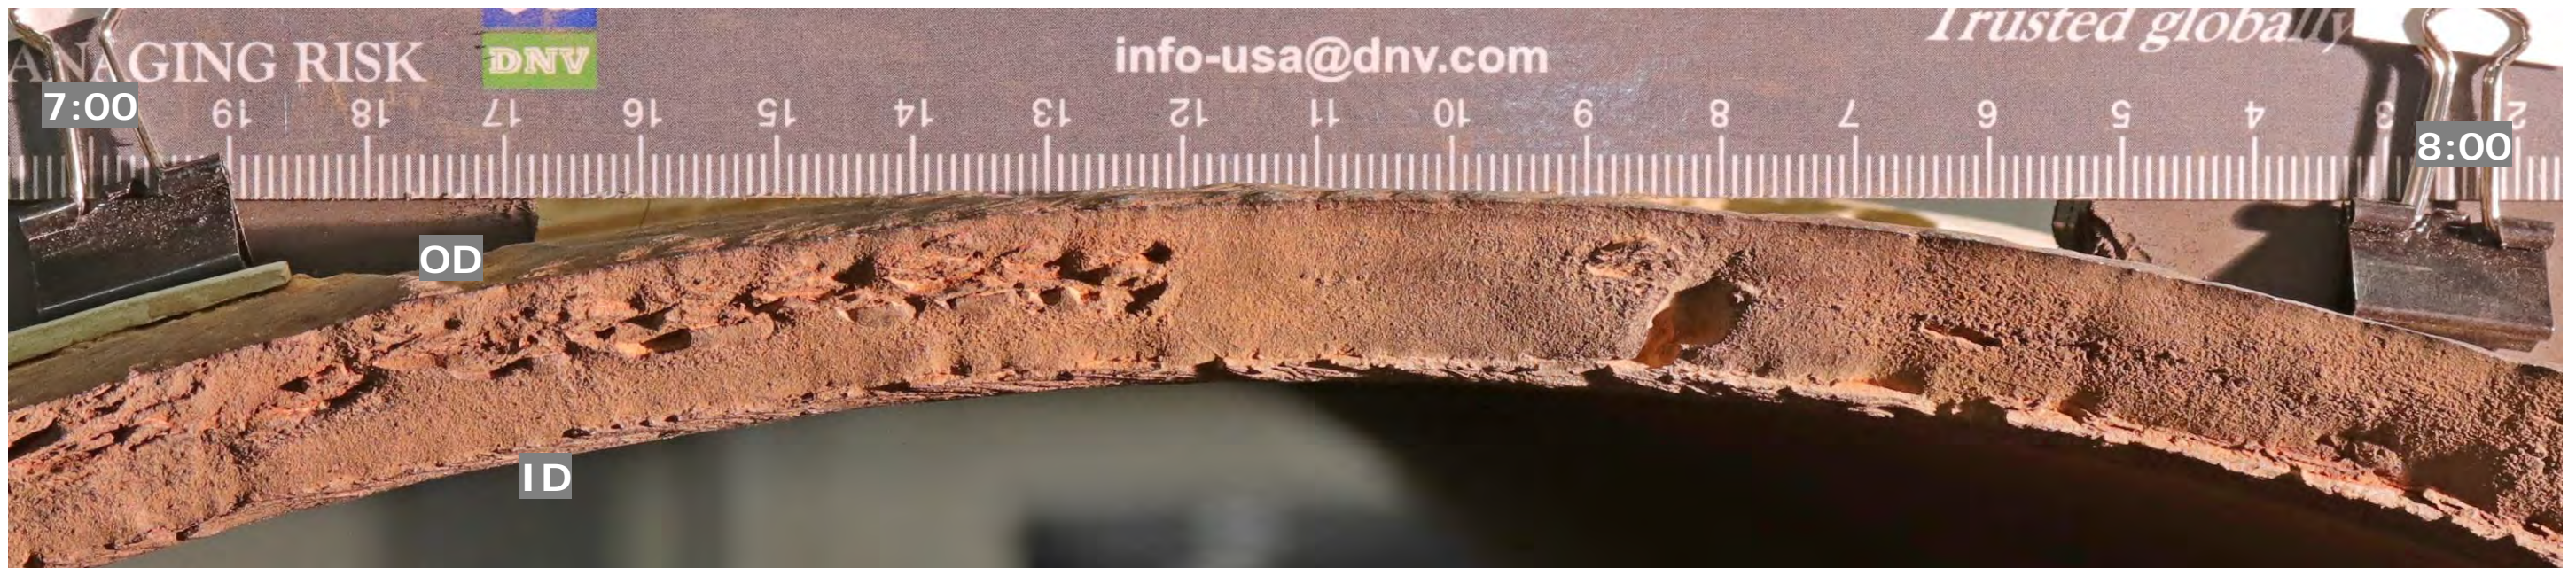
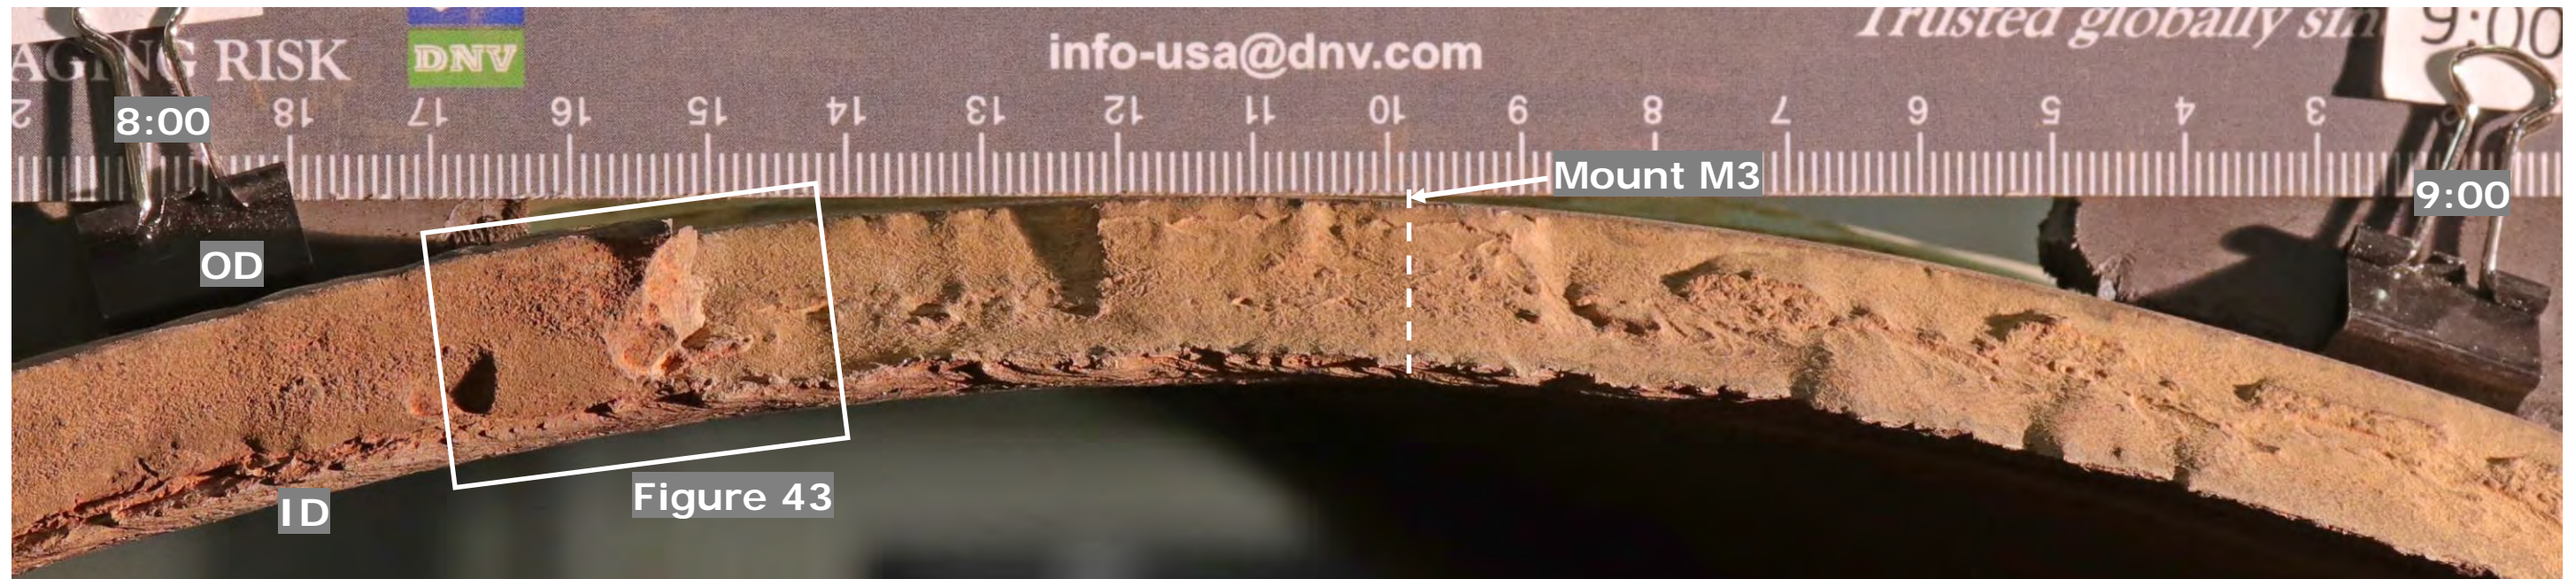
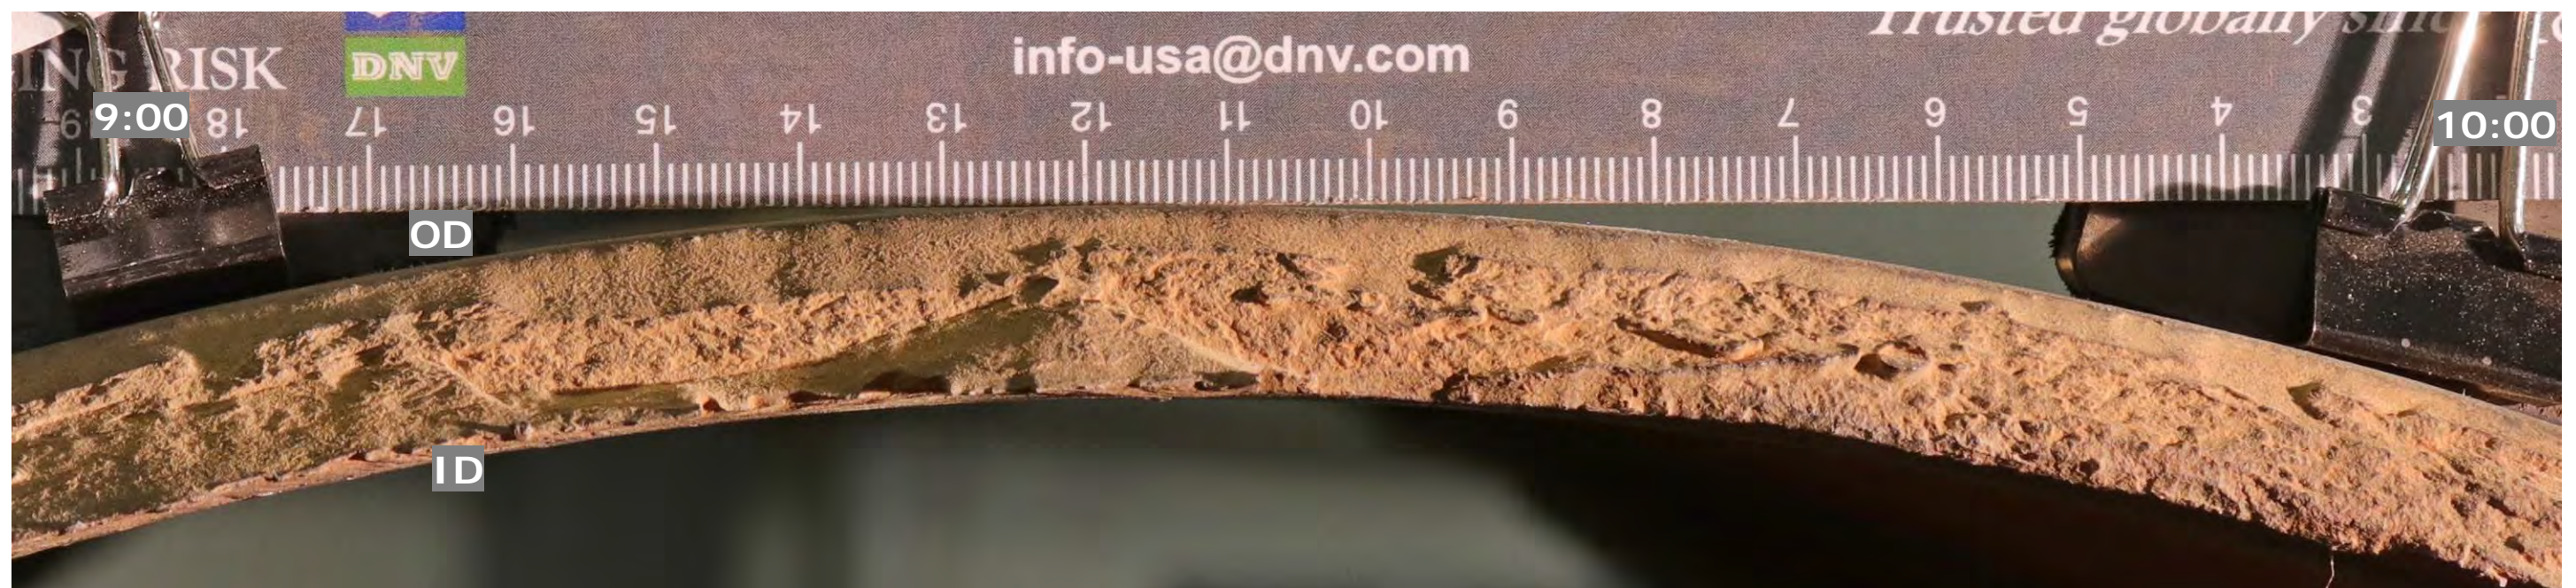
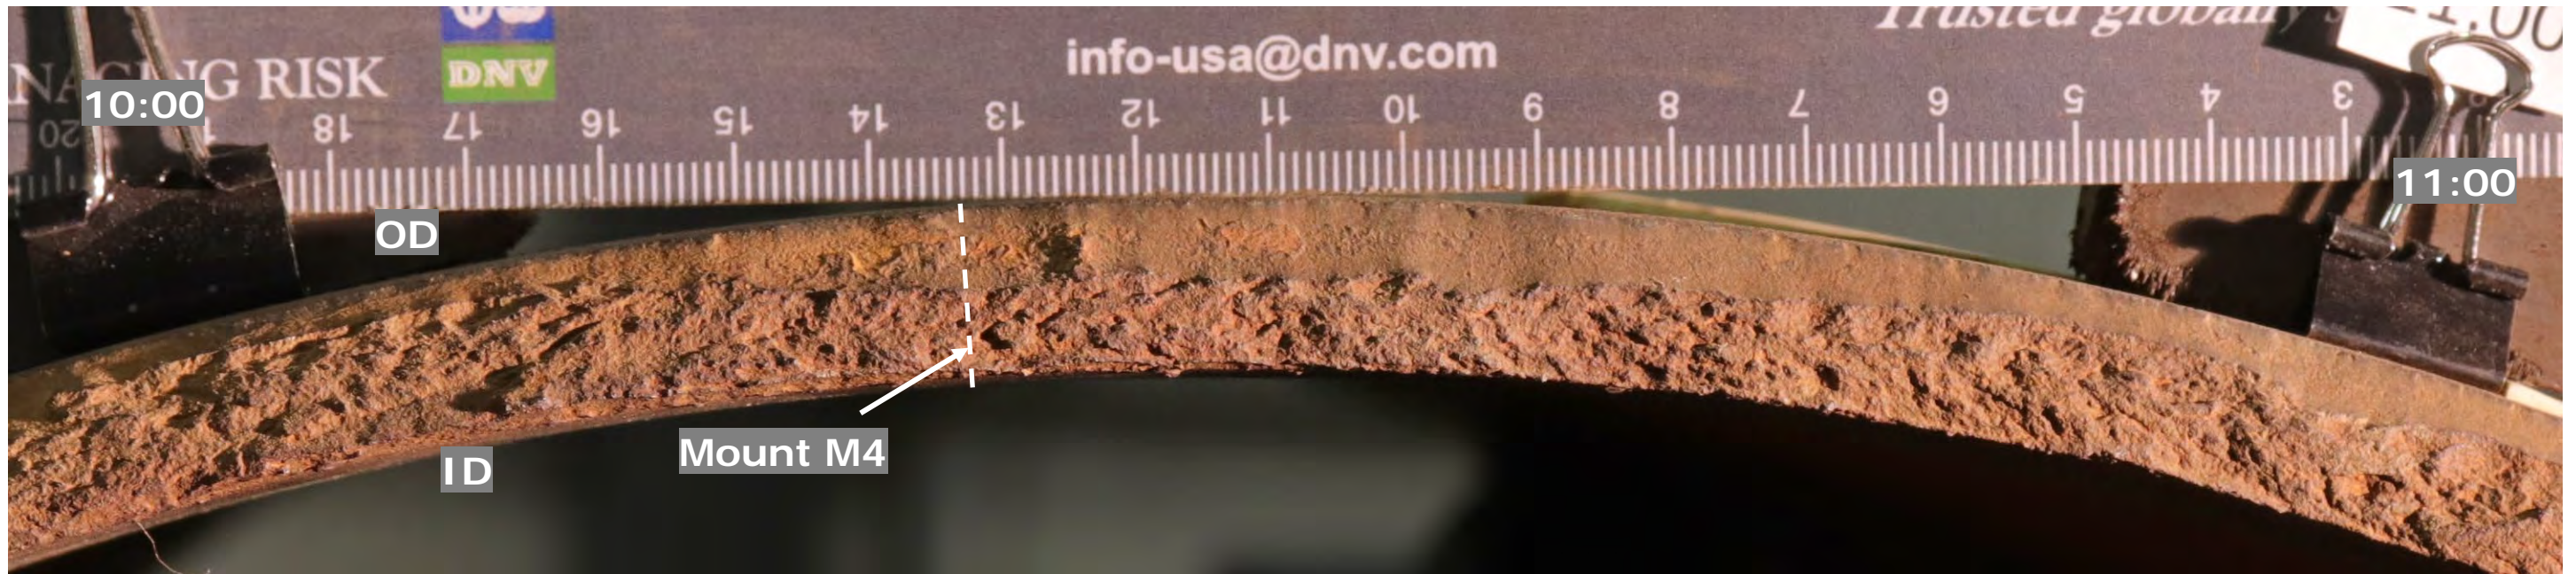
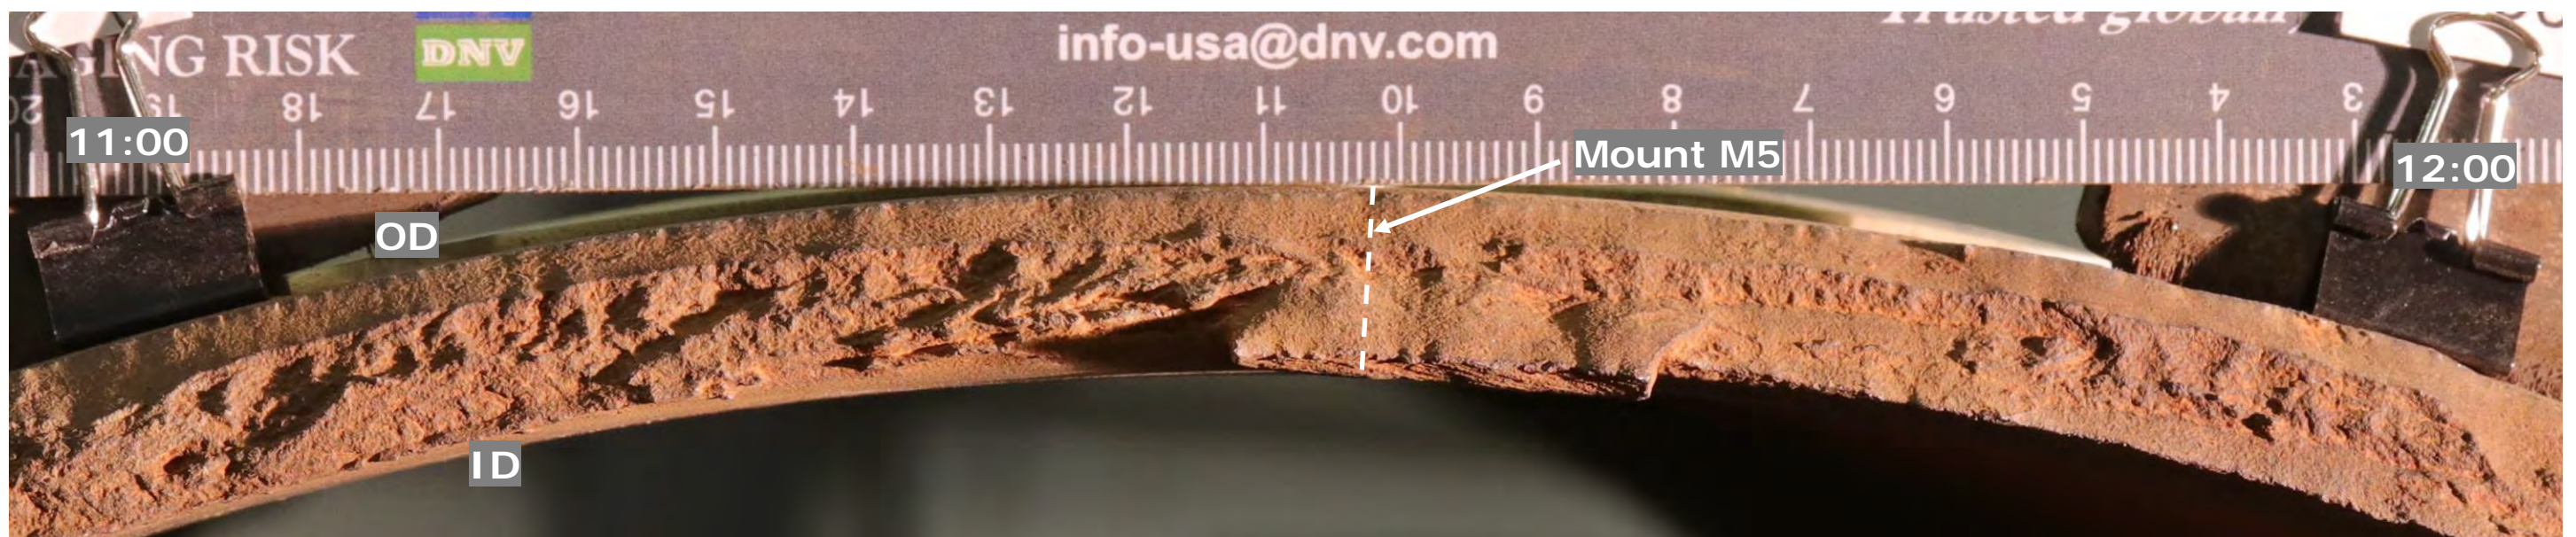
Figure 20. Photograph of the fracture surface of PS A between the 12 and 1 o'clock orientations. Units of ruler are in cm. Flow direction is into the photograph.

Figure 21. Photograph of the fracture surface of PS A between the 1 and 2 o'clock orientations. Units of ruler are in cm. Flow direction is into the photograph.

Figure 22. Photograph of the fracture surface of PS A between the 2 and 3 o'clock orientations. Units of ruler are in cm. Flow direction is into the photograph.

Figure 23. Photograph of the fracture surface of PS A between the 3 and 4 o'clock orientations. Units of ruler are in cm. Flow direction is into the photograph.

Figure 24. Photograph of the fracture surface of PS A between the 4 and 5 o'clock orientations. Units of ruler are in cm. Flow direction is into the photograph.

Figure 25. Photograph of the fracture surface of PS A between the 5 and 6 o'clock orientations. Units of ruler are in cm. Flow direction is into the photograph.

Figure 26. Photograph of the fracture surface of PS A between the 6 and 7 o'clock orientations. Units of ruler are in cm. Flow direction is into the photograph.

Figure 27. Photograph of the fracture surface of PS A between the 7 and 8 o'clock orientations. Units of ruler are in cm. Flow direction is into the photograph.

Figure 28. Photograph of the fracture surface of PS A between the 8 and 9 o'clock orientations. Units of ruler are in cm. Flow direction is into the photograph.

Figure 29. Photograph of the fracture surface of PS A between the 9 and 10 o'clock orientations. Units of ruler are in cm. Flow direction is into the photograph.

Figure 30. Photograph of the fracture surface of PS A between the 10 and 11 o'clock orientations. Units of ruler are in cm. Flow direction is into the photograph.

Figure 31. Photograph of the fracture surface of PS A between the 11 and 12 o'clock orientations. Units of ruler are in cm. Flow direction is into the photograph.
