DOT US Department of Transportation  
PHMSA Pipeline and Hazardous Materials Safety Administration  
OPS Office of Pipeline Safety – Accident Investigation Division

**Principal Investigator** Wesley Mathews  
**Acting Accident Investigation Director** Chris Ruhl  
**Date of Report** May 26, 2022  
**Subject** Failure Investigation Report - Denbury Gulf Coast  
Pipelines, LLC – Pipeline Rupture/ Natural Force Damage

**Failure Investigation Report – Denbury Gulf Coast Pipelines LLC**  
**Pipeline Rupture/Natural Force Damage**  
February 22, 2020

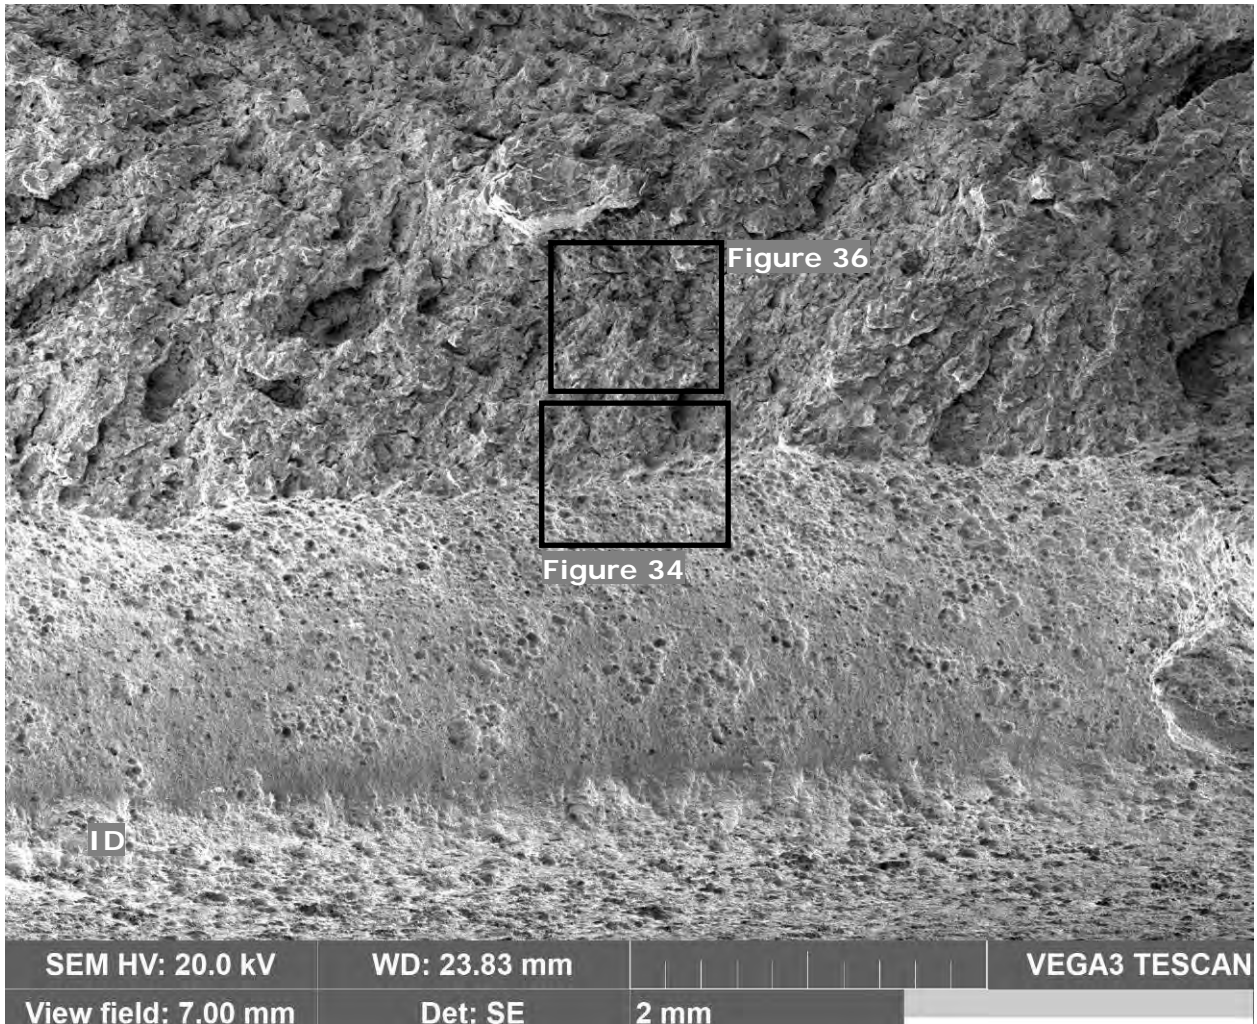
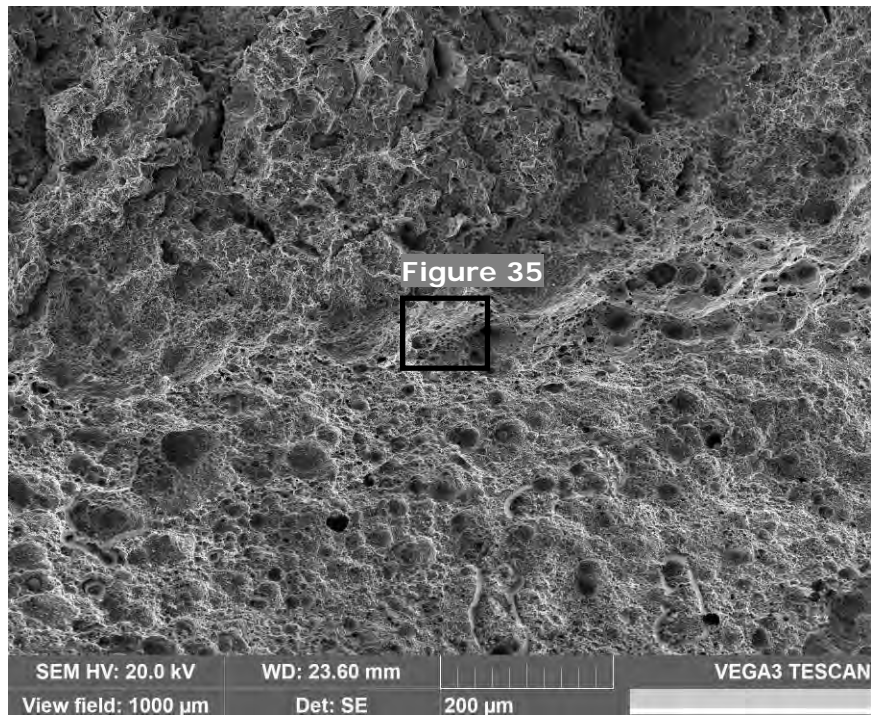
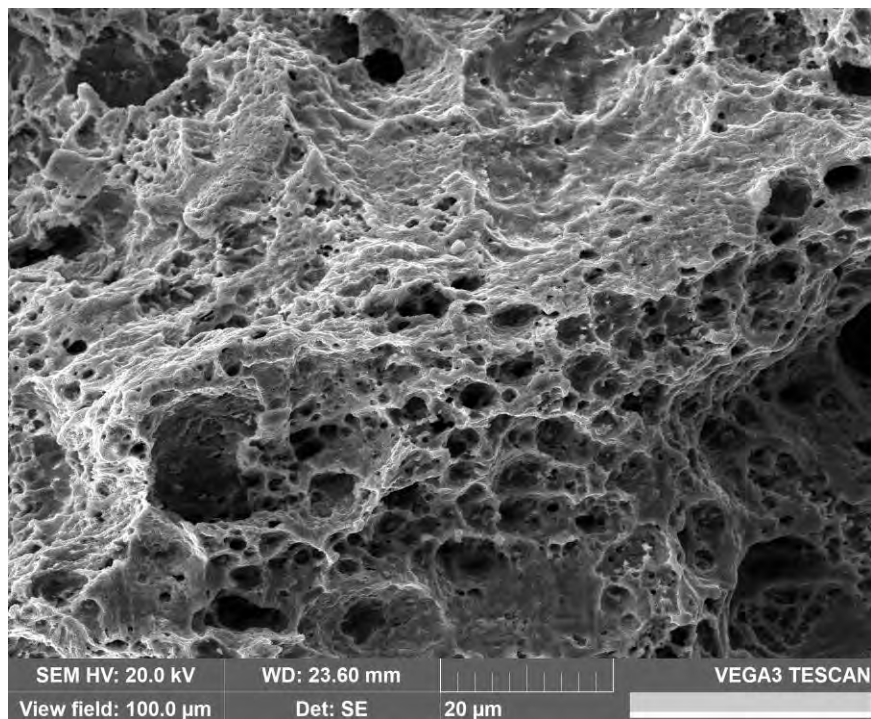
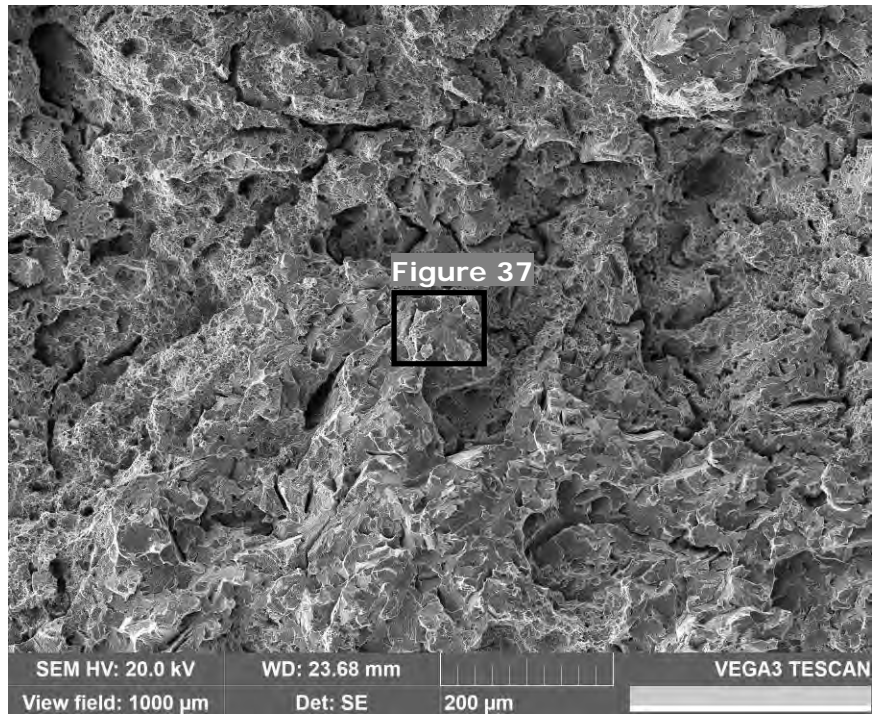
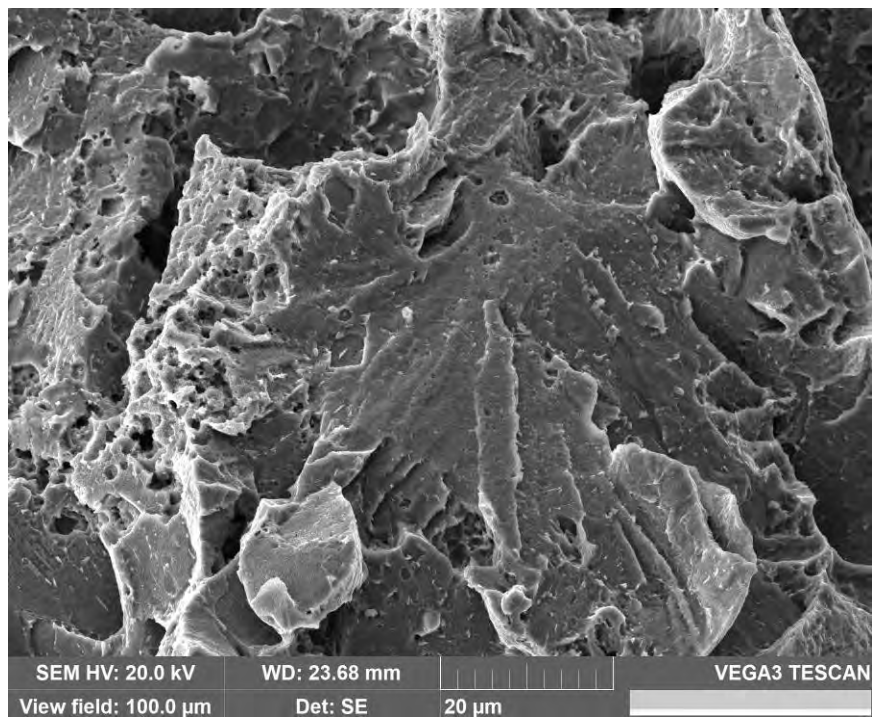
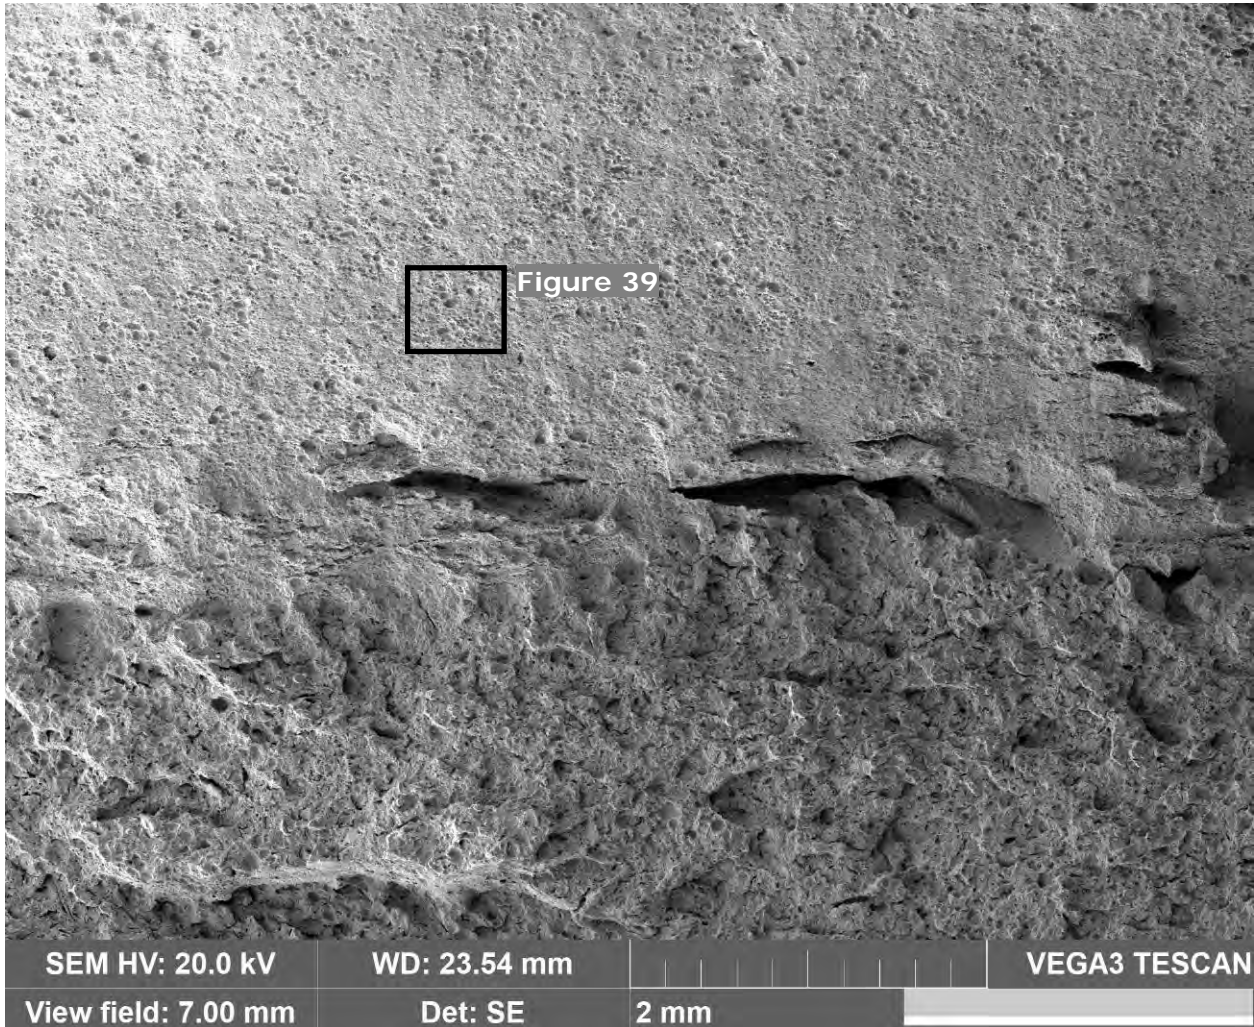
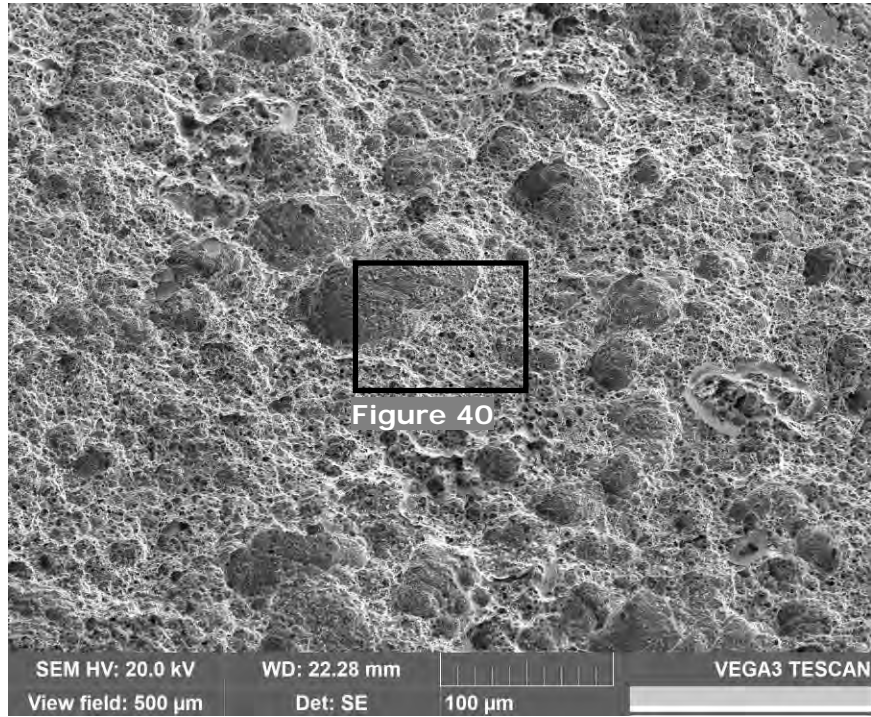
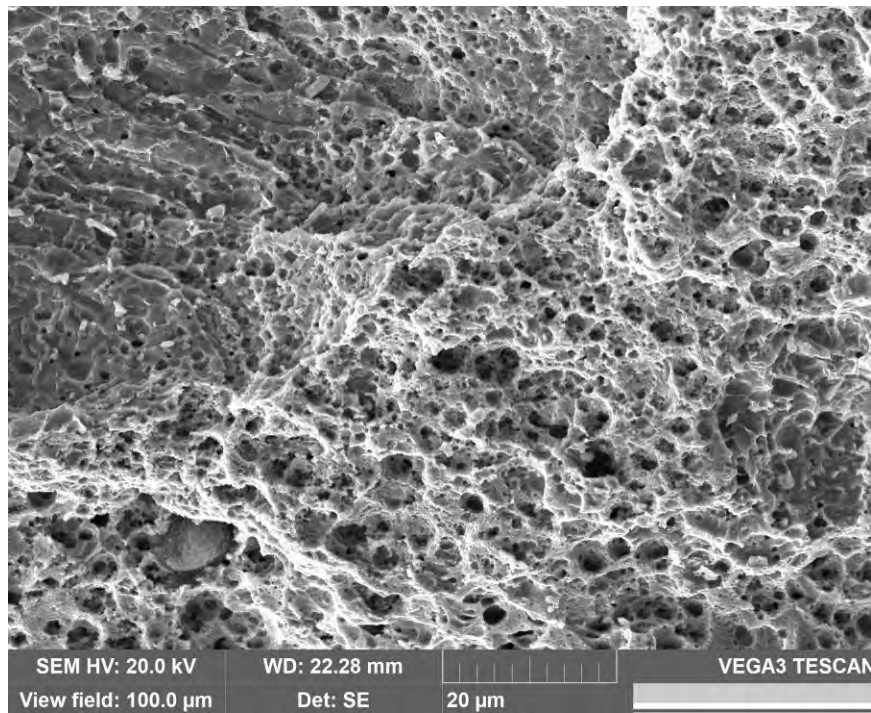
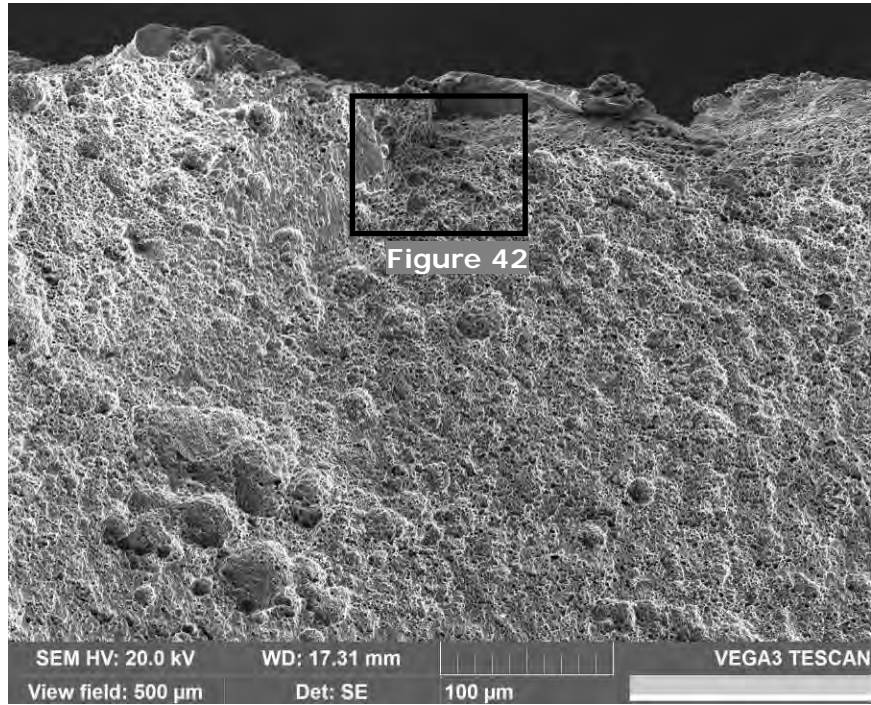
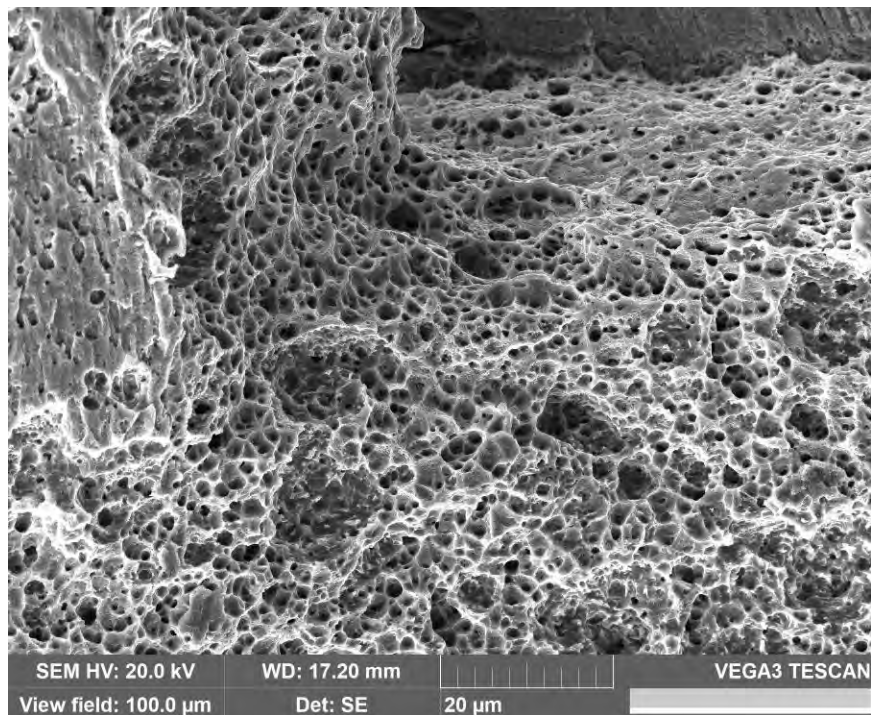
Figure 33. SEM image of Sample S2 adjacent to the ID surface; area indicated in Figure 32.

Figure 34. SEM image of Sample S2 at the interface of a macroscopically smooth and rough region; area indicated in Figure 33.

Figure 35. High magnification SEM image of Sample S2 in the macroscopically smooth region; area indicated in Figure 34.

Figure 36. SEM image of Sample S2 in a macroscopically rough region; area indicated in Figure 33.

Figure 37. High magnification SEM image of Sample S2 in a macroscopically rough region; area indicated in Figure 36.

Figure 38. SEM image of Sample S2 midwall, showing macroscopically rough and smooth regions; area indicated in Figure 32.

Figure 39. SEM image of Sample S2 in a macroscopically smooth region, near the OD surface; area indicated in Figure 38.

Figure 40. High magnification SEM image of Sample S2 in a macroscopically smooth region, near the OD surface; area indicated in Figure 39.

Figure 41. SEM image of Sample S2 adjacent to the OD surface; area indicated in Figure 32.

Figure 42. High magnification SEM image of Sample S2 adjacent to the OD surface; area indicated in Figure 41.

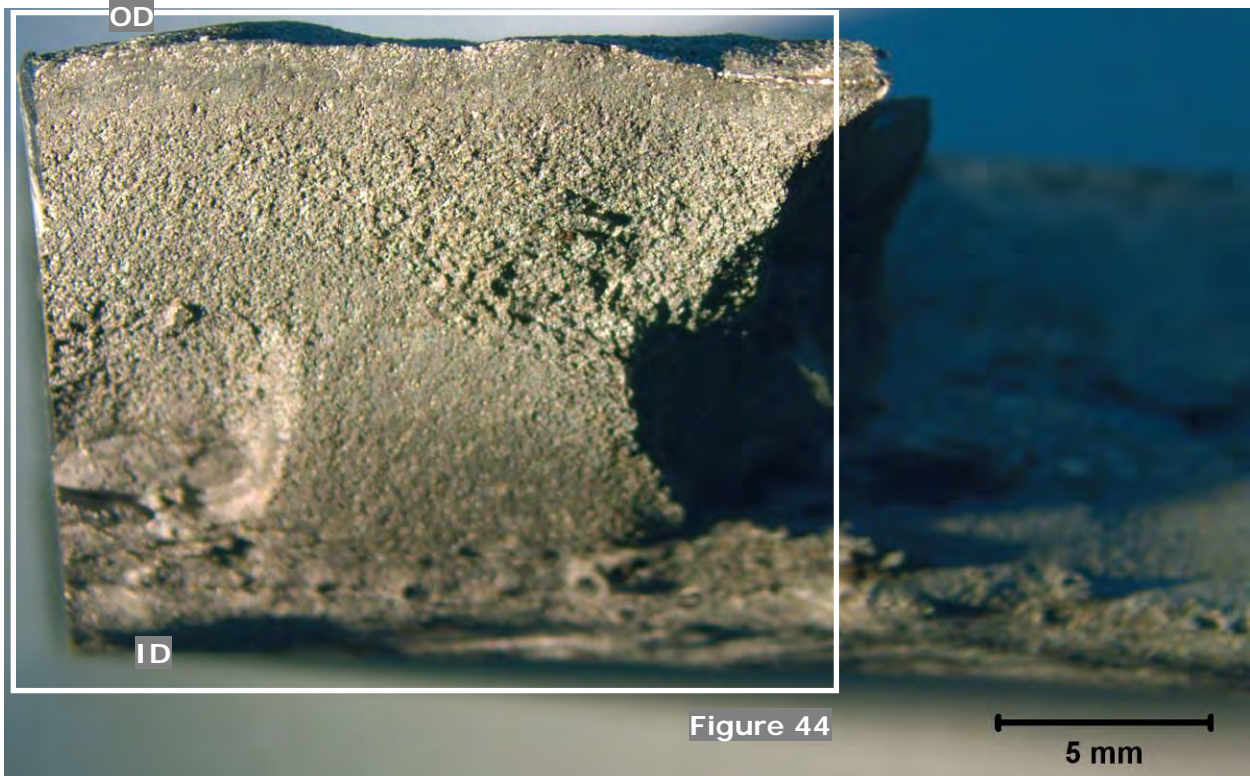
Figure 43. Light photomicrograph of the fracture surface of Sample S3, following cleaning in ENPREP® 214. The sample was removed near the 8:00 orientation; area indicated in Figure 28.

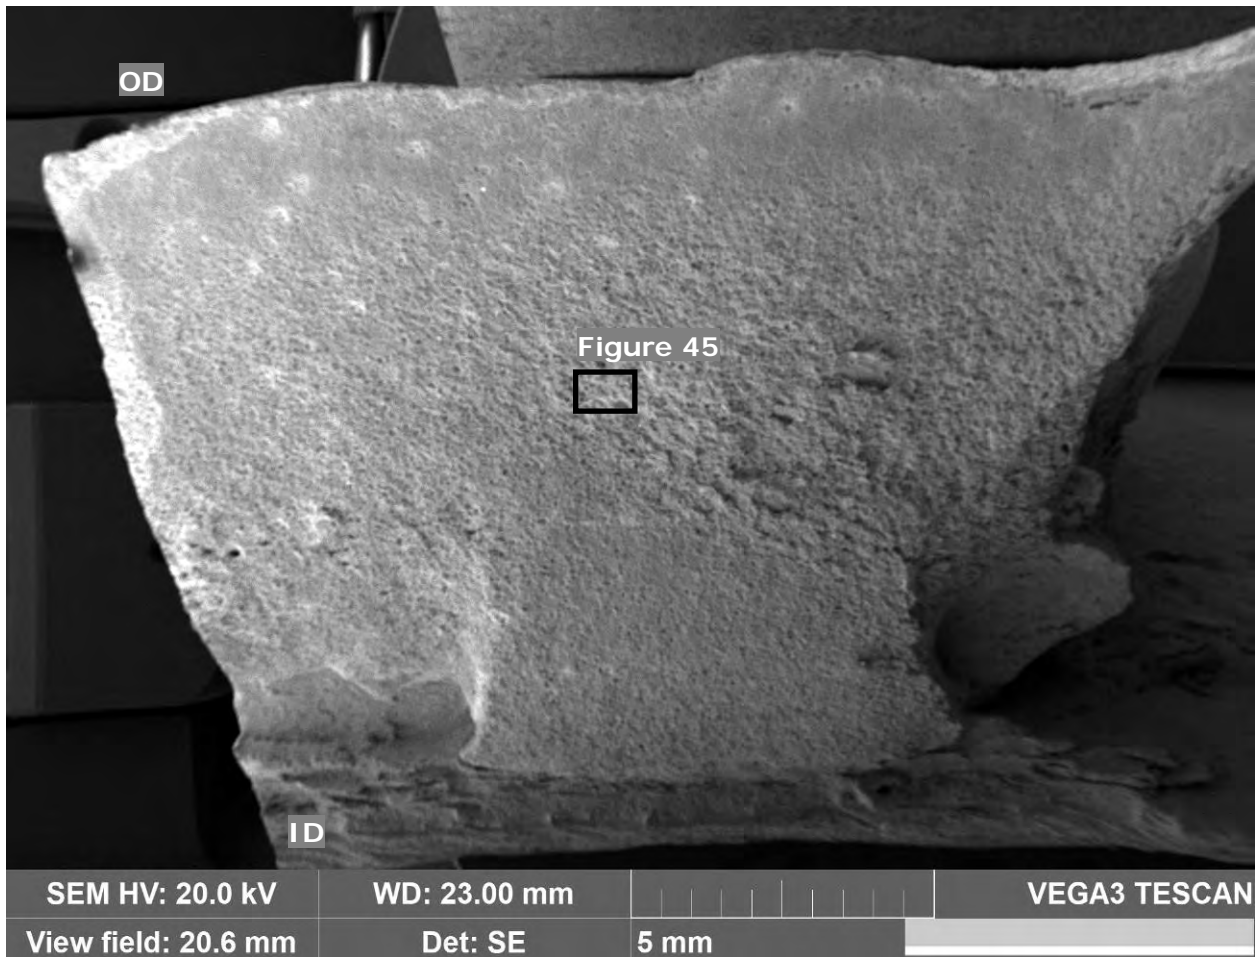
Figure 44. SEM image of Sample S3; area indicated in Figure 43.

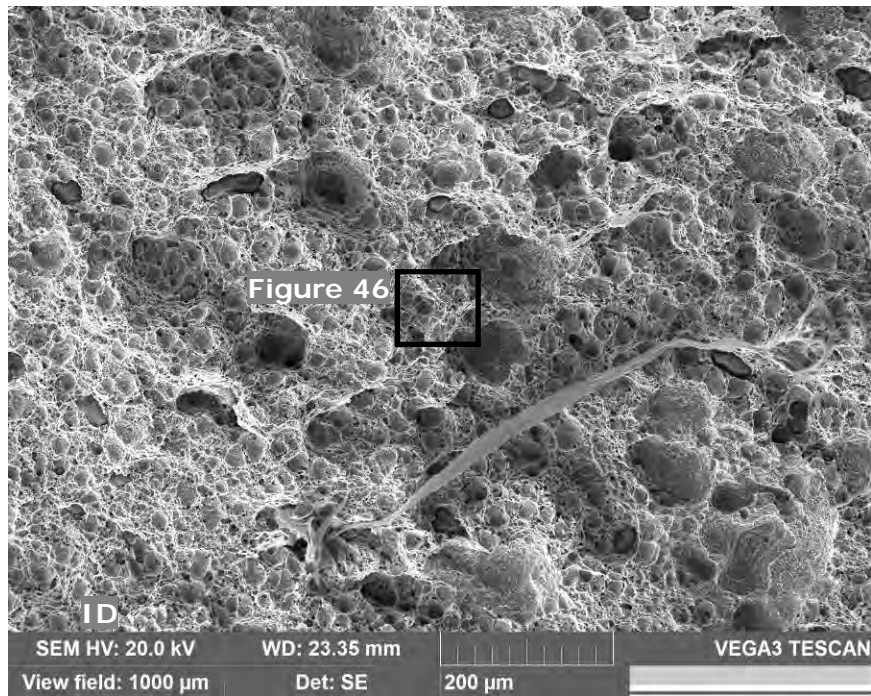
Figure 45. SEM image of Sample S3 midwall; area indicated in Figure 44.

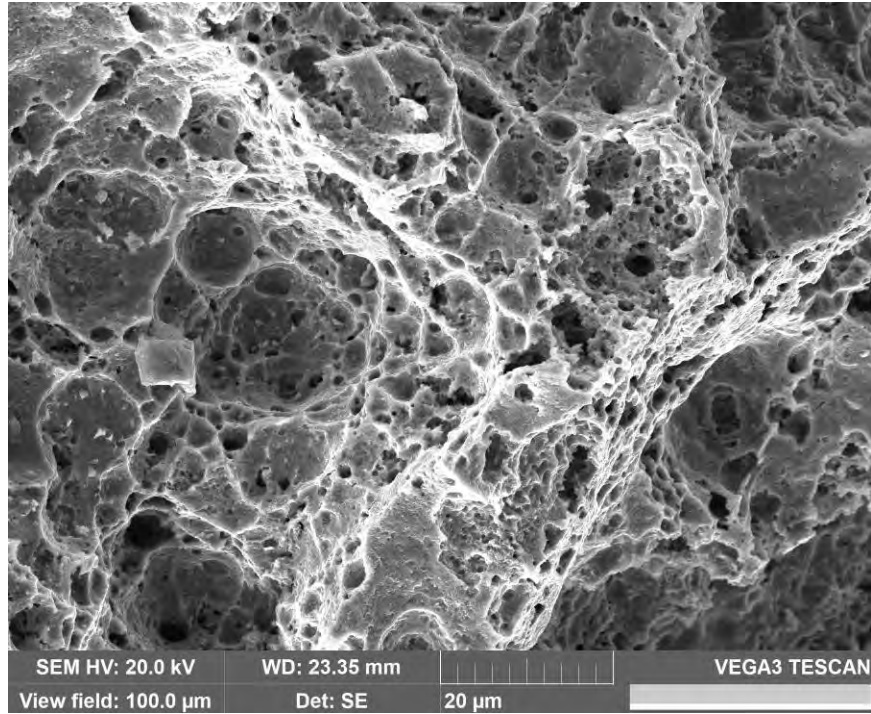
Figure 46. High magnification SEM image of Sample S3 midwall; area indicated in Figure 45.

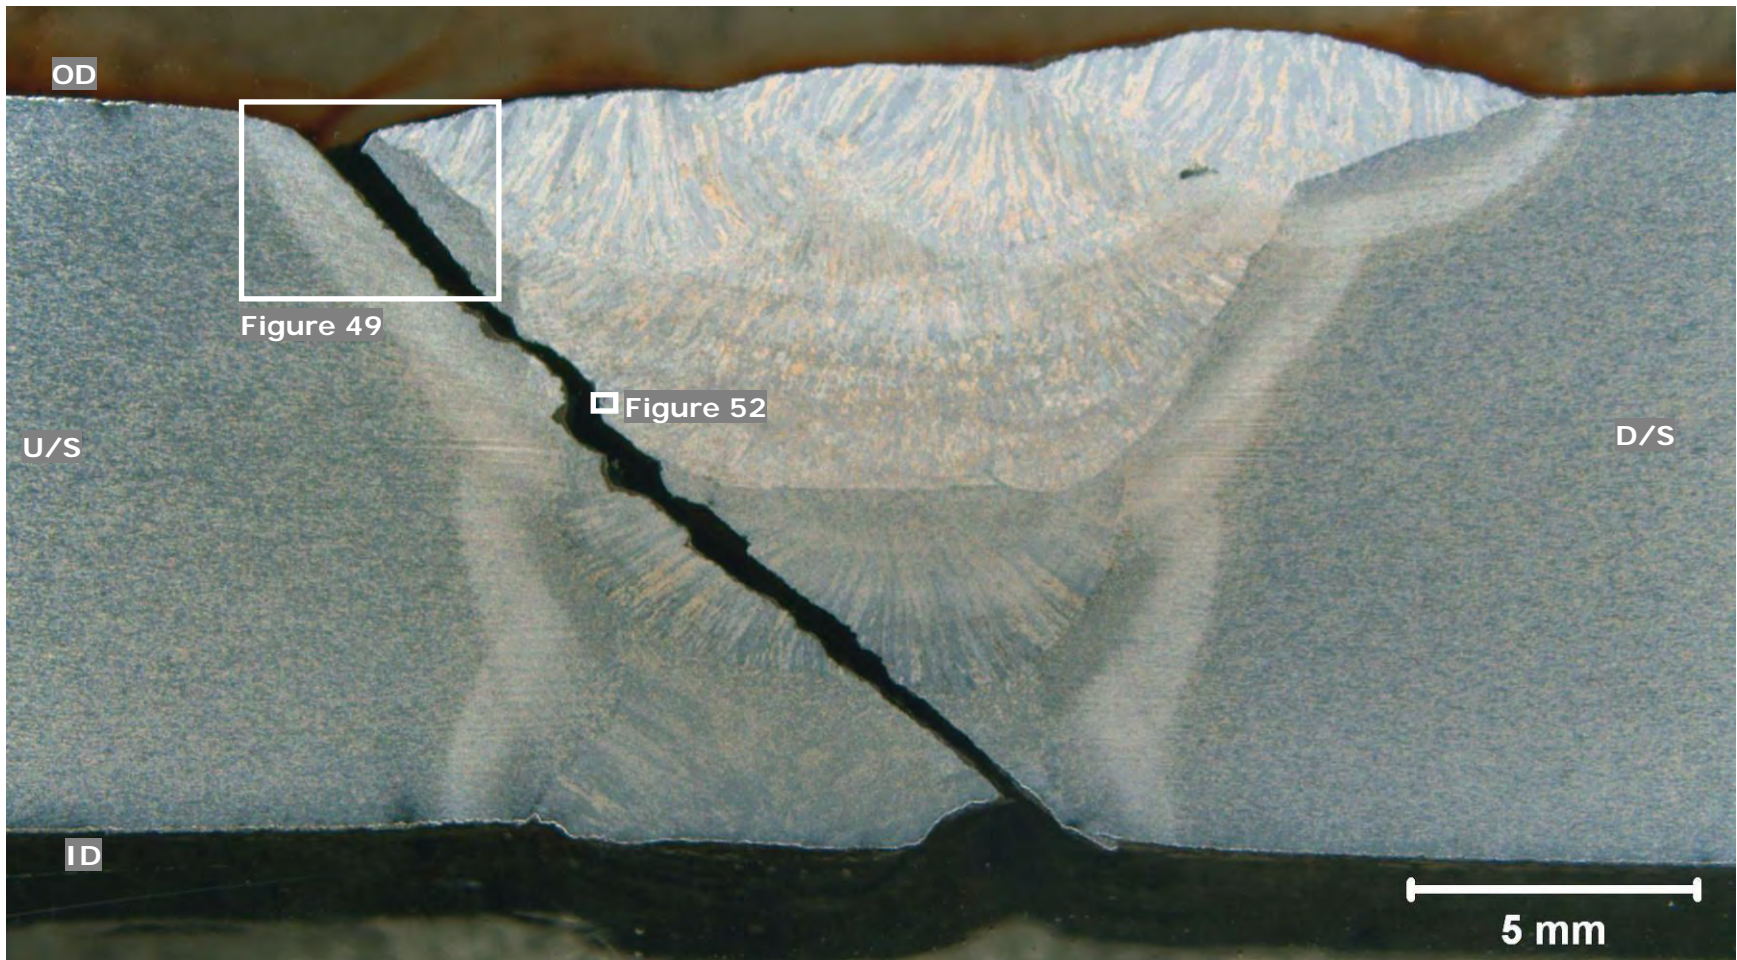
Figure 48. Light photomicrograph of Mount M1 (axial cross-section), which was removed from the failed GW at the 1:35 orientation; refer to Figure 1, Figure 11, and Figure 21 for location (2% Nital Etchant).

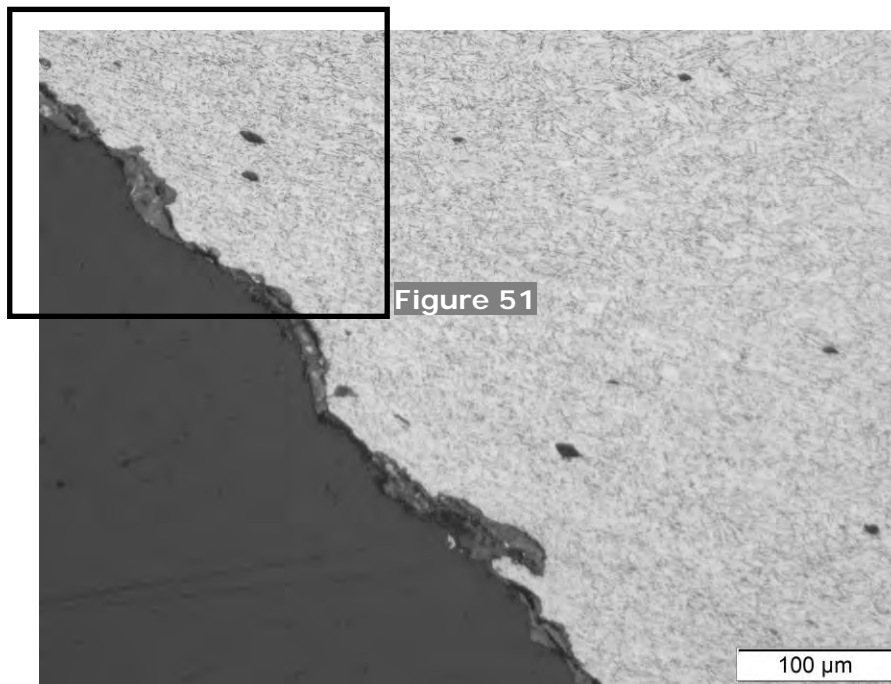
Figure 50. Light photomicrograph of Mount M1 showing inclusions in HAZ adjacent to the fracture surface; area indicated in Figure 49.

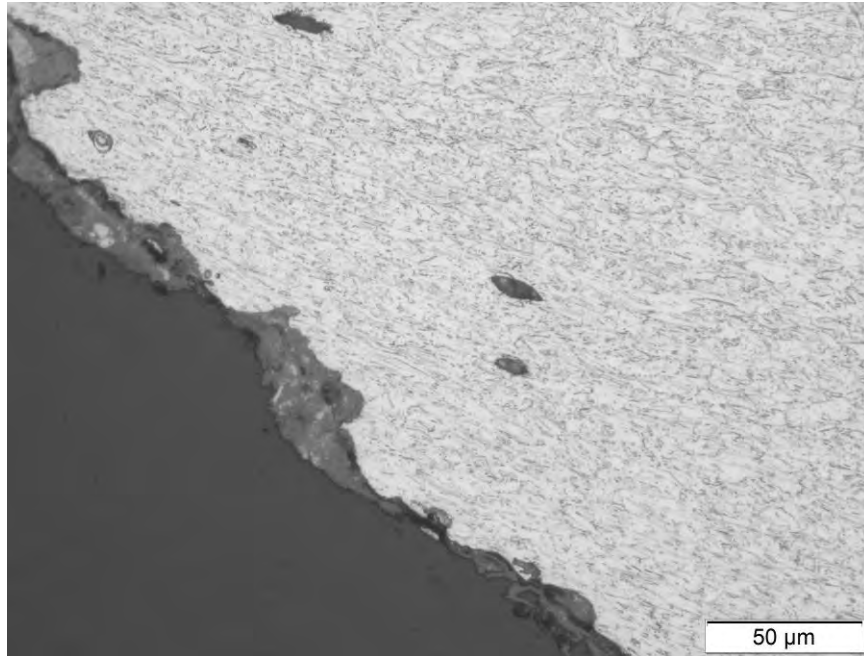
Figure 51. High magnification light photomicrograph of Mount M1 showing grain elongation adjacent to the fracture surface; area indicated in Figure 50.

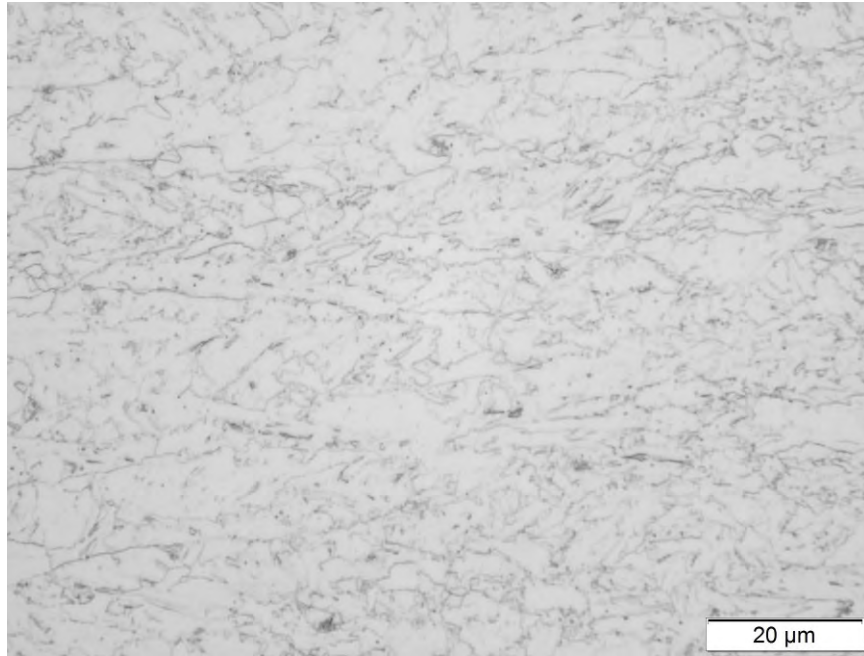
Figure 53. High magnification light photomicrograph of Mount M1 showing the typical base metal microstructure of the U/S Joint (PS B, 2% Nital Etchant).

Figures 53 and 54 of the DNV Metallurgical Analysis Report (Section 3.4) characterize the microstructure of the upstream and downstream pipe. Analysis of these photomicrographs indicate a significantly larger amount of ferrite than pearlite, which is consistent with the expected microstructure for pipe with the specified minimum yield strength and vintage of the Delhi 24-inch pipeline. Compared with photomicrographs of metal samples provided through industry literature, the microstructure of the 24-inch pipeline has a low carbon content, consistent with other X-80 pipelines. The microstructure of the failed girth shows similar characteristics (see Figure 62 of the DNV Metallurgical Analysis Report).

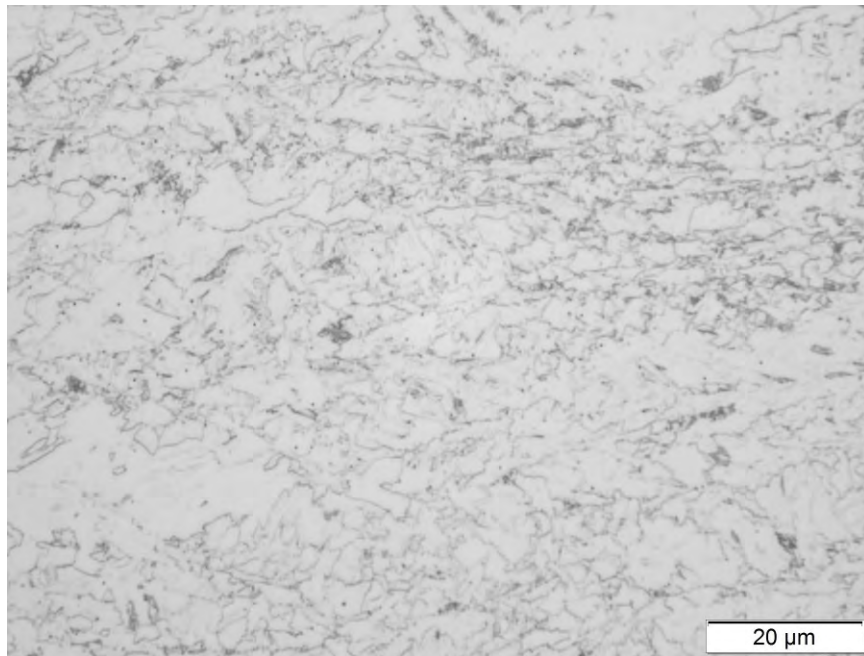
Figure 54. High magnification light photomicrograph of Mount M1 showing the typical base metal microstructure of the D/S Joint (PS A, 2% Nital Etchant).

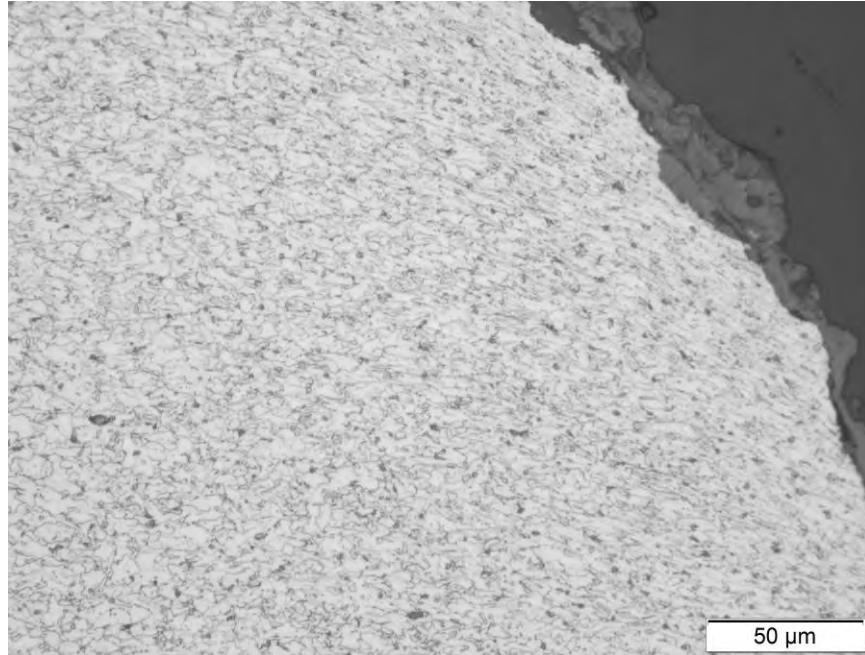
Figure 57. High magnification light photomicrograph of Mount M2 near the ID surface, adjacent to the fracture surface (2% Nital Etchant); area indicated in Figure 56.

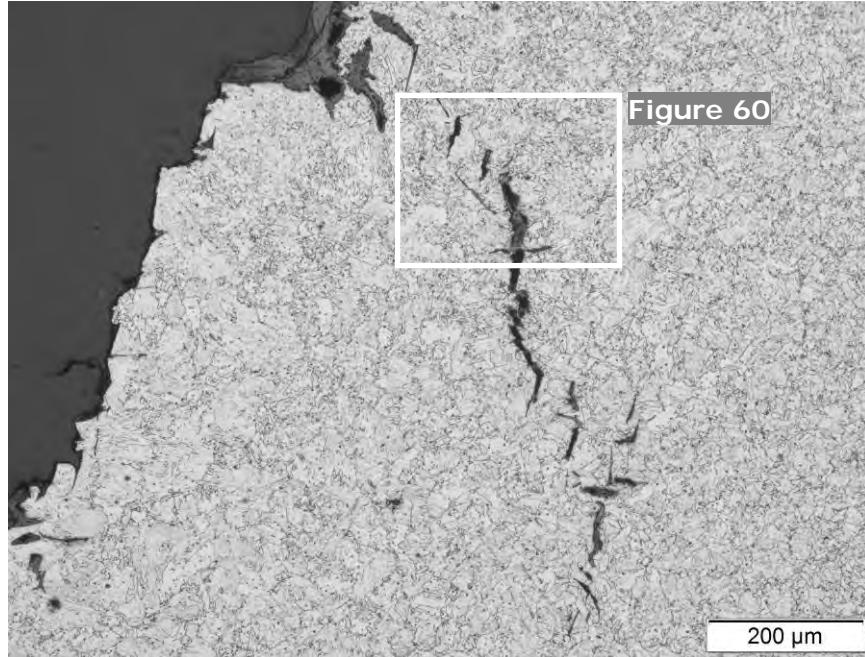
Figure 59. Light photomicrograph of Mount M2 adjacent to the fracture surface showing fissures (2% Nital Etchant); area indicated in Figure 58.

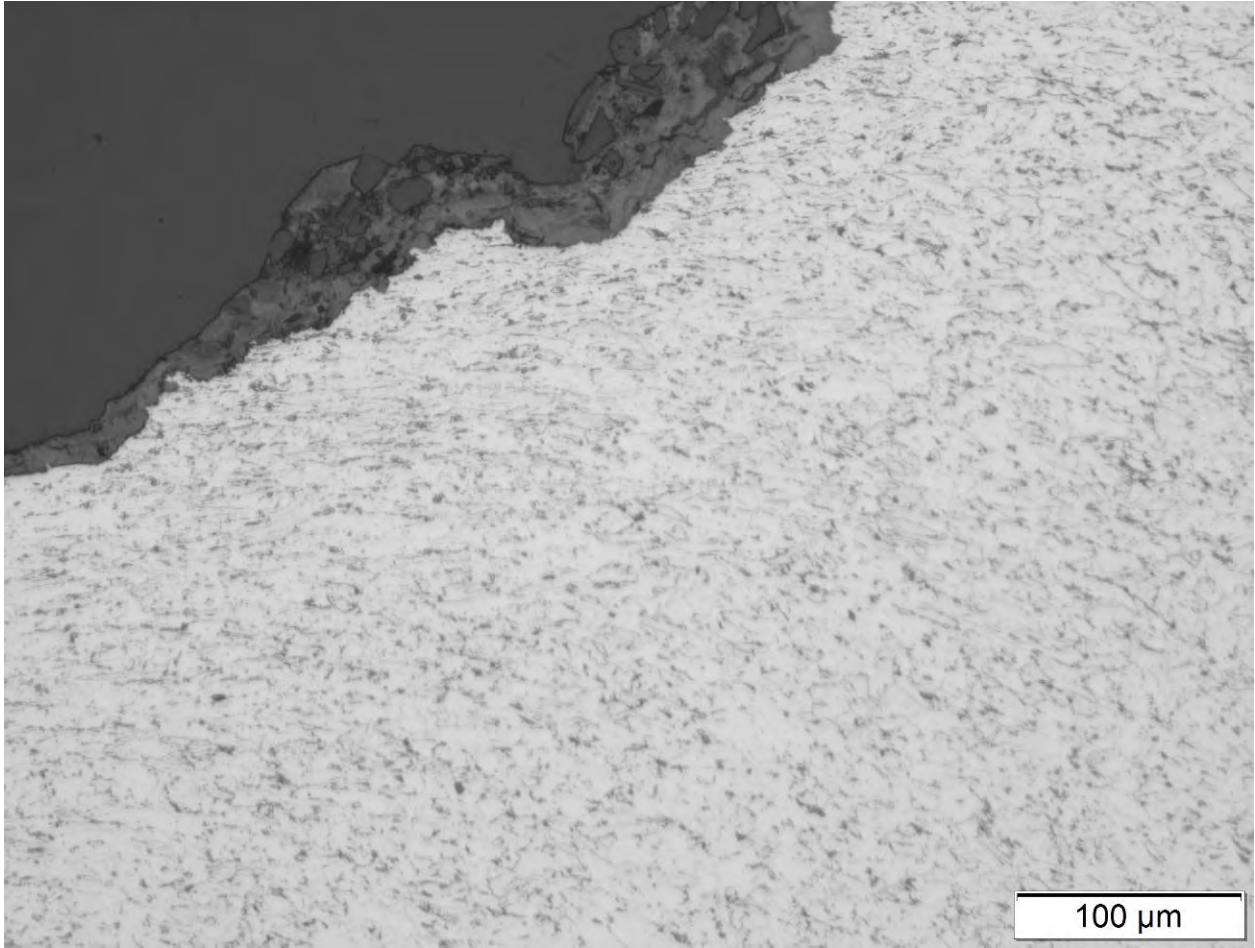
Figure 62 is light photomicrograph of Mount M3 adjacent to the fracture surface, near the ID surface. The figure shows grain elongation adjacent to the fracture surface that is consistent with ductile overload.

Figure 62. Light photomicrograph of Mount M3 adjacent to the fracture surface, near the ID surface (2% Nital Etchant); area indicated in Figure 61.

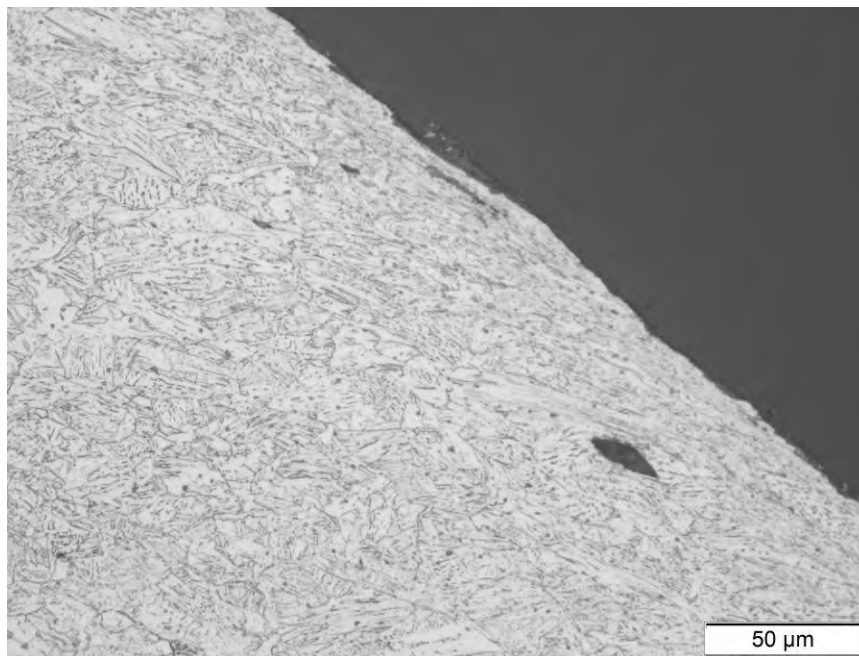
Figure 65. High magnification light photomicrograph of Mount M4 showing grain elongation adjacent to the fracture surface (2% Nital Etchant); area indicated in Figure 64.

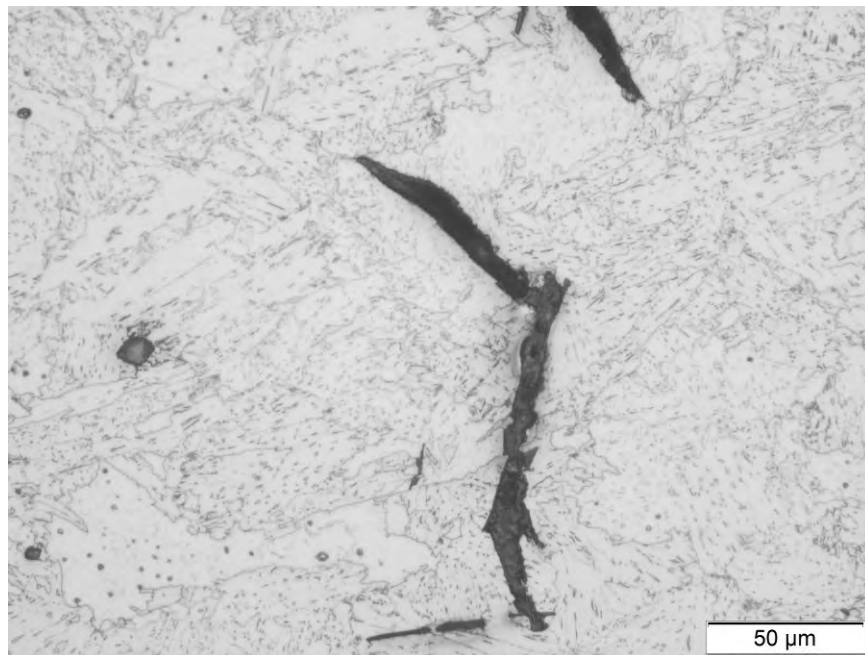
Figure 67. High magnification light photomicrograph of Mount M4 showing fissures (2% Nital Etchant); area indicated in Figure 66.

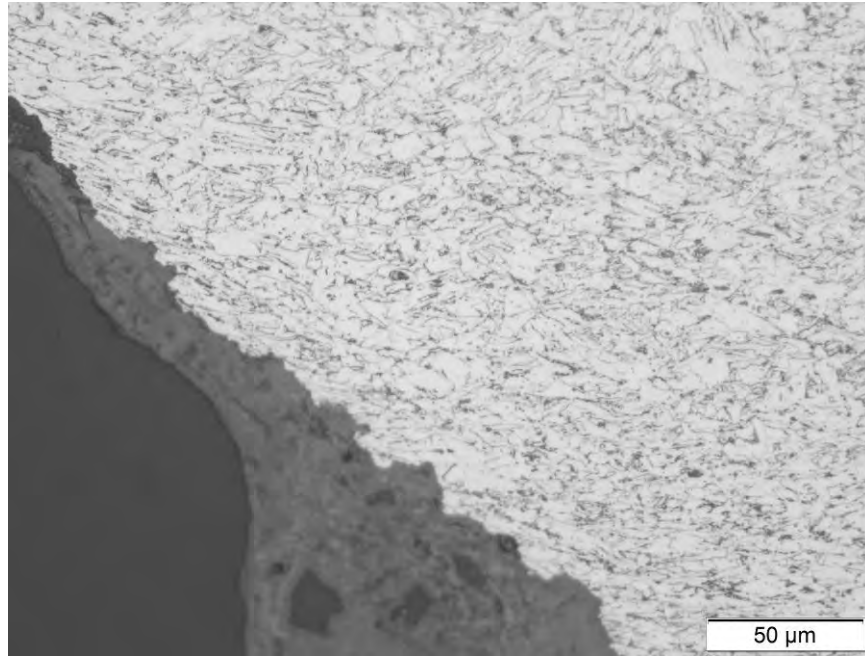
Figure 68. High magnification light photomicrograph of Mount M4 showing grain elongation adjacent to the fracture surface, near the ID surface (2% Nital Etchant); area indicated in Figure 66.

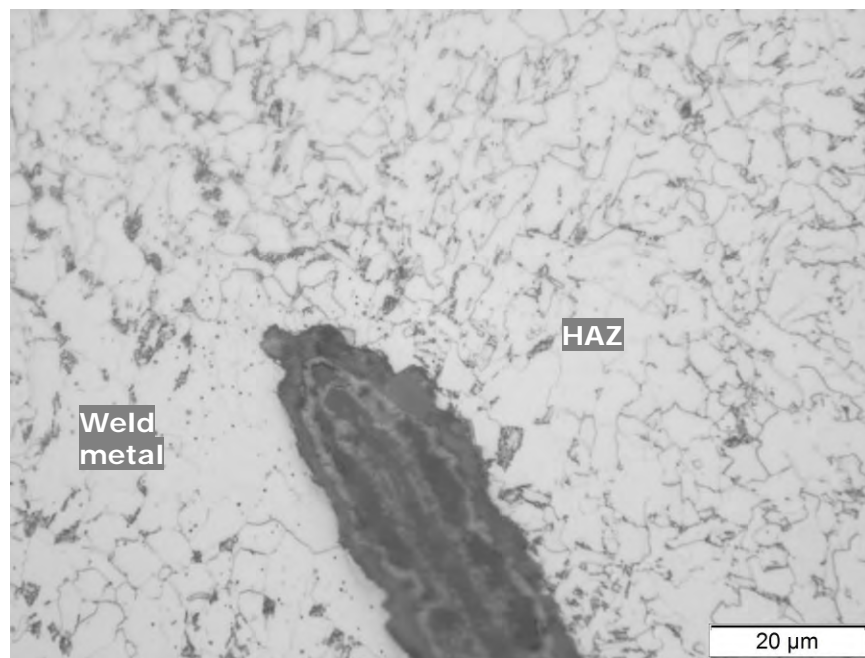
Figure 72. High magnification light photomicrograph of Mount MU1 at the tip of a shallow incomplete fusion (IF) flaw (2% Nital Etchant); area indicated in Figure 71.

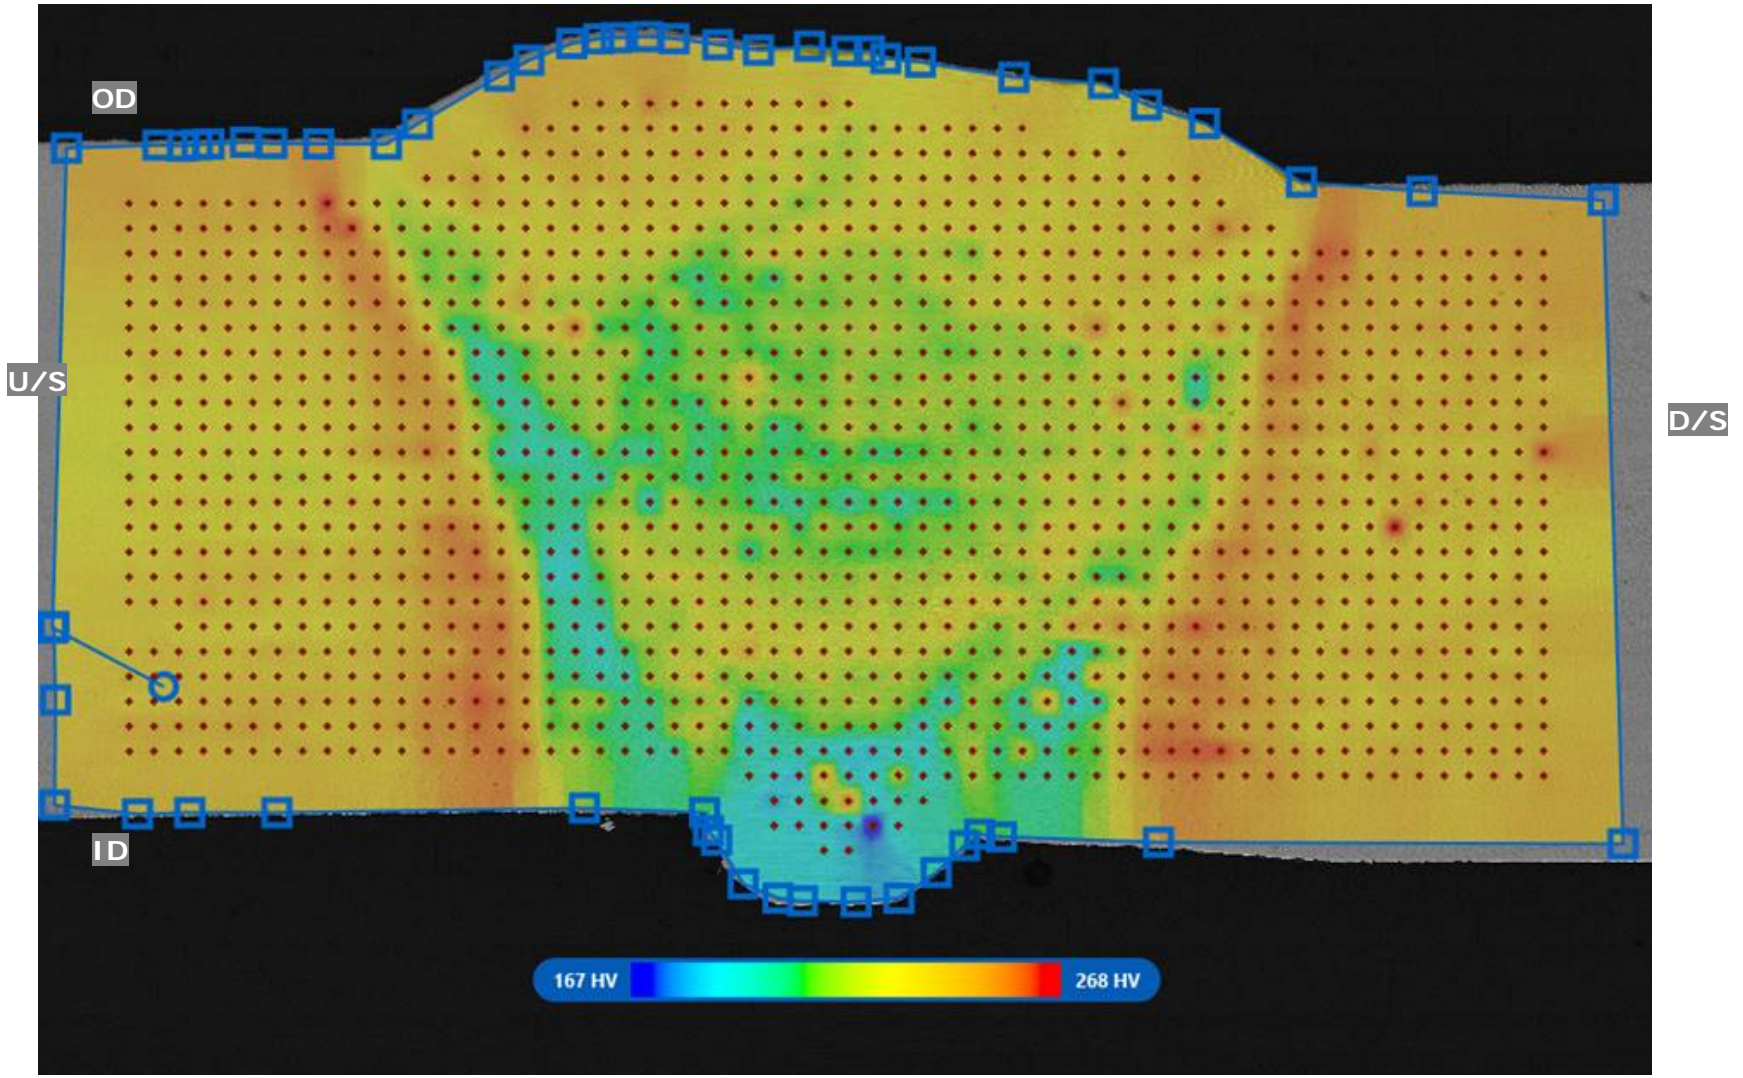
Figure 78. Hardness map overlay following hardness testing (Vickers 1 kg load) performed on Mount MU1.

The hardness montage for mount MU1 is provided in Figure 78 of the DNV Metallurgical Analysis Report (Appendix C).
