DOT US Department of Transportation  
PHMSA Pipeline and Hazardous Materials Safety Administration  
OPS Office of Pipeline Safety – Accident Investigation Division

**Principal Investigator** Wesley Mathews  
**Acting Accident Investigation Director** Chris Ruhl  
**Date of Report** May 26, 2022  
**Subject** Failure Investigation Report - Denbury Gulf Coast  
Pipelines, LLC – Pipeline Rupture/ Natural Force Damage

**Failure Investigation Report – Denbury Gulf Coast Pipelines LLC**  
**Pipeline Rupture/Natural Force Damage**  
February 22, 2020

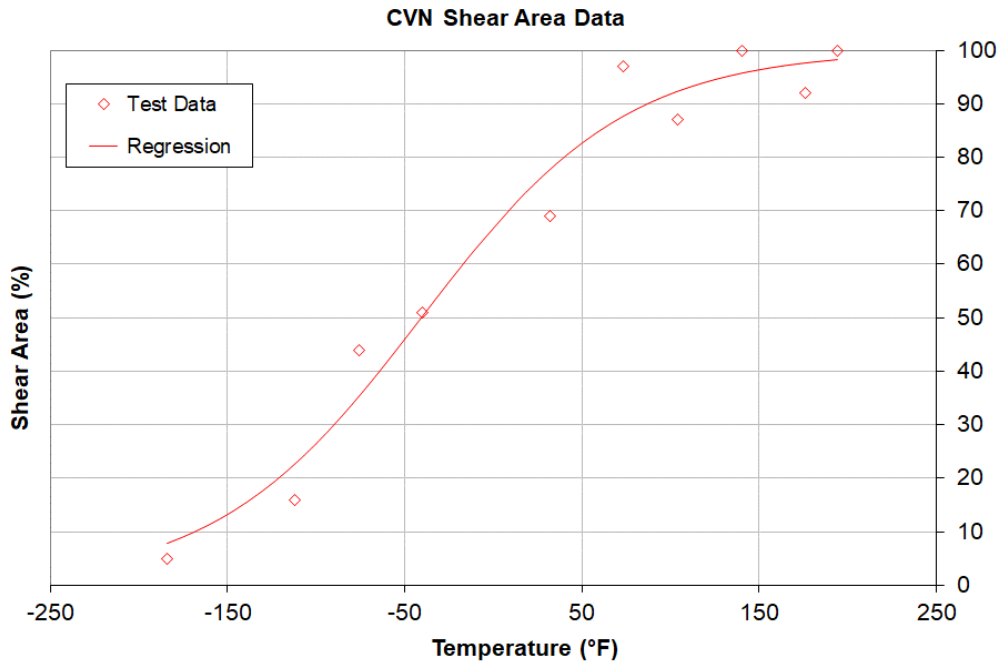
Table 6 shows the results of CVN testing for axial specimens removed from the intact girth weld (notch in the HAZ from PS C), while Figure 79 and Figure 80 show the Charpy percent shear and impact energy curves. An analysis of the data for the girth weld specimens indicates that the 85% FATT is 59.9°F and upper shelf Charpy energy is 114 ft lbs, as shown in Table 7. Both values are good for line pipe steel.

Figure 79. Percent shear from Charpy V-notch tests as a function of temperature for axial/cross-girth weld (HAZ notch) specimens removed from Pipe Section C.

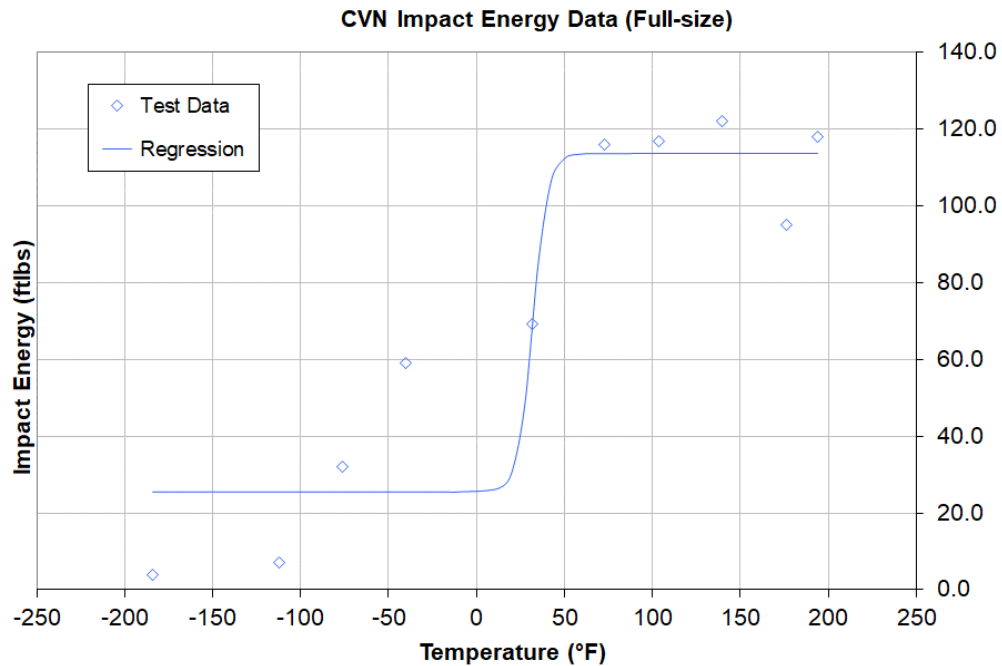
Figure 80. Charpy V-notch impact energy as a function of temperature for axial/cross-girth weld (HAZ notch) specimens removed from Pipe Section C.

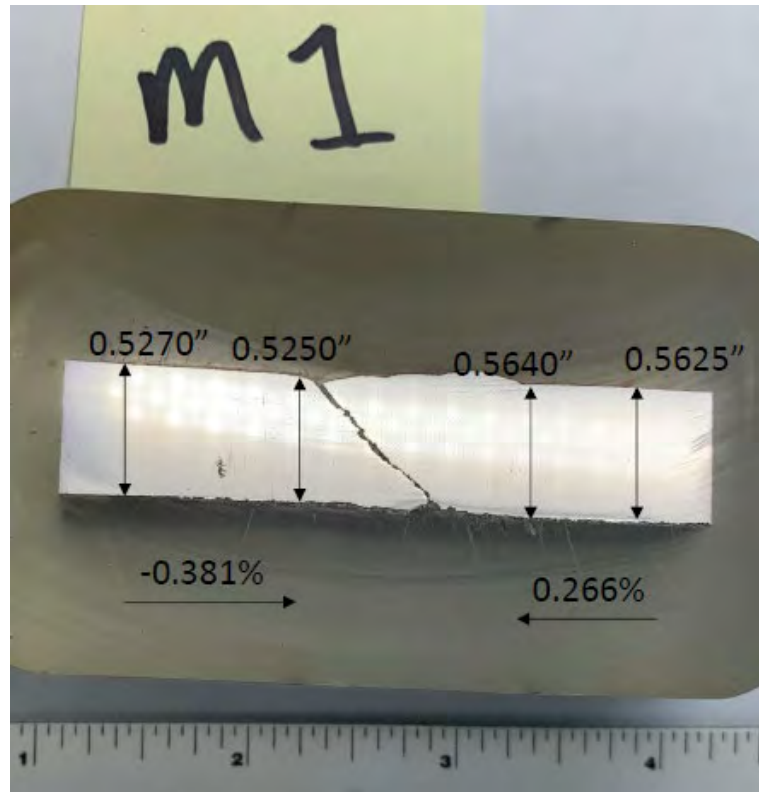
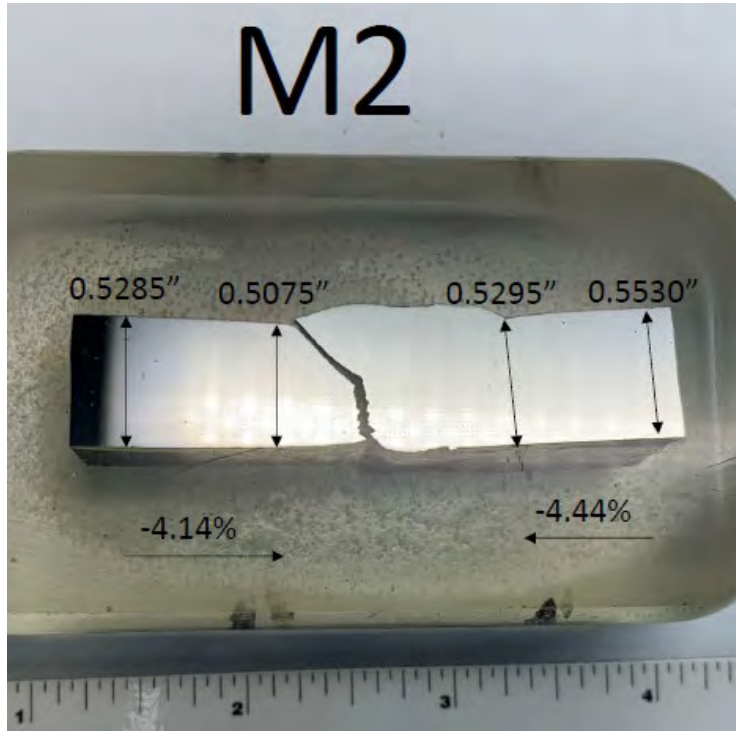
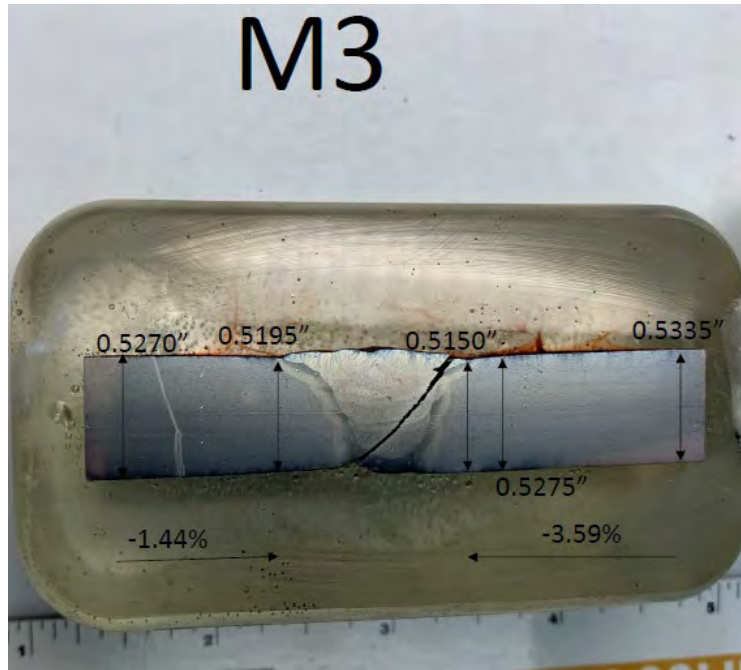
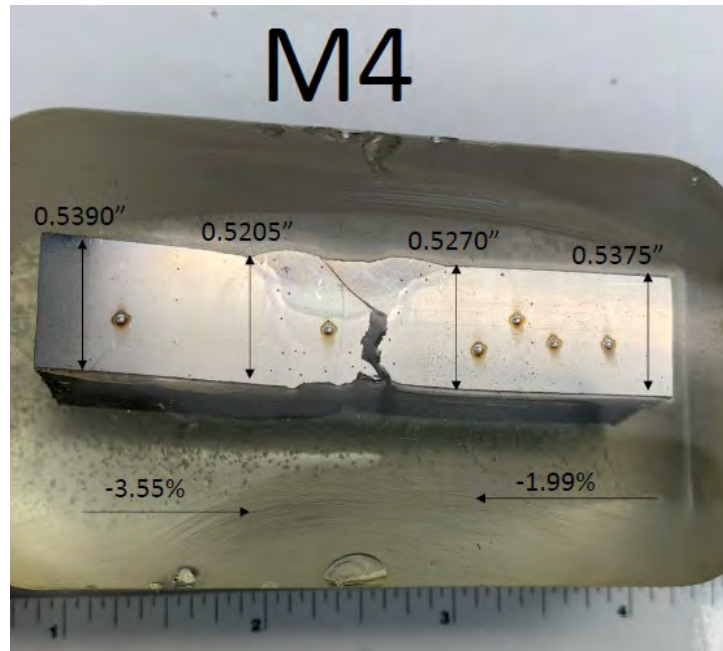
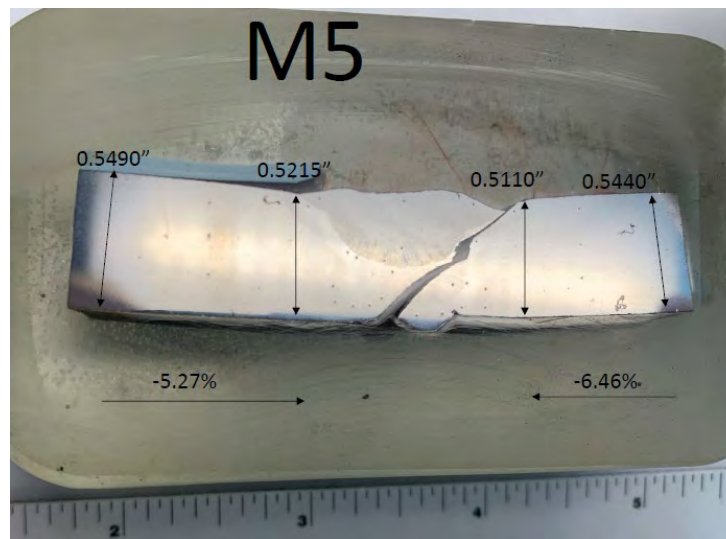
Evaluation of the metallurgical samples indicated slight reduction in wall thickness in each sample, ranging from 1.44% to 6.46%. Photos and measurements are provided in in figures 1 through 5 below:

These results are consistent with the characteristics of API X80M PSL 2 Line pipe.

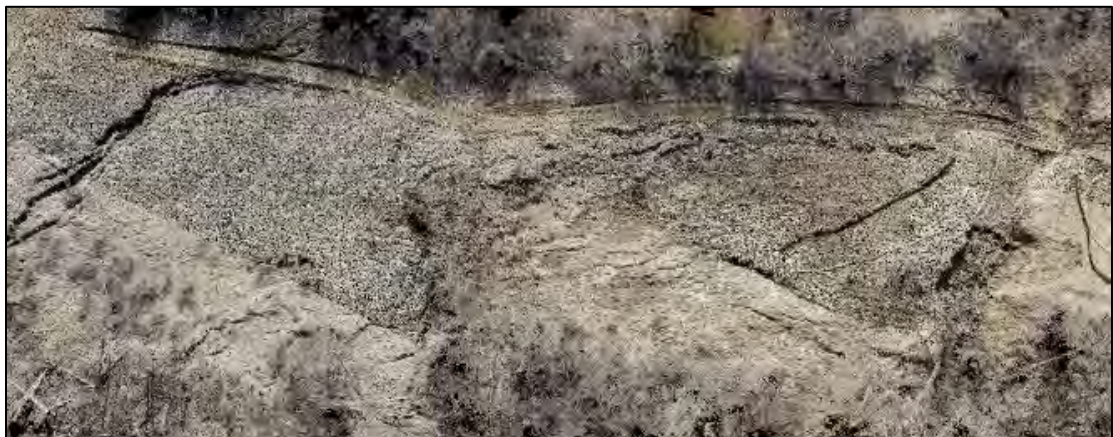
FIGURE 1: SOIL MOVEMENT PLAN VIEW

During the initial site visit, Mott MacDonald noticed evidence of soil movement along the ROW. The soil failure planes in the ROW extended approximately 900 ft at varying angles from 45° to 90°. Figure 1 and Figure 2 below show 3D photogrammetry scans taken of the ROW and displays the long linear failures.

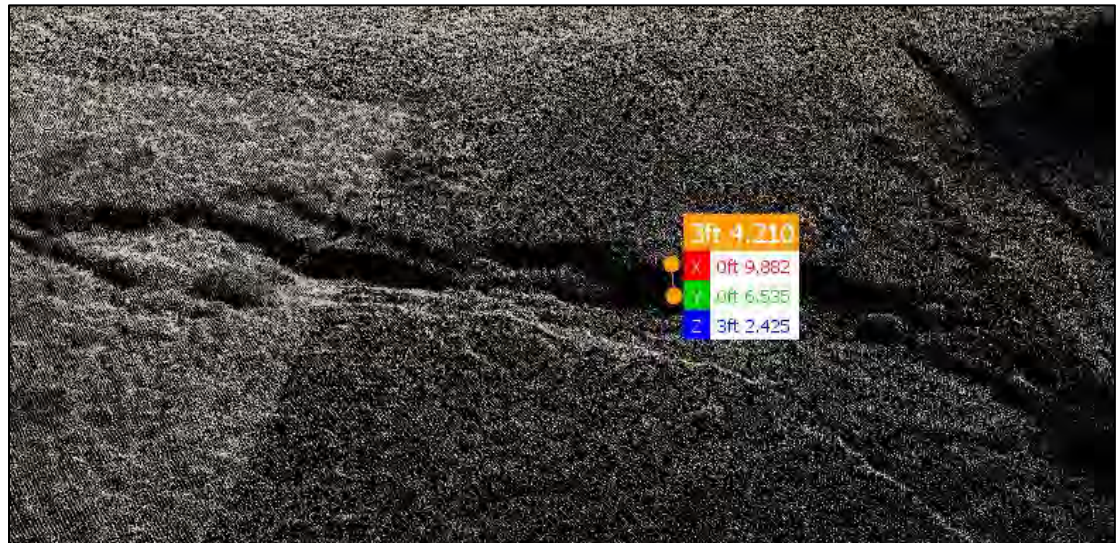
**FIGURE 3: SOIL FAILURE DEPTH**

The depth of the soil failures varied throughout the ROW, but as shown in Figure 3, the high level of detail captured with the 3D photogrammetry allowed for accurate measurements.

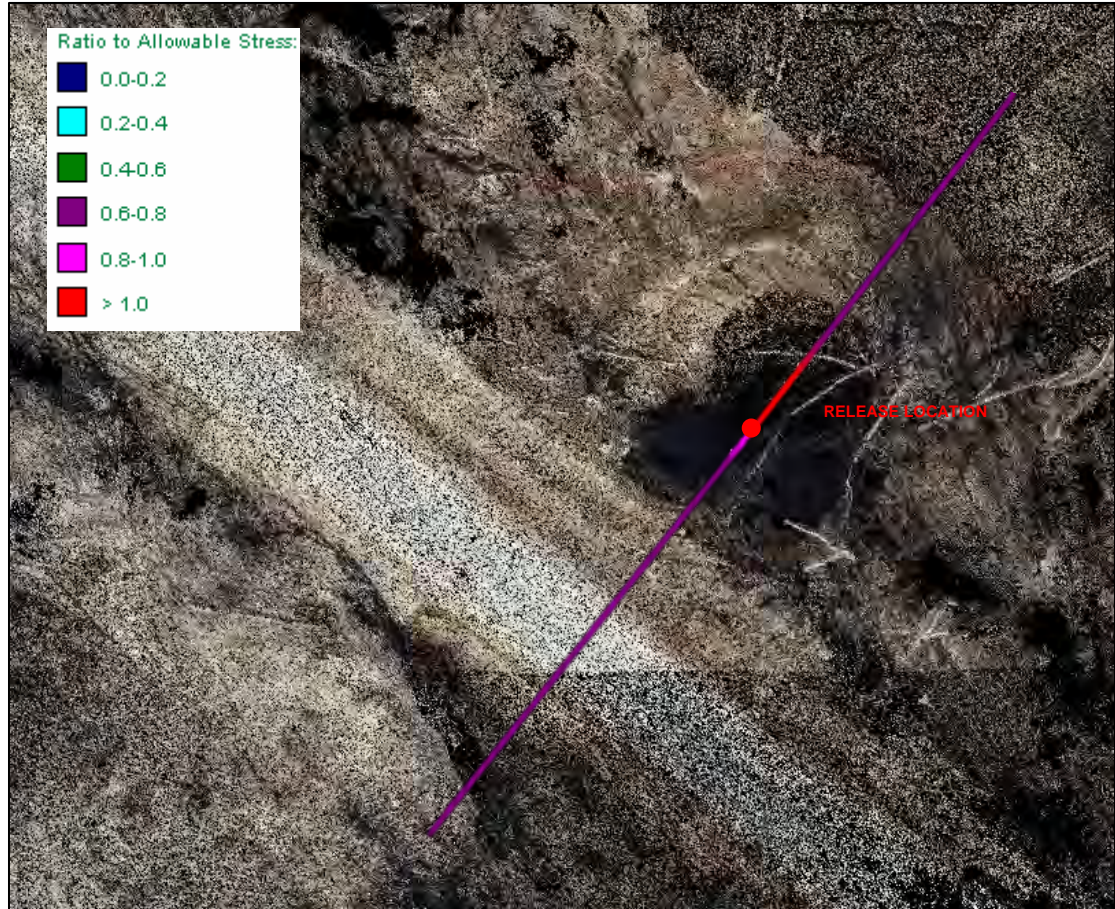
FIGURE 10: FAILURE LOCATION

The most significant stress values came from the external loading from soil movement. To establish a baseline, the stress team determined the maximum horizontal distributed load the pipe could withstand without rupture. Once the geotechnical team determined the estimated distributed loads, these numbers were compared. The comparison showed that the geotechnically determined loads exceeded the allowable horizontal distributed loads by more than 300 lbs/ft (2,800 lbs/ft vs. 2,475 lbs/ft).

As shown in Figure 10 below, the pipeline release location experienced excessive stress. The focal point of the stress at this location shows a maximum stress ratio of 1.43.

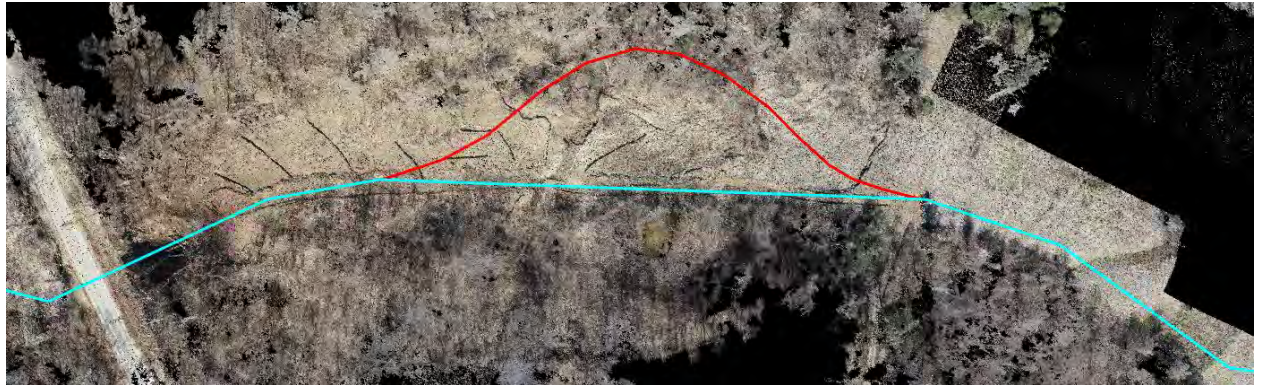
**FIGURE 11: DEFLECTION CURVE**

Figure 11 below shows an exaggerated deflection curve of the pipeline.

Mott MacDonald examined results as full design group to analyze the failure types and deflection curves. It was established that forces applied to the pipeline from the soil movement were significant enough to exceed the allowable stress limit of the Delhi Pipeline and likely was a contributing factor to the rupture.

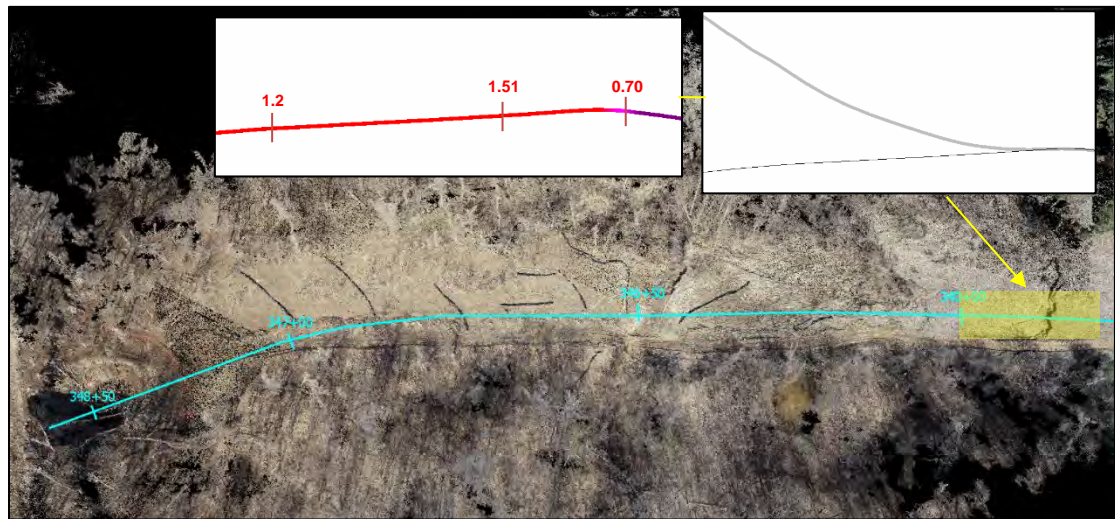
**FIGURE 12: RECOMMENDED**

The stress on the downstream side of 339+00 was caused by the restrained/unrestrained boundary condition created by the soil movement. This bending stress is the target of the relief exercise. The area shown in Figure 12 below, show a sharp rise in stress from a ratio of 0.70 to 1.51 in less than 50 ft. This boundary condition at the soil failure plane did not relieve after the pipeline failure and will have to be repaired.

Exposing at least 135 ft and removing and replacing as least a 10 ft section of pipe as recommended in the repair alleviates the overstressed boundary condition left by the soil movement and allows for safe transition between the two soil conditions. This recommendation is with the understanding that the remainder of the area of concern will be hydrotested as per ASME B31.4 to ensure the integrity of the pipe that experienced high tensile loads.
